Affiliated to Federation Internationale Des Experts En Automobile							
LONE	PAC INSURANCE	BHD	Ref : CC4/LPC19020665/Kda3s2					
300 BEACH ROAD #17-04/07 THE CONCOURSESINGAPORE 199555		Date: 02-10-2020 Code: LPC2

ADJUSTMENT ON REPAIR COST FOR VEHICLE NO. SMQ 8898E

PHOTOGRAPHS FOR VEHICLE NO. SMQ 8898E

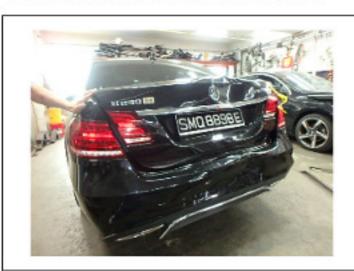
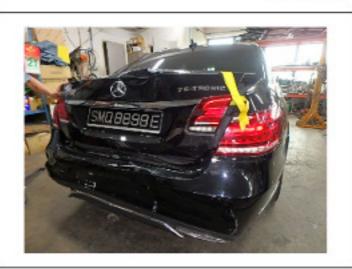
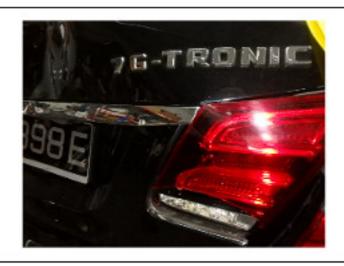
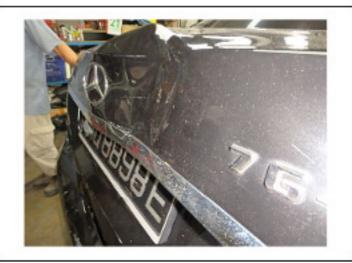
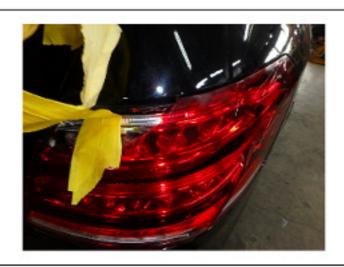
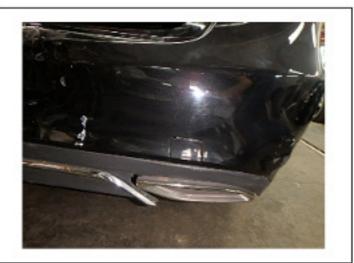
4.		•	on of Damages					
	THE VEHICLE SUS	STAINED DAMAGES AT THE REA	AR PORTION.					
	DAMAGES SEE DI	ETAILS.						
5.		General	Information					
	Accident Date	20/11/2019	Inspection Date	21/11/2019				
	Survey held at	CHENG HOE MOTOR PL						
		BLK 1019 YISHUN IND. PARK A #01-374/382 SINGAPORE 768761						
5a.		Re	emarks					
	A)THE INSPECTION WAS CONDUCTED ON A"WITHOUT PREJUDICE" BASIS. B)IN ACCORDANCE TO YOUR INSTRUCTIONS, WE HAVE NOT AUTHORISED REPAIRS.							
5b.	5b. Estimate Days of Repair							
	ESTIMATED NORMAL PERIOD FOR REPAIR: 7 Working Days

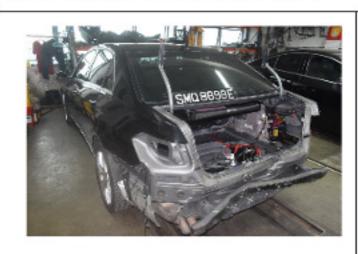
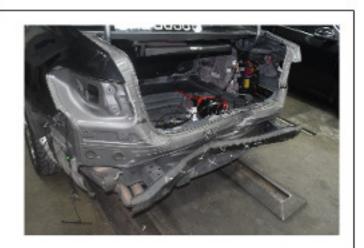
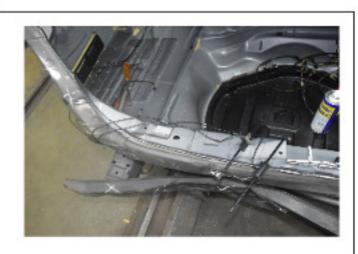
RE-INSPECTION

PHOTOGRAPHS FOR VEHICLE NO. SMQ 8898E
