## ADJUSTMENT ON REPAIR COST FOR VEHICLE NO. PC 4239Y

### PHOTOGRAPHS FOR VEHICLE NO. PC 4239Y

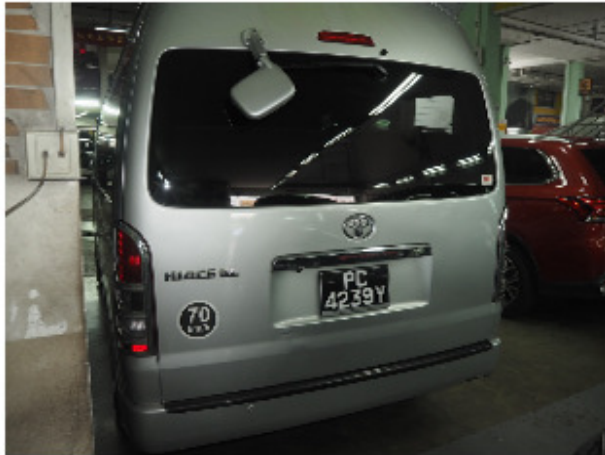
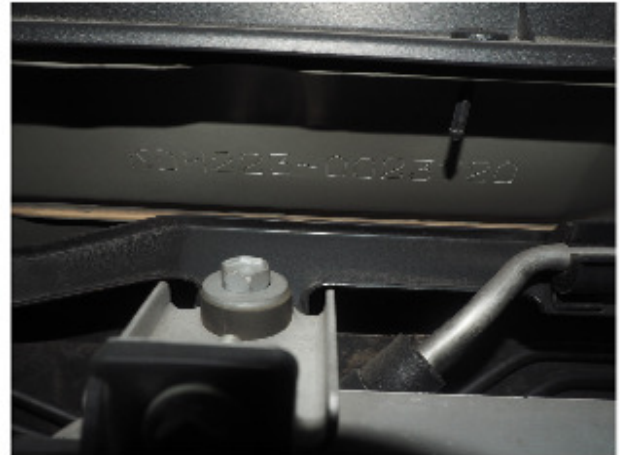
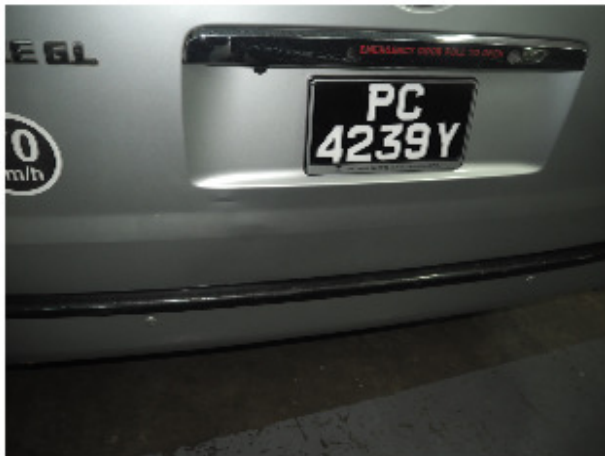
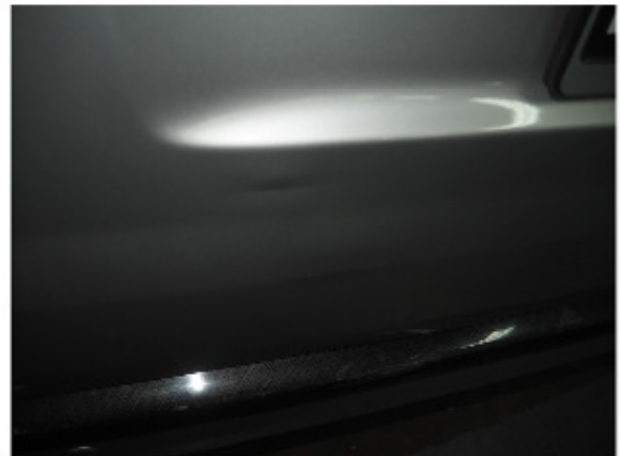
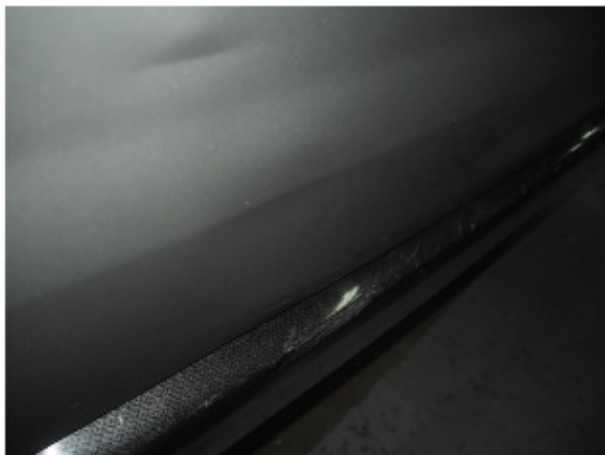
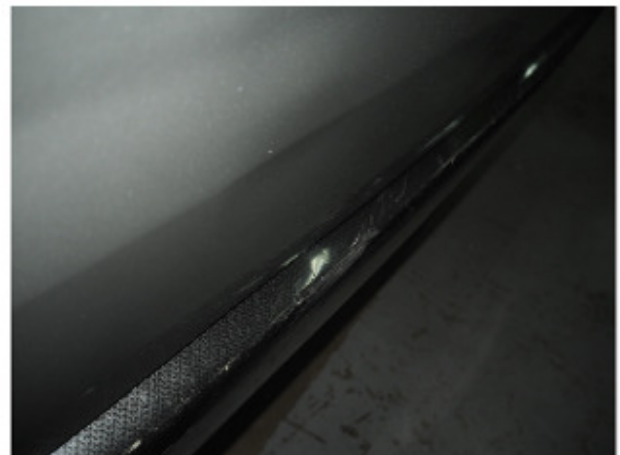
### INSPECTION

THE VEHICLE SUSTAINED DAMAGES AT THE REAR PORTION. DAMAGES SEE DETAILS.				
<b>5. General Information</b>				
Accident Date	14/11/2019	Inspection Date	20/11/2019	
Survey held at	HUA MENG SPRAY PAINTING WORKSHOP 1 KAKI BUKIT AVE 6 #01-61 AUTOBAY SINGAPORE 417883			
<b>5a. Remarks</b>				
A)THE INSPECTION WAS CONDUCTED ON A"WITHOUT PREJUDICE" BASIS. B)IN ACCORDANCE TO YOUR INSTRUCTIONS, WE HAVE NOT AUTHORISED REPAIRS.				
<b>5b. Estimate Days of Repair</b>				
ESTIMATED NORMAL PERIOD FOR REPAIR:		<b>5 Working Days</b>

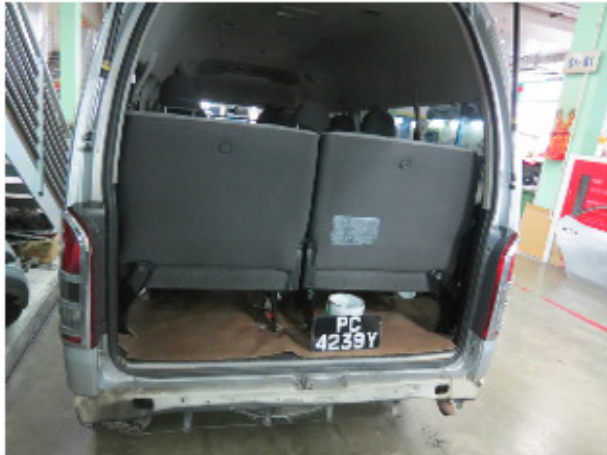
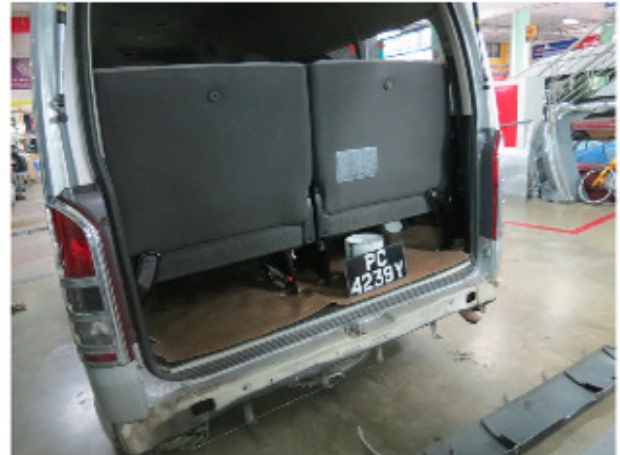
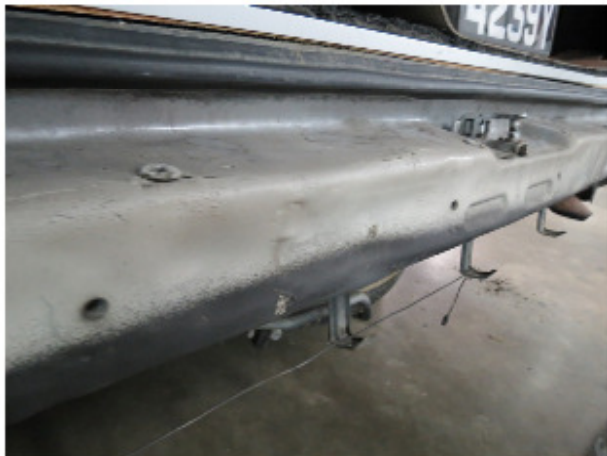
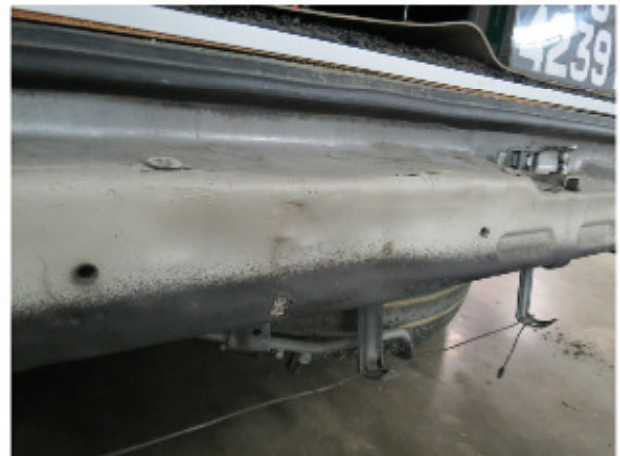
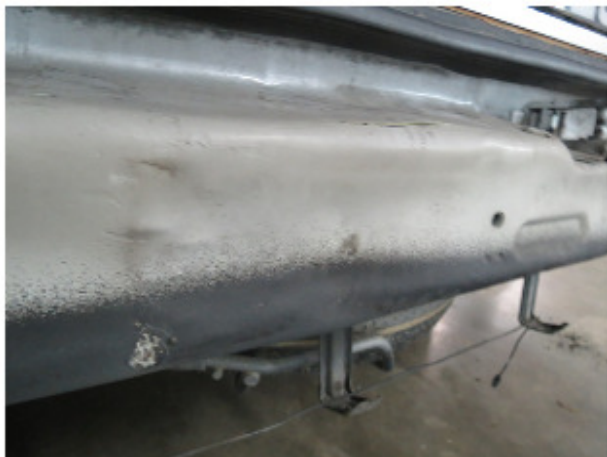
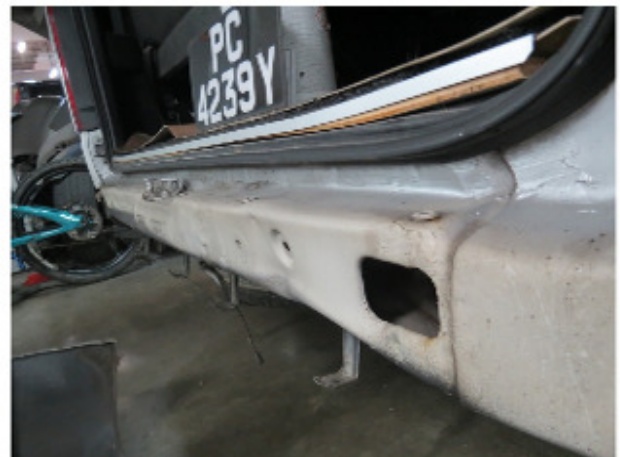
RE-INSPECTION

PHOTOGRAPHS FOR VEHICLE NO. PC 4239Y
