UNITED Appraisal And Management Pte Ltd

Re : Third Party Claim For Vehicle Registration No. SJP8716M

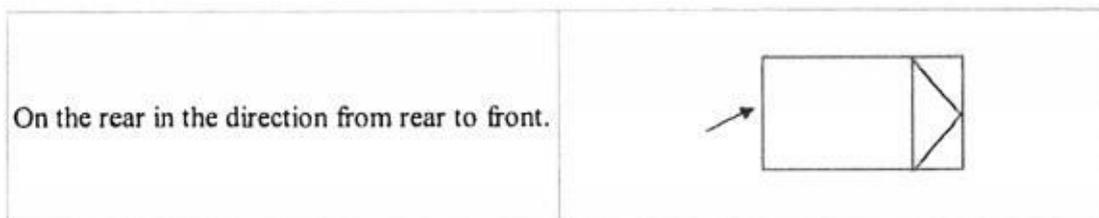
POINT OF IMPACT

The impact of the collision has damaged / affected the bootlid, rear bumper, taillamps, rear end panel, rear fender and etc...

THE VEHICLE SUSTAINED DAMAGES AT THE REAR PORTION.
DAMAGES SEE DETAILS.
