## LKK Auto Consultants Pte Ltd

### ADJUSTMENT ON REPAIR COST FOR VEHICLE NO. SMP 3711Z

PHOTOGRAPHS FOR VEHICLE NO. SMP 3711Z

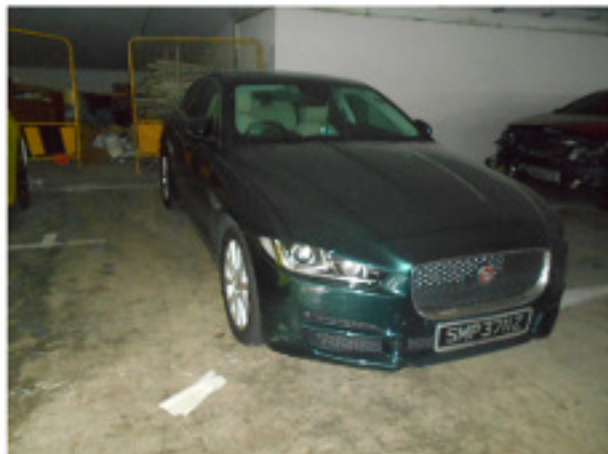
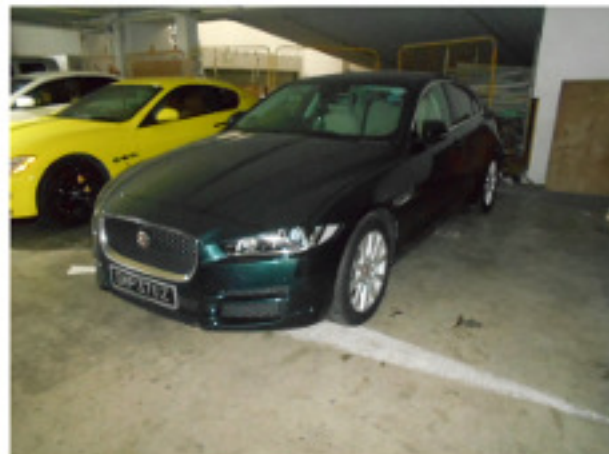
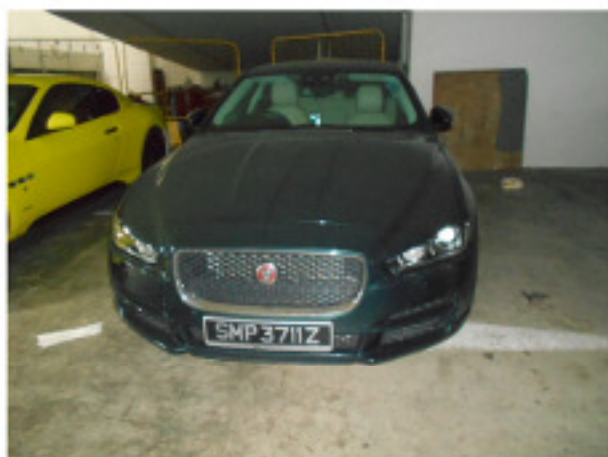
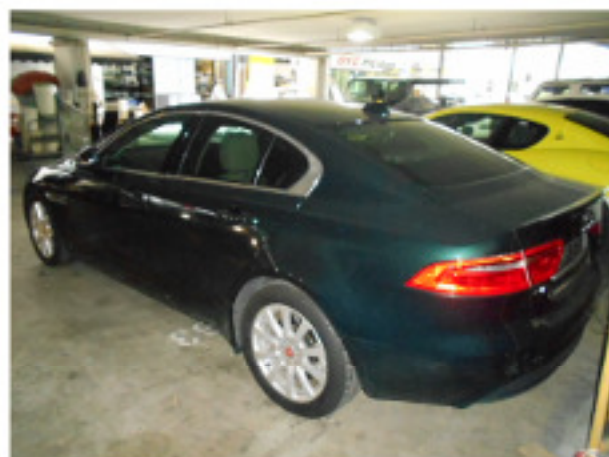
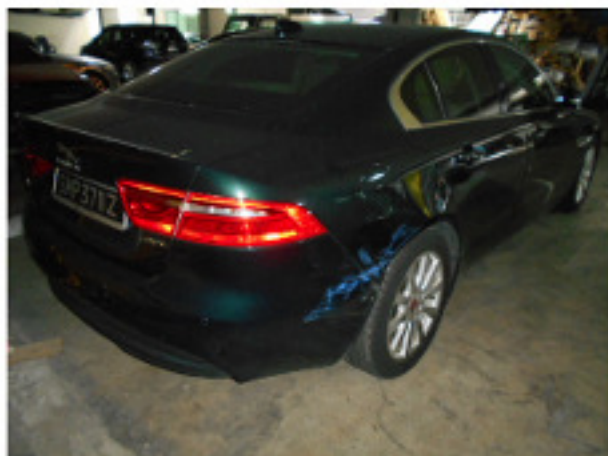
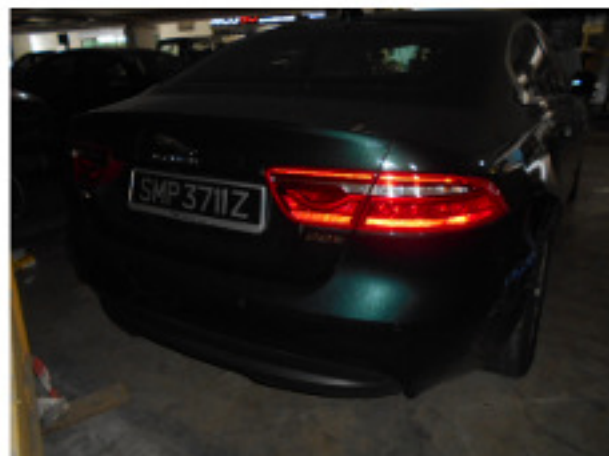
THE VEHICLE SUSTAINED DAMAGES AT THE O/S BODY. DAMAGES SEE DETAILS.
--

INSPECTION

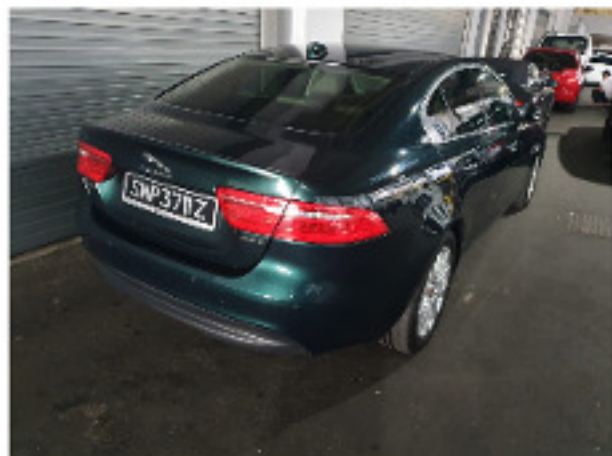
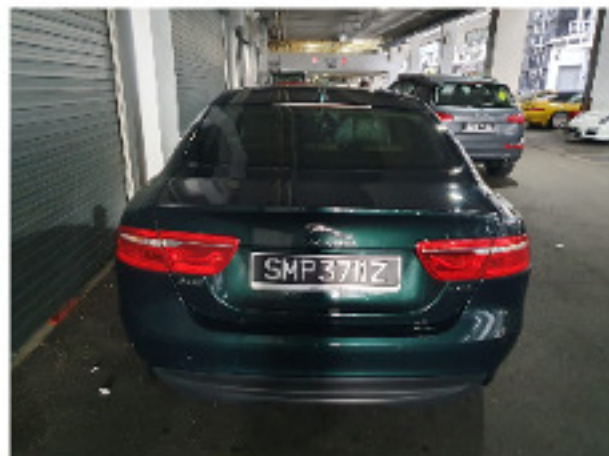
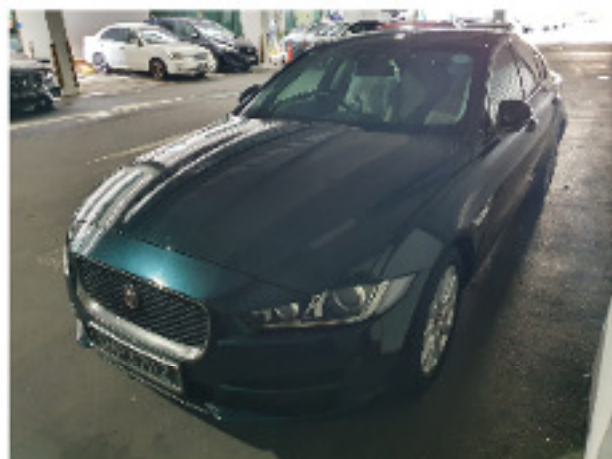
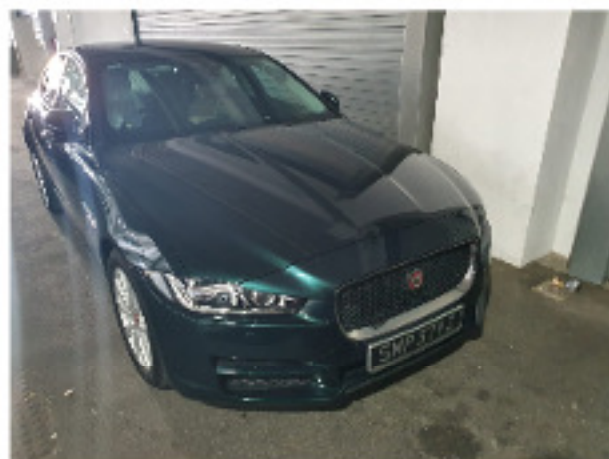
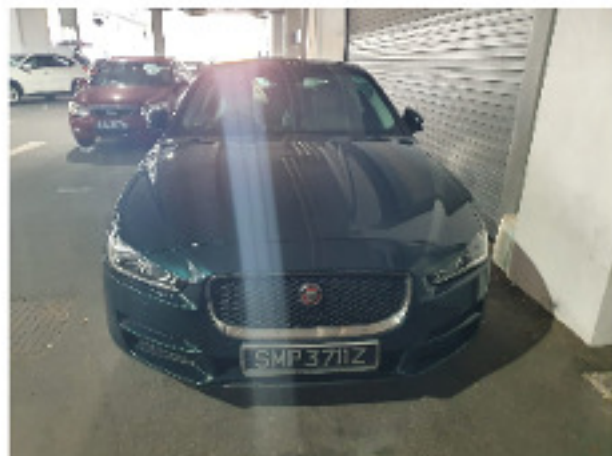
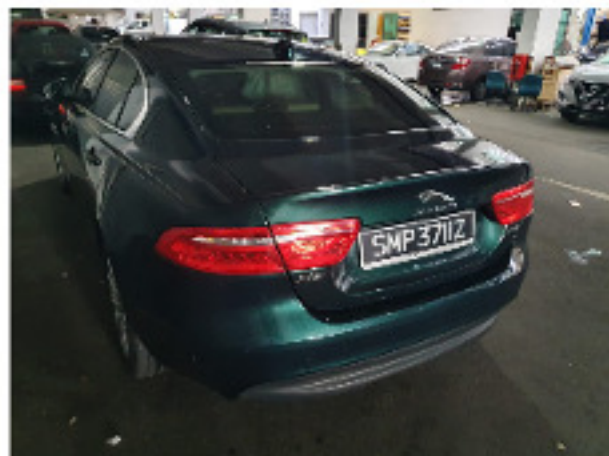
PHOTOGRAPHS FOR VEHICLE NO. SMP 3711Z

RE-INSPECTION
