LKK Auto Consultants Pte Ltd

PROFESSIONAL SERVICE FEE

Vehicle No. PA 8798J
Insured Veh. SHC 1909L
Claim No. D19007645MFSH/1
Policy No. D-19092580MFSH
Accident Date 01/12/2019
Inspection Date 10/12/2019

ADJUSTMENT ON REPAIR COST FOR VEHICLE NO. PA 8798J

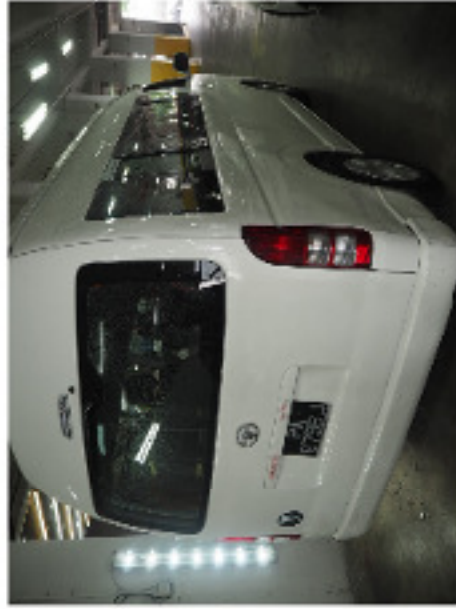
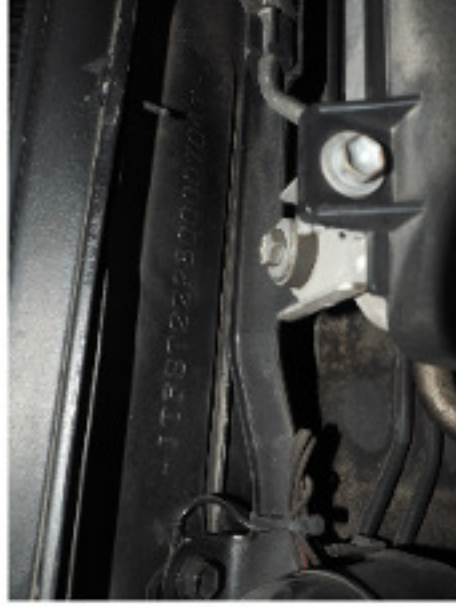
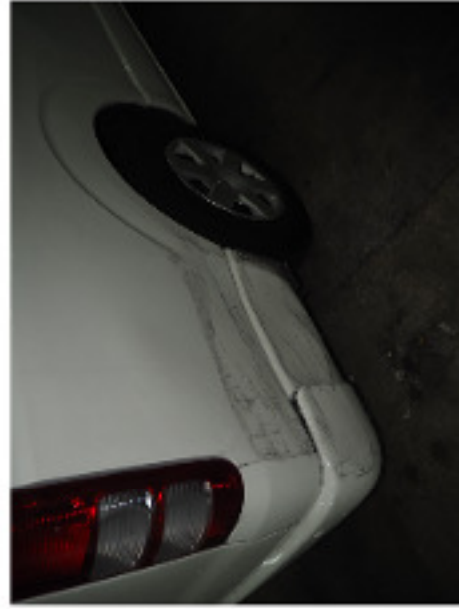
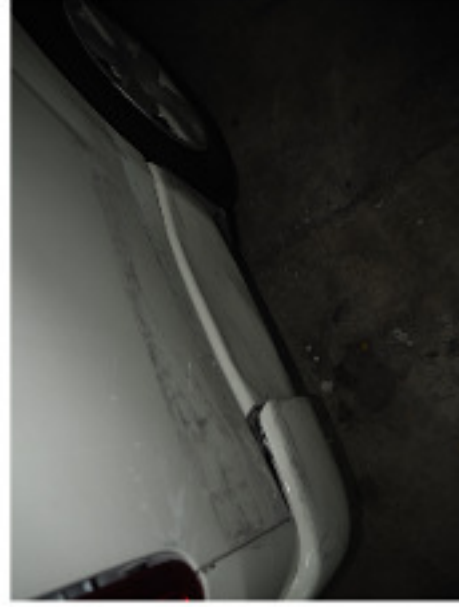
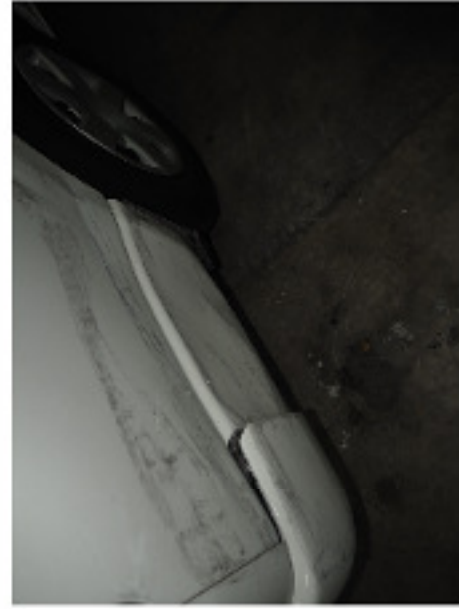
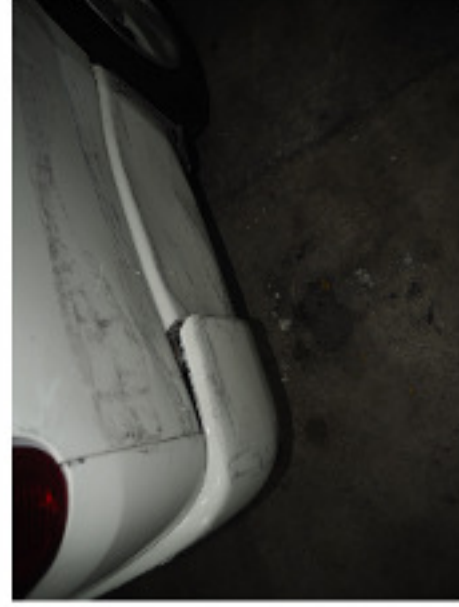
PHOTOGRAPHS FOR VEHICLE NO. PA 8798J

4. Description of Damages				
THE VEHICLE SUSTAINED DAMAGES AT THE O/S BODY. DAMAGES SEE DETAILS.				
5. General Information				
Accident Date	01/12/2019	Inspection Date	10/12/2019	
Survey held at	MG SOLUTION PTE LTD 23 KAKI BUKIT AVE 4 (SOUTH WING) #02-03B VICOM INSPECTION CENTRE, SINGAPORE 415933			
5a. Remarks				
A)THE INSPECTION WAS CONDUCTED ON A"WITHOUT PREJUDICE" BASIS. B)IN ACCORDANCE TO YOUR INSTRUCTIONS, WE HAVE NOT AUTHORISED REPAIRS.				
5b. Estimate Days of Repair				
ESTIMATED NORMAL PERIOD FOR REPAIR:		5 Working Days

INSPECTION

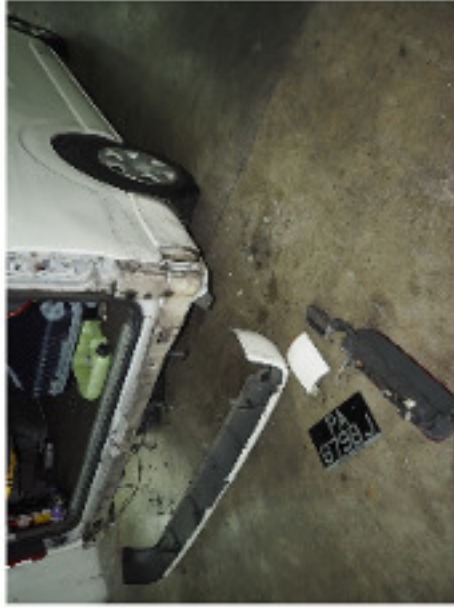
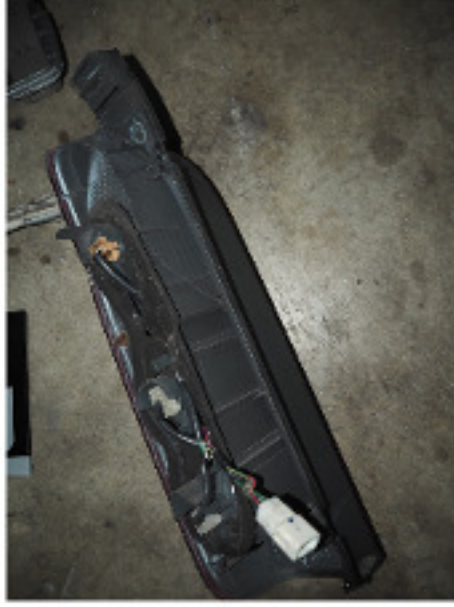
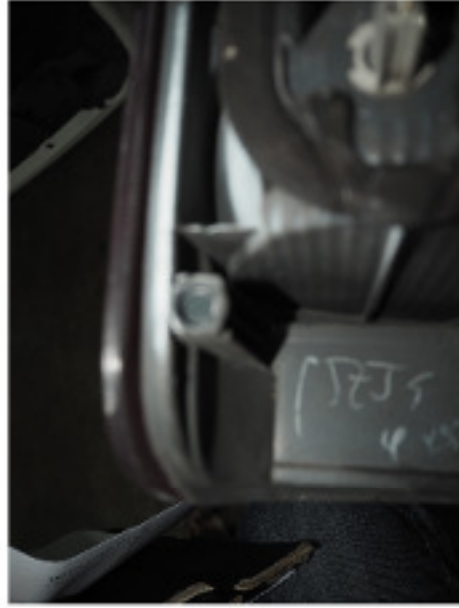
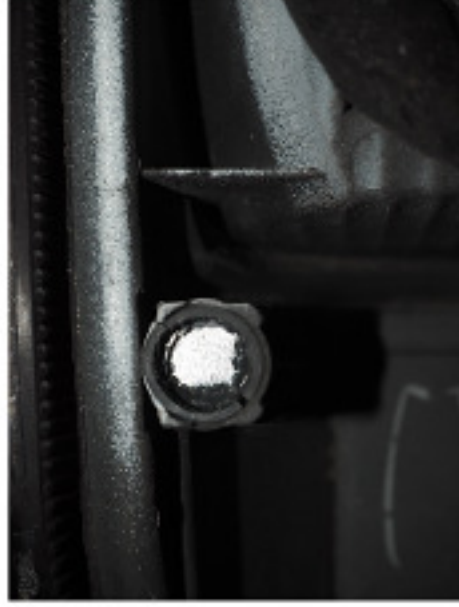
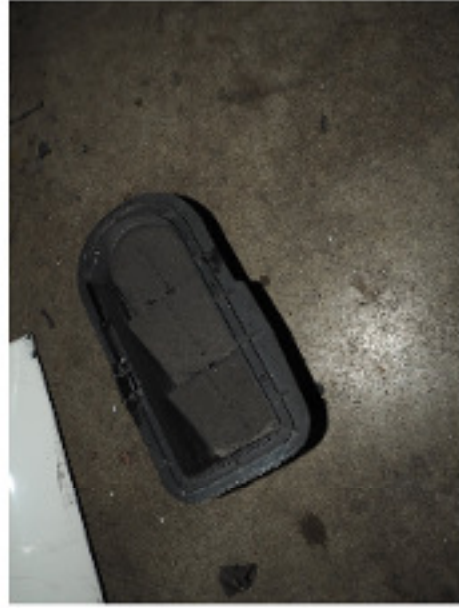
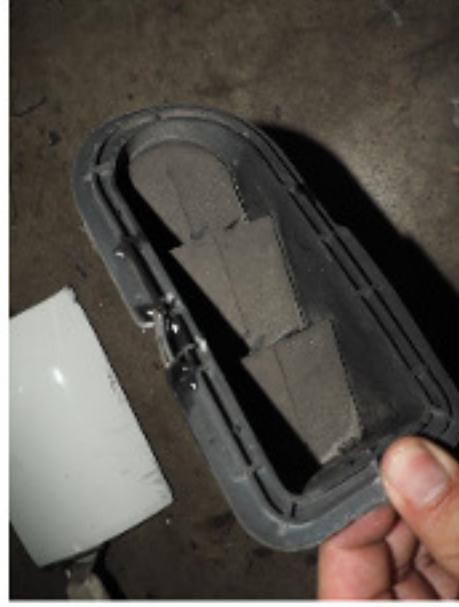
PHOTOGRAPHS FOR VEHICLE NO. PA 8798J

RE-INSPECTION
