## LKK Auto Consultants Pte Ltd

## ADJUSTMENT ON REPAIR COST FOR VEHICLE NO. SHD 1859S

PHOTOGRAPHS FOR VEHICLE NO. SHD 1859S

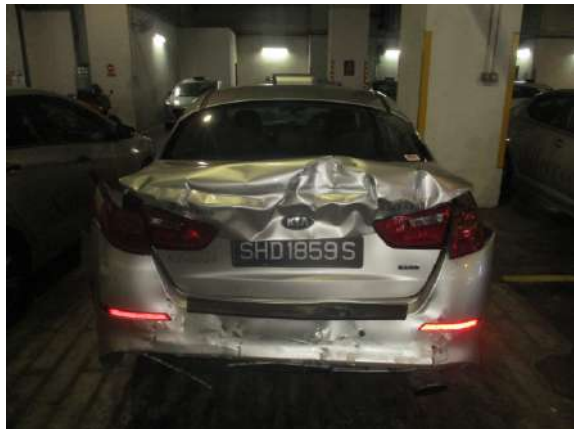
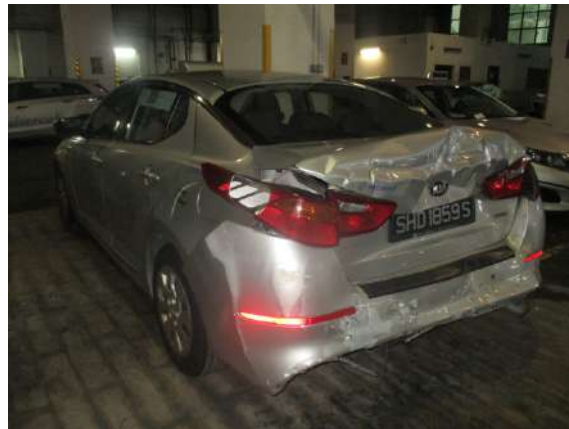
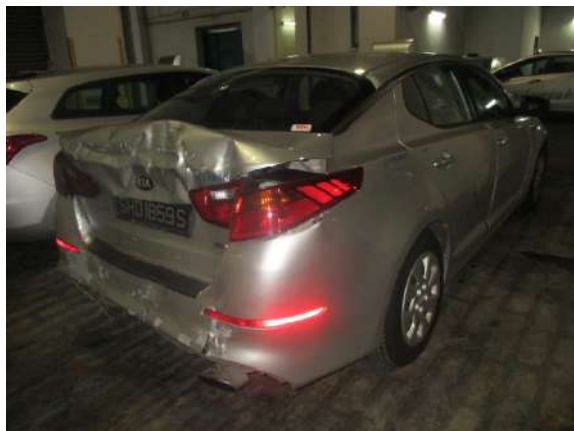
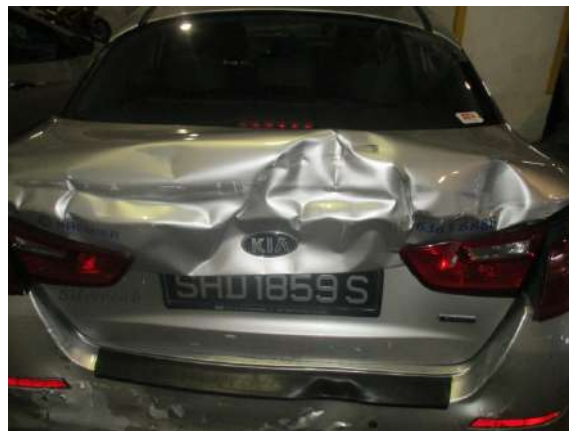
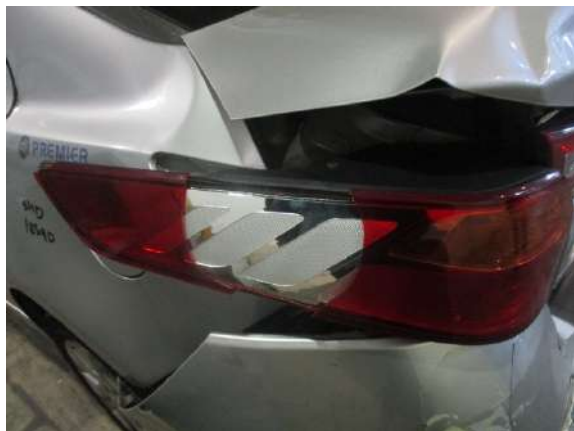
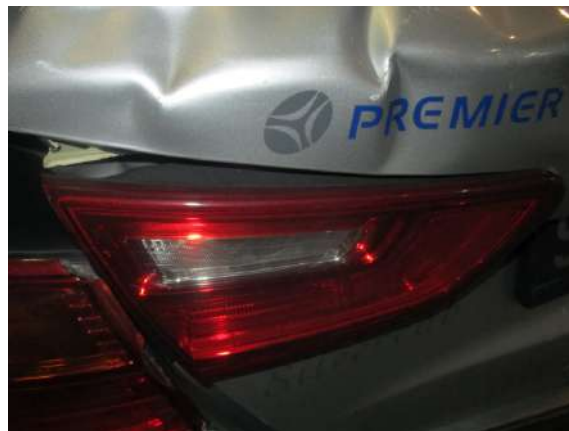
INSPECTION

| Affiliated to Federation Internationale Des Experts En Automobile | | | | |
|---|---|---|---|---|
| | THE VEHICLE SUSTAINED DAMAGES AT THE FRONT & REAR PORTION.<br>DAMAGES SEE DETAILS. | | | |
