LKK Auto Consultants Pte Ltd

TAX INVOICE

Vehicle No. SMG 8870L
Insured Veh. YN 9893K
Claim No. CMTD1905755/MYE
Policy No.
Accident Date 09/12/2019
Inspection Date 16/12/2019

ADJUSTMENT ON REPAIR COST FOR VEHICLE NO. SMG 8870L

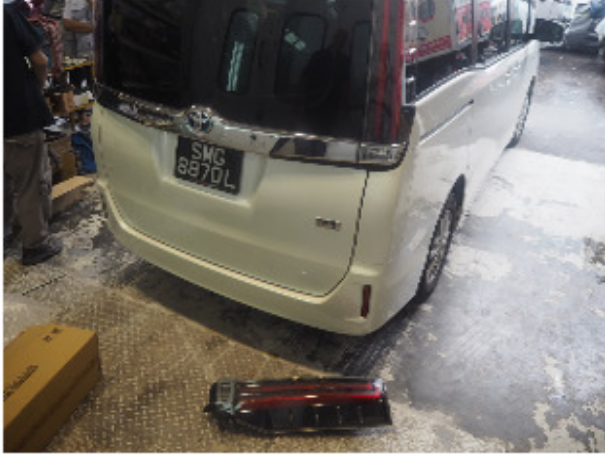
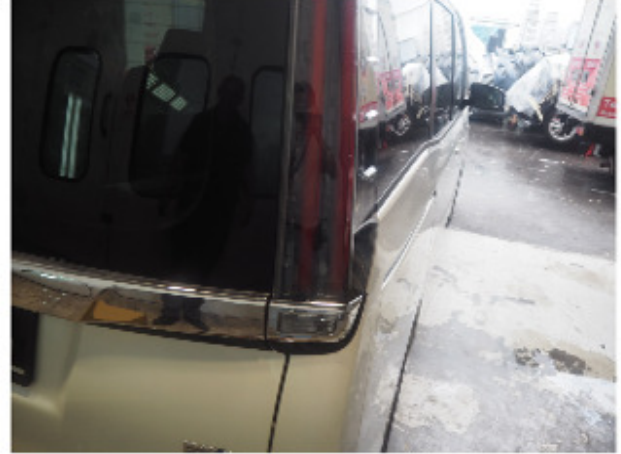
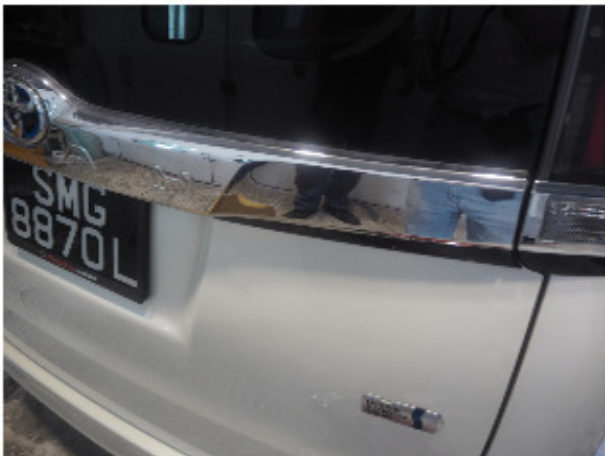
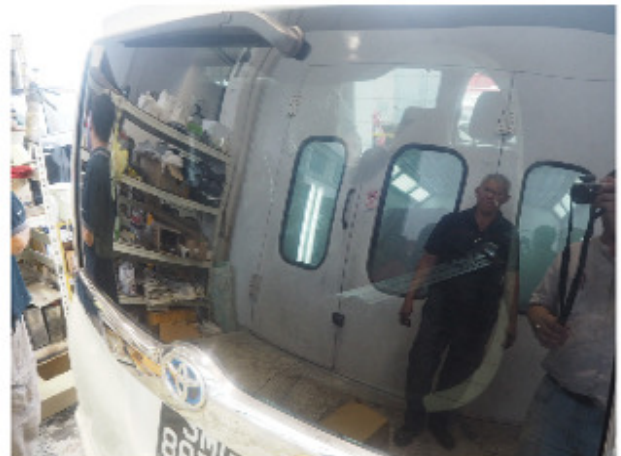
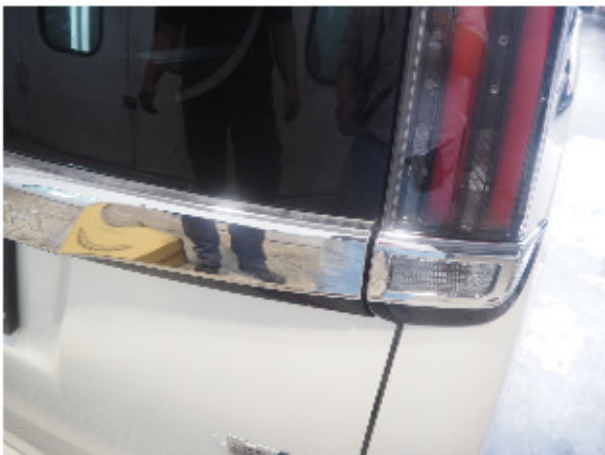
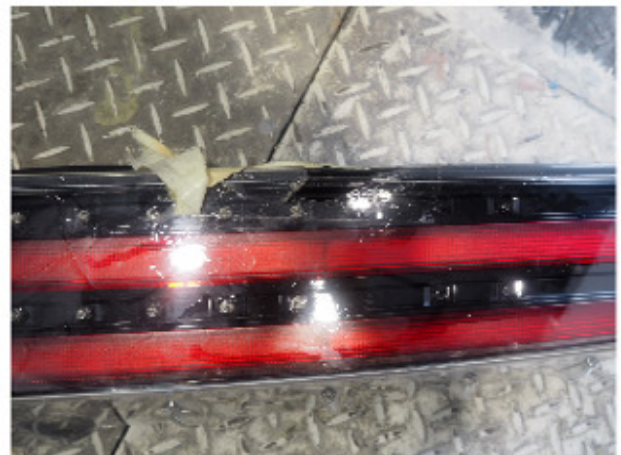
PHOTOGRAPHS FOR VEHICLE NO. SMG 8870L

RE-INSPECTION

THE VEHICLE SUSTAINED DAMAGES AT THE REAR PORTION.
