## ASSIGNMENT (Office)

To inspect Vehicle No:

G6J 5745A

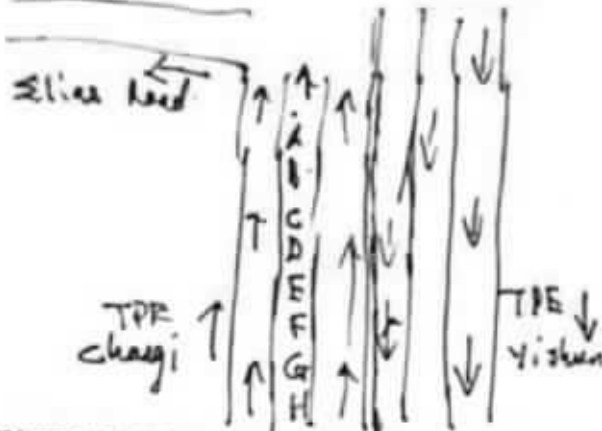
### SKETCH PLAN

- A SLV 7037R  
B SLJ 5849R  
C GY 3652J  
D SGX 4895Z  
E SJS 6305M  
F SKQ 5830T  
G GBJ 5745A  
H YP 4250M
