LKK Auto Consultants Pte Ltd

ADJUSTMENT ON REPAIR COST FOR VEHICLE NO. SJP 860G

PHOTOGRAPHS FOR VEHICLE NO. SJP 860G

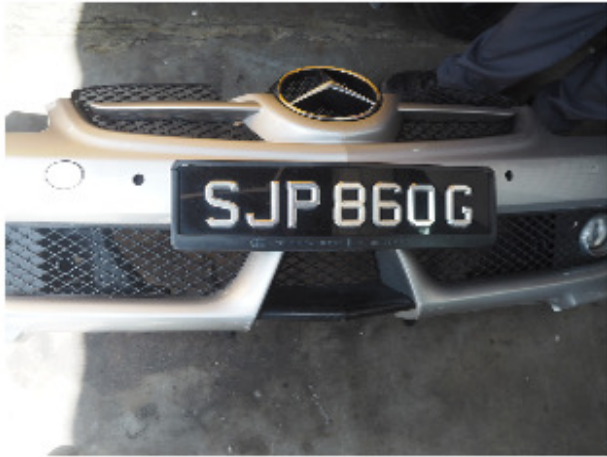
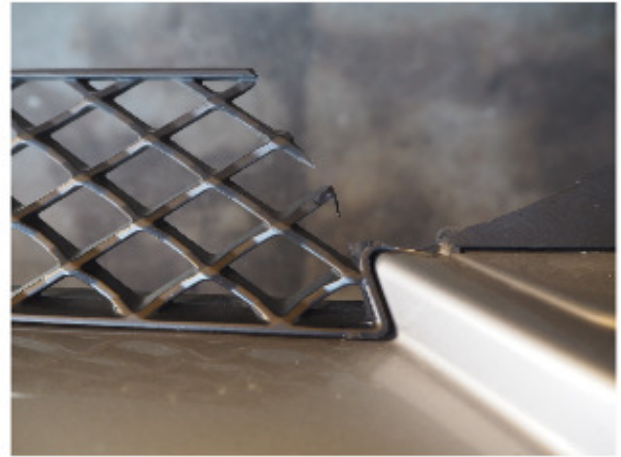
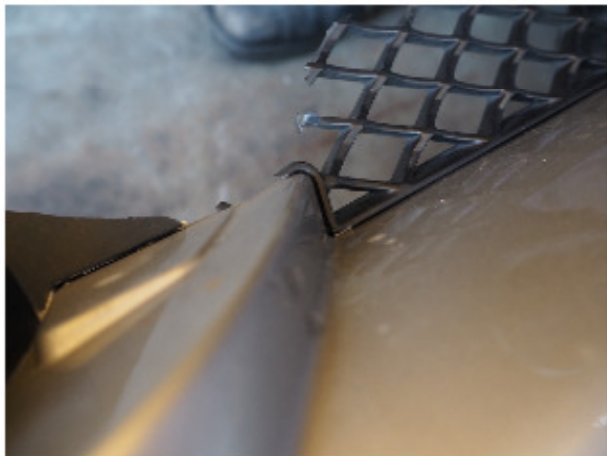
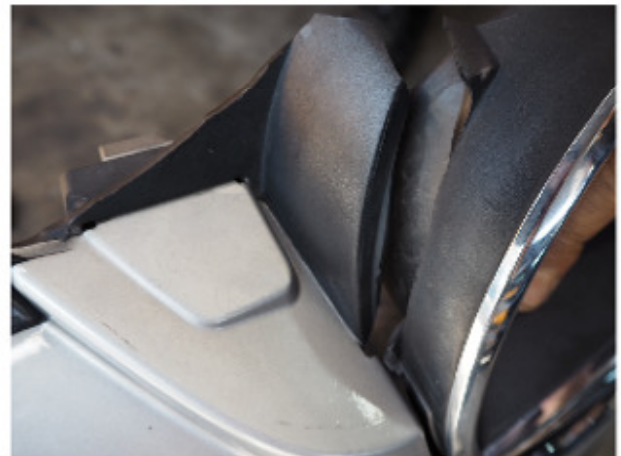
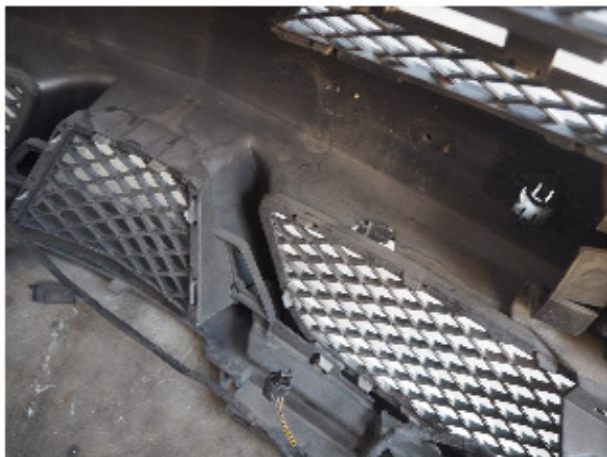
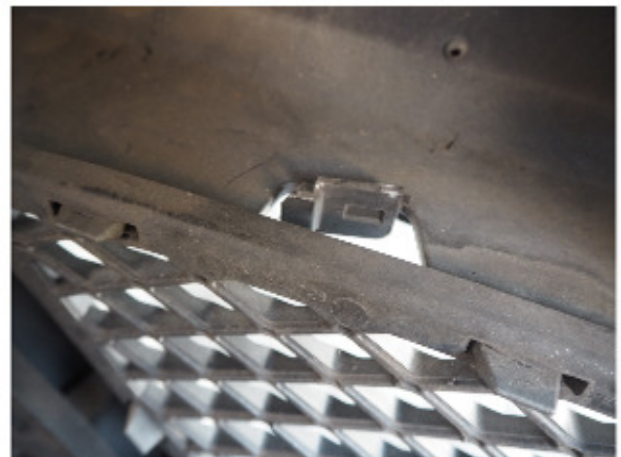
RE-INSPECTION

THE VEHICLE SUSTAINED DAMAGES AT THE FRONT PORTION. DAMAGES SEE DETAILS.
