## LKK Auto Consultants Pte Ltd

### PROFESSIONAL SERVICE FEE

Vehicle No. SLD 1710P  
Insured Veh. SHD 3576U  
Claim No. D20000062MFSH  
Policy No. D-19092580MFSH  
Accident Date 27/12/2019  
Inspection Date 02/01/2020

## ADJUSTMENT ON REPAIR COST FOR VEHICLE NO. SLD 1710P

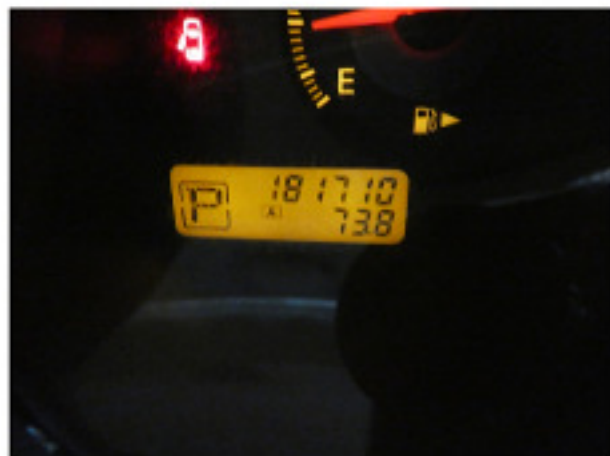
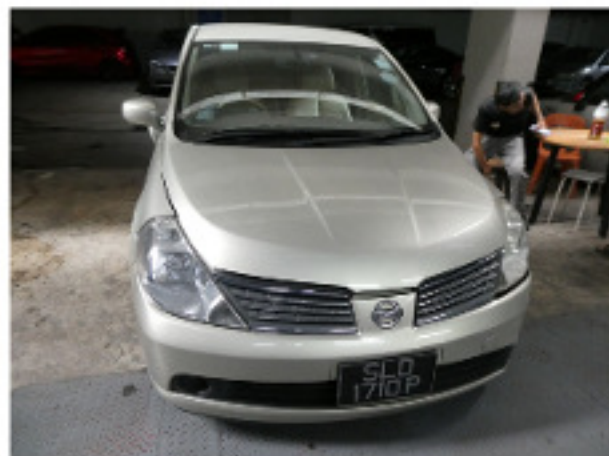
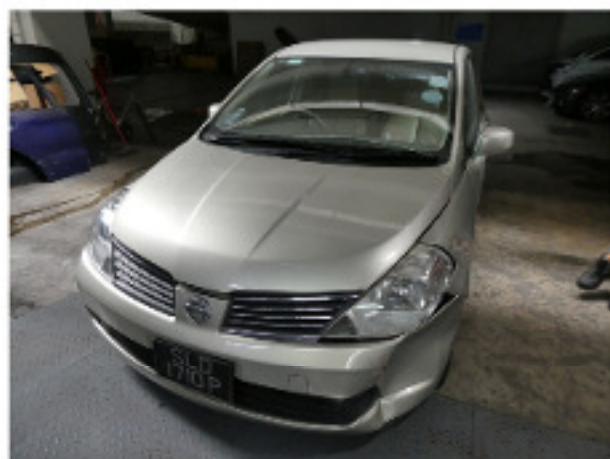
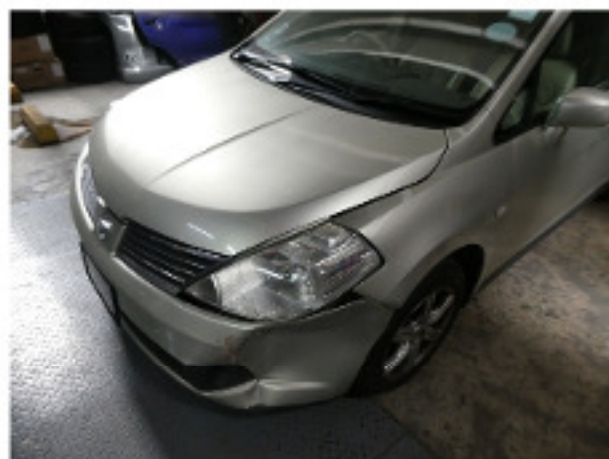
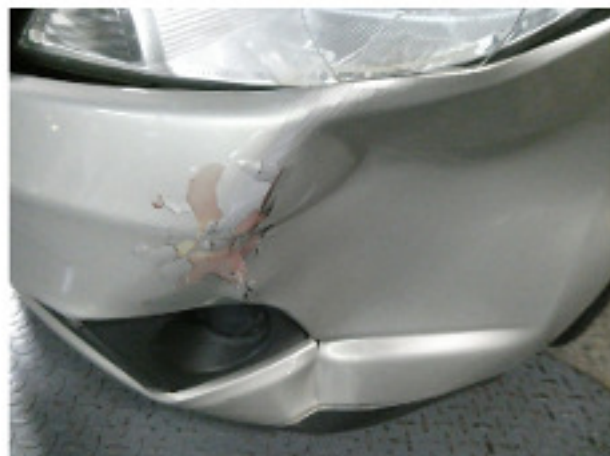
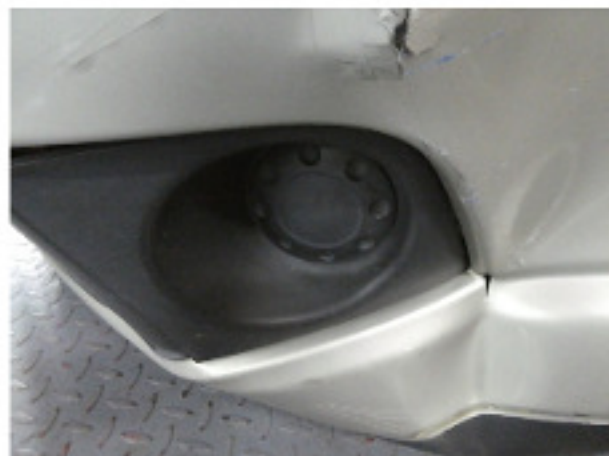
PHOTOGRAPHS FOR VEHICLE NO. SLD 1710P

| Affiliated to Federation Internationale Des Experts En Automobile | | | | |
|---|---|---|---|--|
| THE VEHICLE SUSTAINED DAMAGES AT THE FRONT N/S PORTION.<br><br>DAMAGES SEE DETAILS | | | | |

INSPECTION

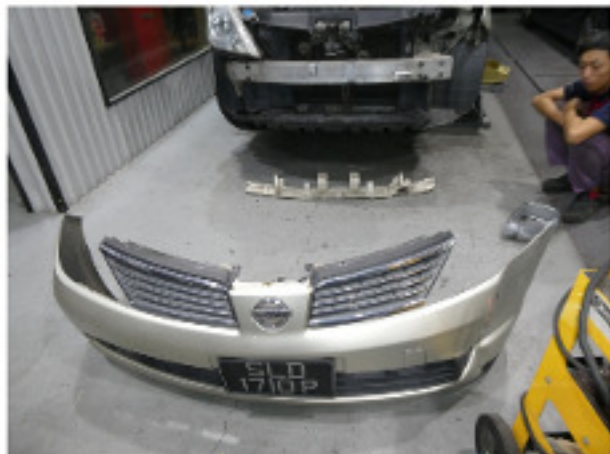
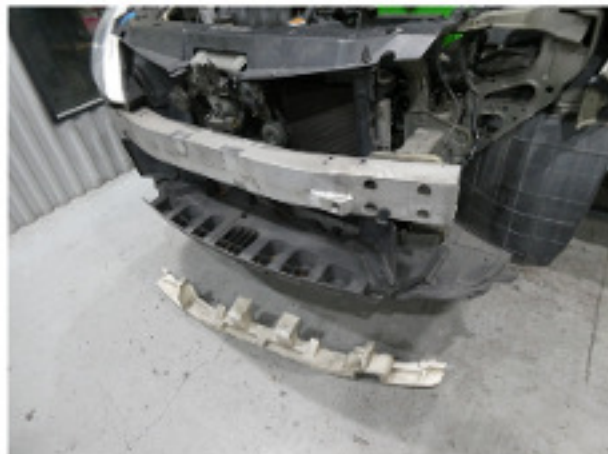
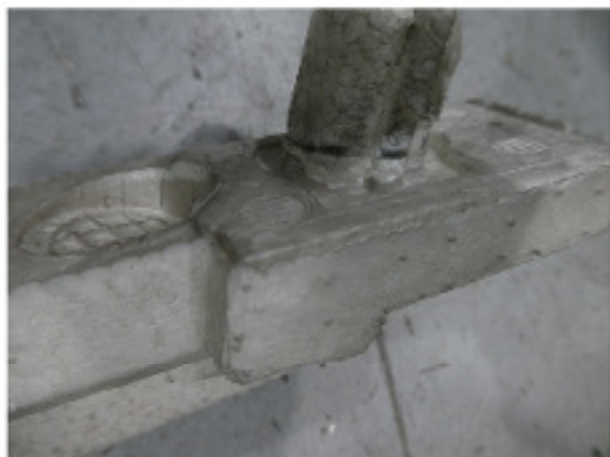
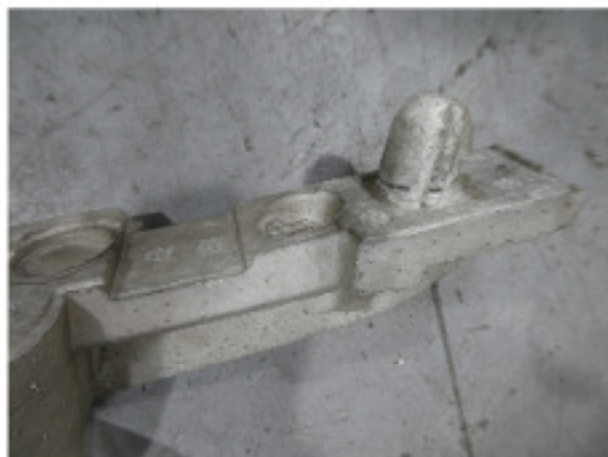
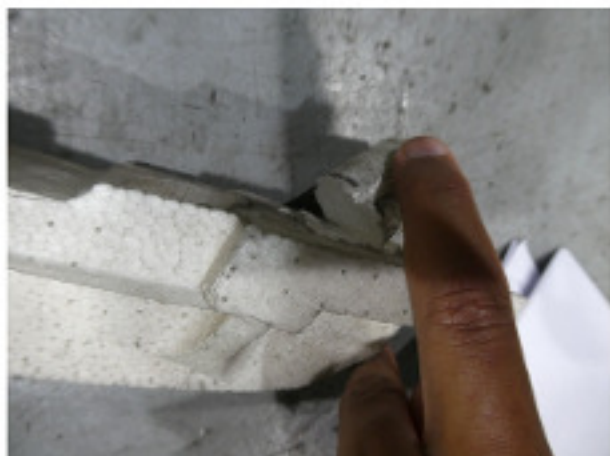
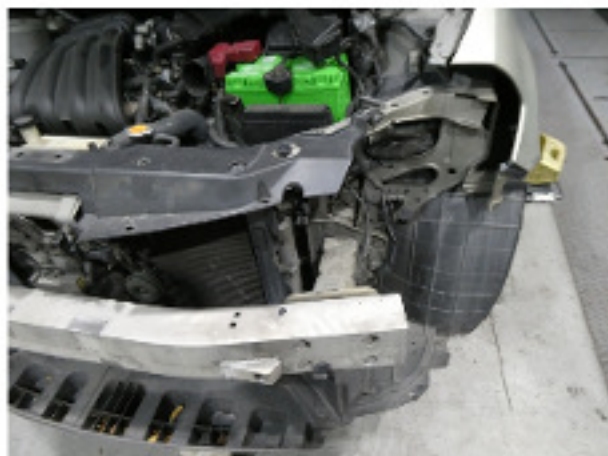
PHOTOGRAPHS FOR VEHICLE NO. SLD 1710P

RE-INSPECTION
