Affiliated to Federation Internationale Des Experts En Automobile				
SOMPO INSURANCE SINGAPORE PL		Ref : CS/SMO20000189/T1sf3n2		
50 RAFFLES PLACE #05-01/06 SINGAPORE LAND TOWERSINGAPORE 048623		Date : 13-08-2020		 
		Code : SMO

ADJUSTMENT ON REPAIR COST FOR VEHICLE NO. GV 8395J

PHOTOGRAPHS FOR VEHICLE NO. GV 8395J

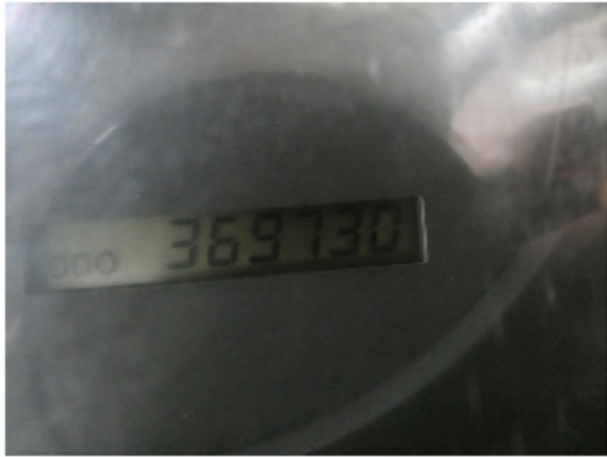
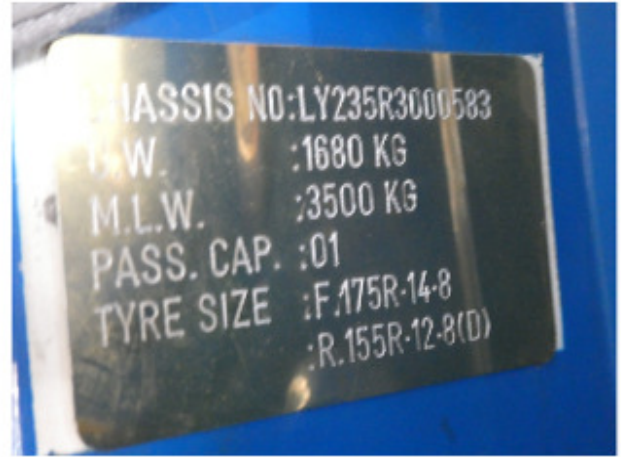
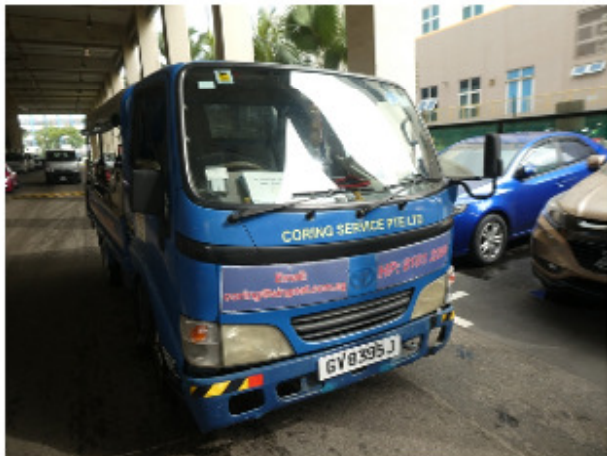
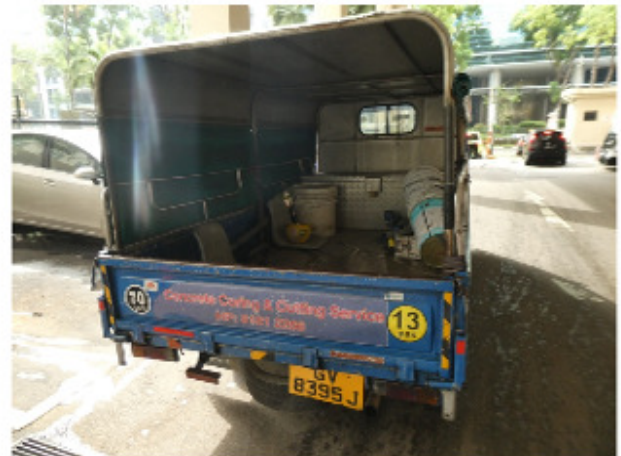
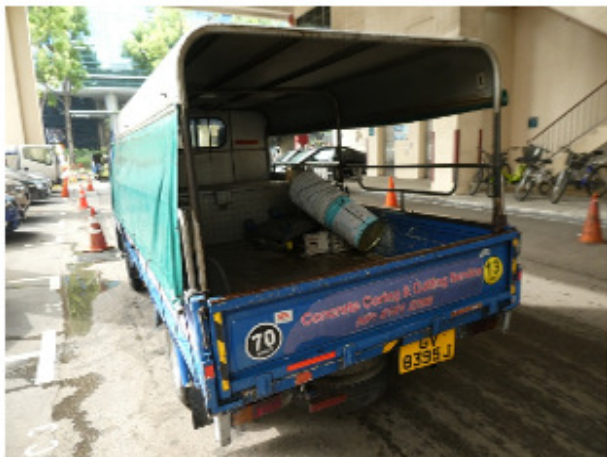
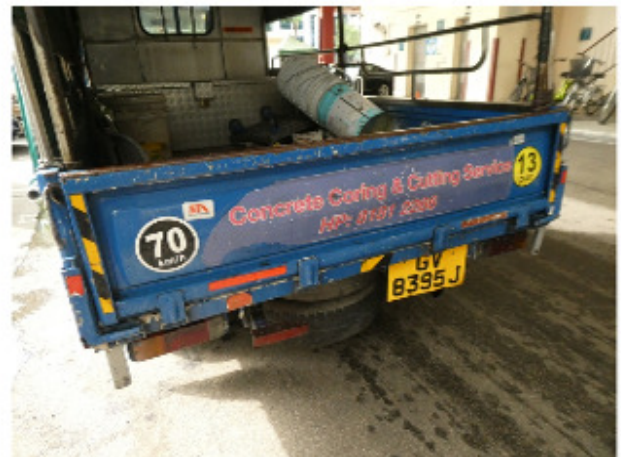
4. Description of Damages				
THE VEHICLE SUSTAINED DAMAGES AT THE REAR N/S PORTION. DAMAGES SEE DETAILS.				
5. General Information				
Accident Date	30/12/2019	Inspection Date	30/06/2020	
Survey held at	TEAMWORK GARAGE PTE LTD 53 UBI AVENUE 1 #01-24 SINGAPORE 408934.			
5a. Remarks				
A)THE INSPECTION WAS CONDUCTED ON A"WITHOUT PREJUDICE" BASIS. B)IN ACCORDANCE TO YOUR INSTRUCTIONS, WE HAVE NOT AUTHORISED REPAIRS.				
5b. Estimate Days of Repair				
ESTIMATED NORMAL PERIOD FOR REPAIR:		4 Working Days

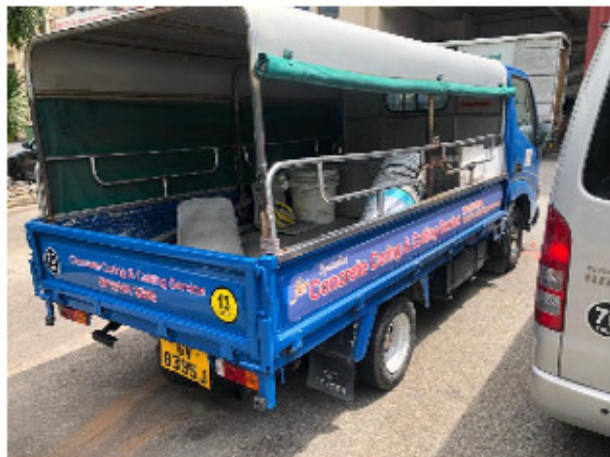
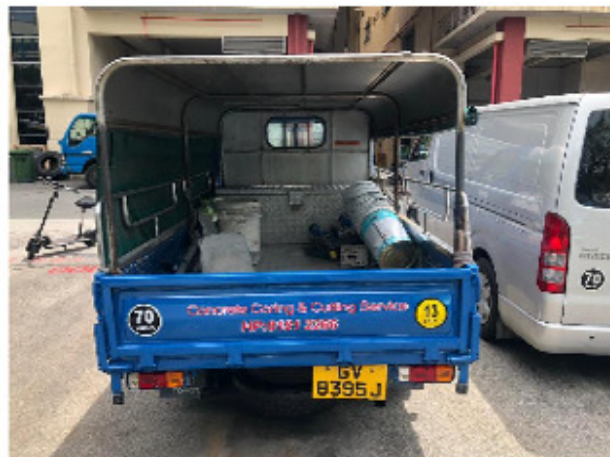
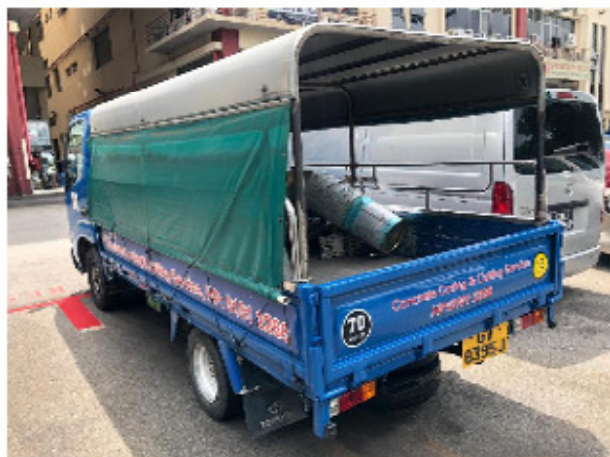
RE-INSPECTION

PHOTOGRAPHS FOR VEHICLE NO. GV 8395J
