Affiliated to Federation Internationale Des Experts En Automobile				
MS FIRST CAPITAL INSURANCE LTD 36 ROBINSON ROAD #16-01 CITY HOUSESINGAPORE 068877			Ref: CC3/FCI20000538/Kpa3q2	
			Date: 03/02/2021	
			Code: FCI2

ADJUSTMENT ON REPAIR COST FOR VEHICLE NO. SHD 9875S

PHOTOGRAPHS FOR VEHICLE NO. SHD 9875S

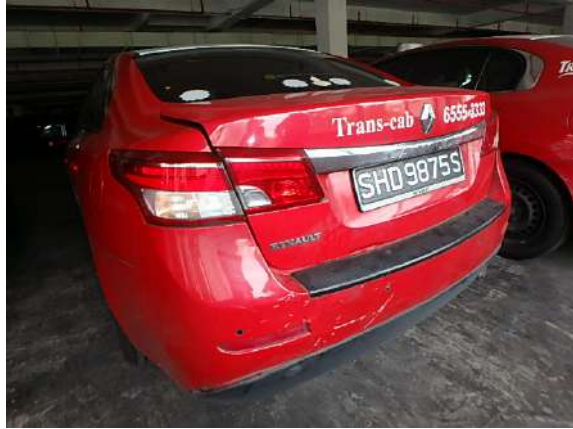
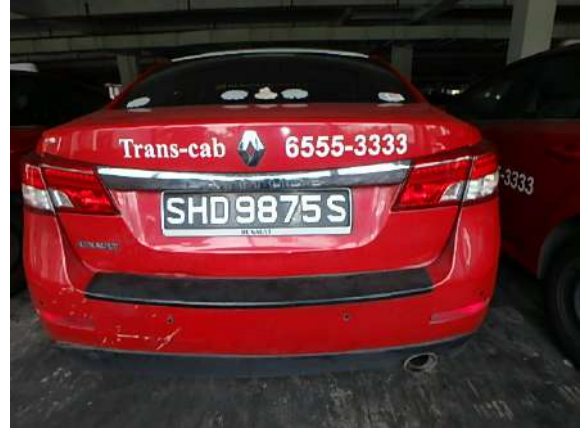
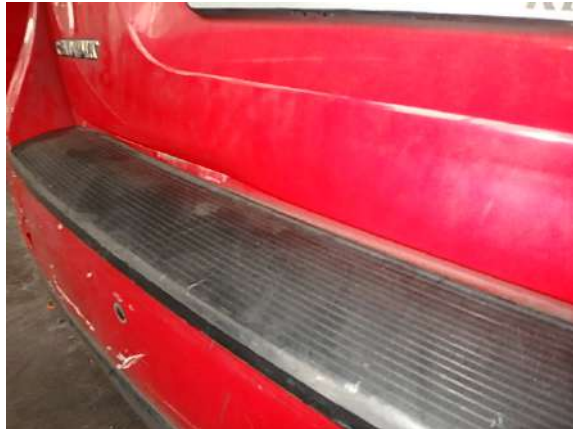
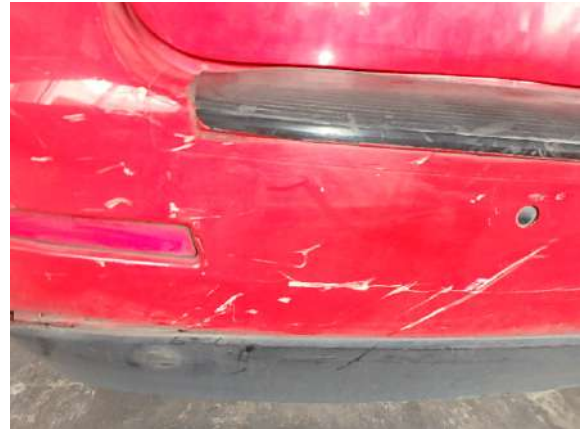
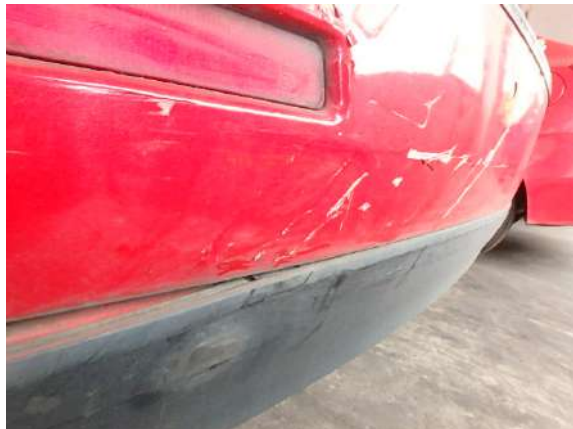
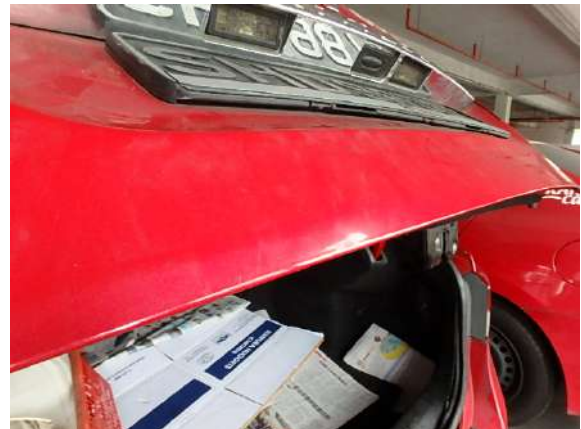
4. Description of Damages				
	THE VEHICLE SUSTAINED DAMAGES AT THE REAR N/S PORTION. DAMAGES SEE DETAILS.			
5. General Information				
	Accident Date	05/01/2020	Inspection Date	07/01/2020
	Survey held at	TRANS-CAB AUTO SERVICES PTE LTD NO.2 ANG MO KIO ST 63 SINGAPORE 569111		
5a. Remarks				
	A)THE INSPECTION WAS CONDUCTED ON A"WITHOUT PREJUDICE" BASIS. B)IN ACCORDANCE TO YOUR INSTRUCTIONS, WE HAVE NOT AUTHORISED REPAIRS.			
5b. Estimate Days of Repair				
	ESTIMATED NORMAL PERIOD FOR REPAIR:		5 Working Days

INSPECTION
