LKK Auto Consultants Pte Ltd

PROFESSIONAL SERVICE FEE

Vehicle No. SJK 6685H
Insured Veh. GBE 4947S
Claim No. 19/20/20/VC05/022879
Policy No. Z19VC05004089
Accident Date 06/01/2020
Inspection Date 09/01/2020

ADJUSTMENT ON REPAIR COST FOR VEHICLE NO. SJK 6685H

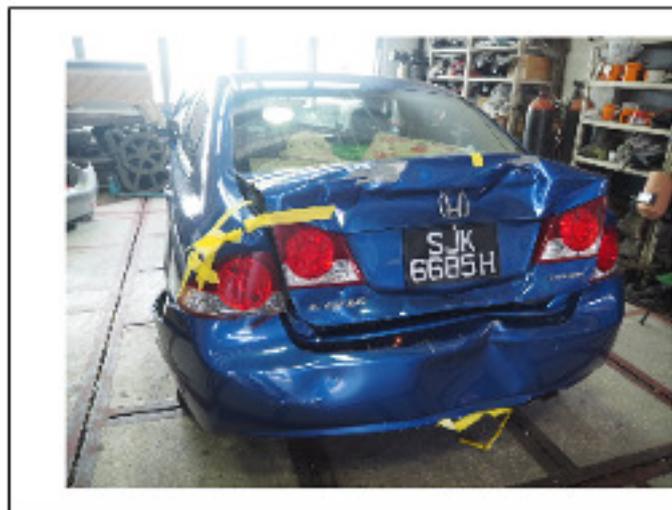
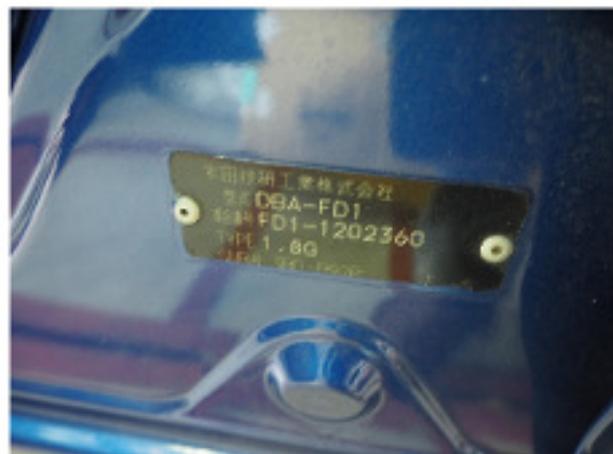
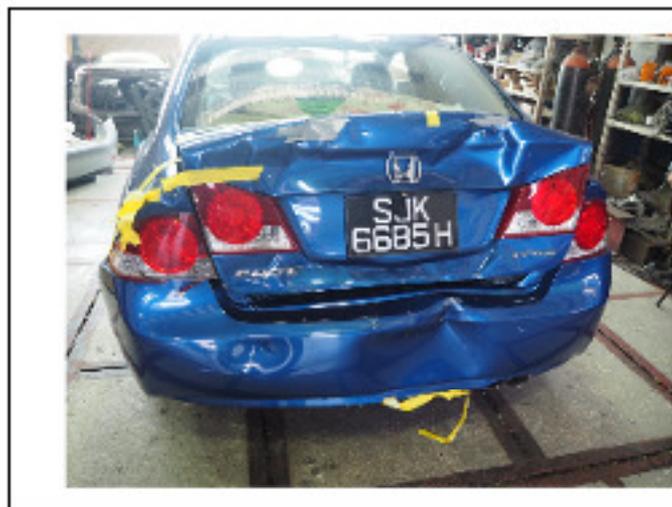
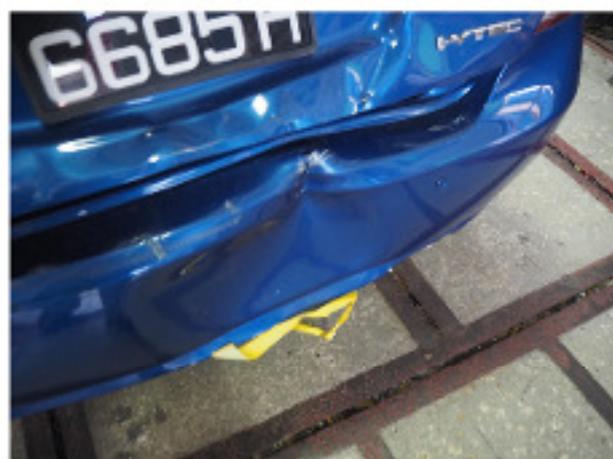
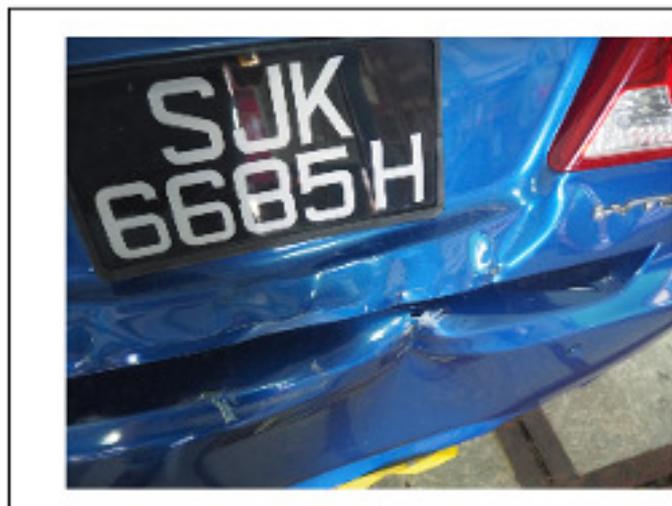
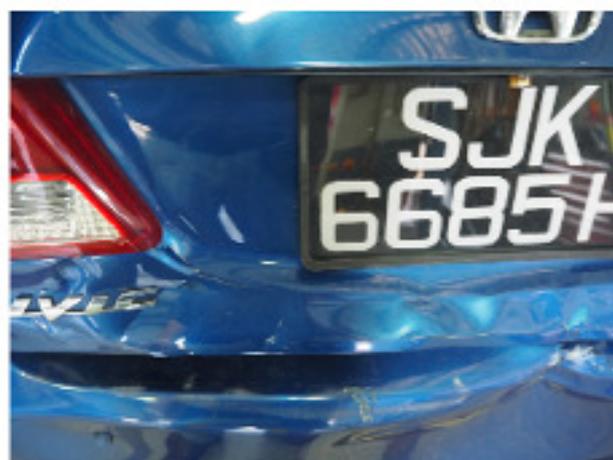
PHOTOGRAPHS FOR VEHICLE NO. SJK 6685H

INSPECTION

THE VEHICLE SUSTAINED DAMAGES AT THE REAR PORTION. DAMAGES SEE DETAILS.
--	--
