# LKK Auto Consultants Pte Ltd

### ADJUSTMENT ON REPAIR COST FOR VEHICLE NO. SLA 7270T

### PHOTOGRAPHS FOR VEHICLE NO. SLA 7270T

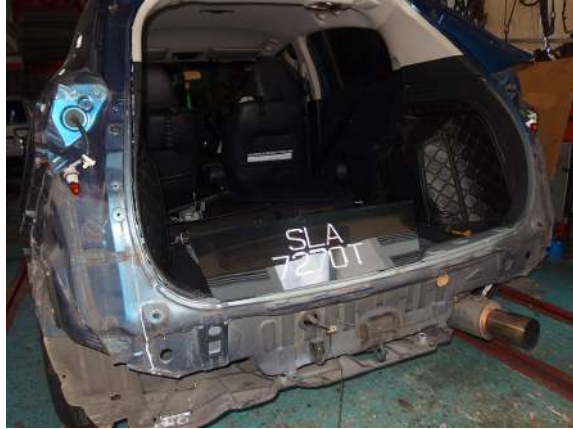
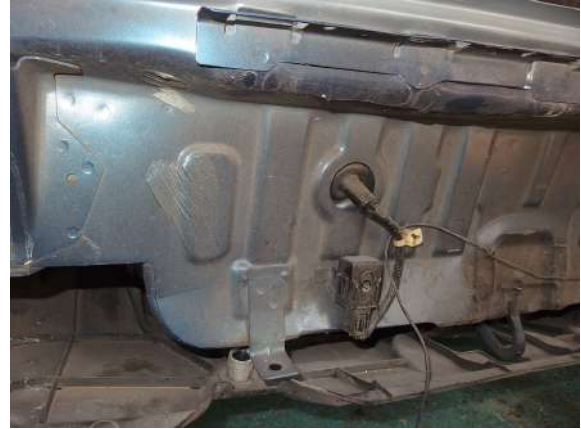
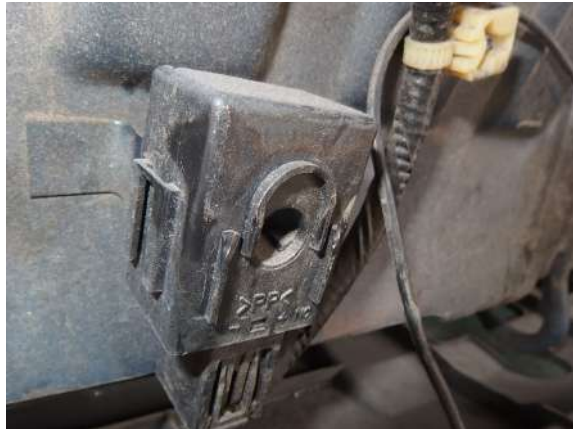
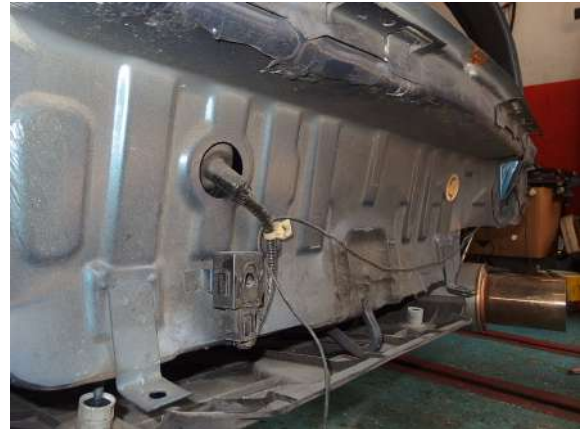
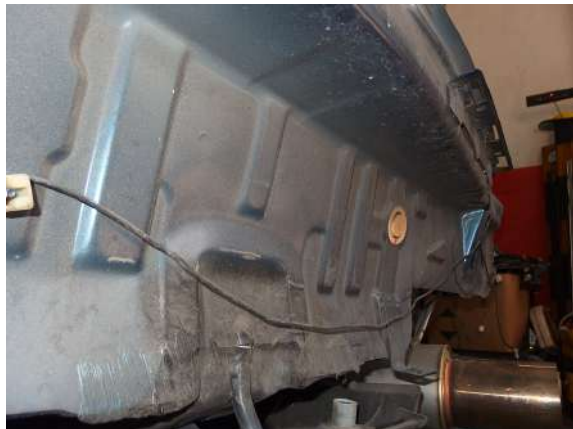
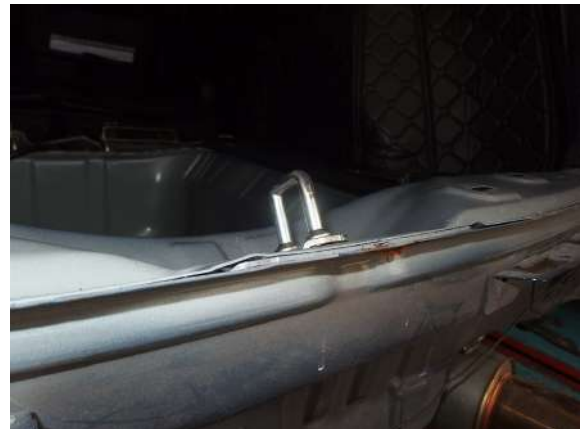
PHOTOGRAPHS FOR VEHICLE NO. SLA 7270T

RE-INSPECTION

| Affiliated to Federation Internationale Des Experts En Automobile | | | | |
|---|---|---|---|--|
| THE VEHICLE SUSTAINED DAMAGES AT THE REAR PORTION.<br><br>DAMAGES SEE DETAILS. | | | | |

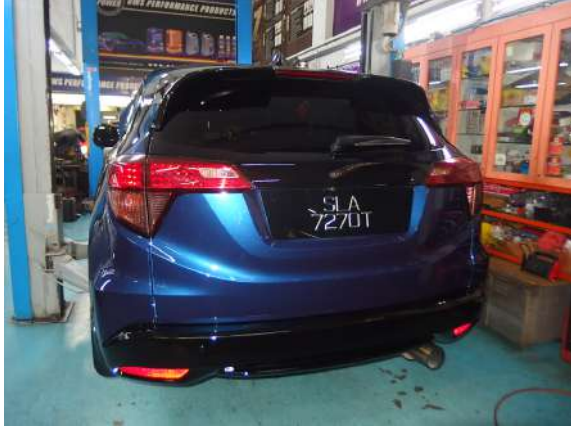
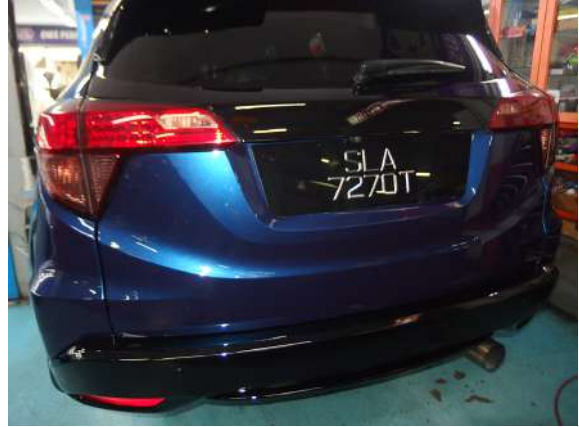
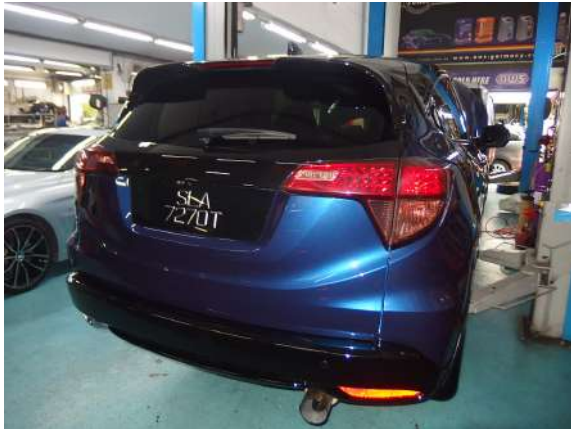
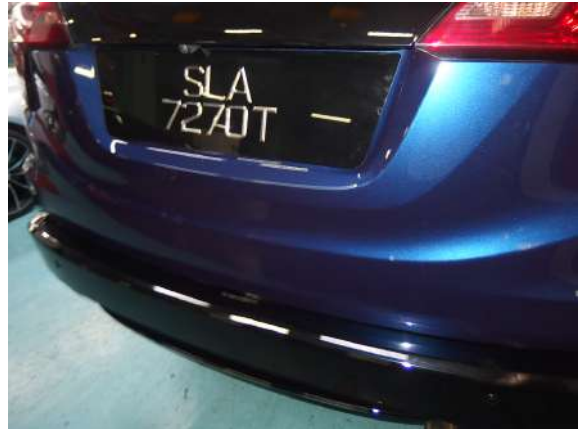
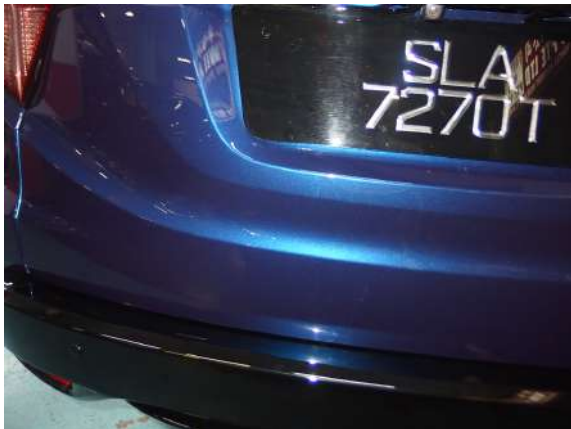
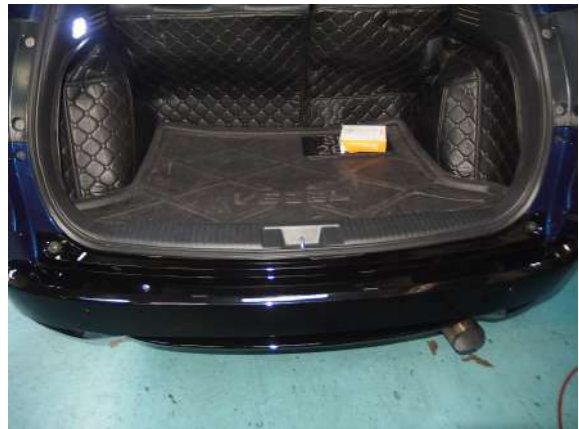
PHOTOGRAPHS FOR VEHICLE NO. SLA 7270T

RE-INSPECTION
