## LKK Auto Consultants Pte Ltd

### ADJUSTMENT ON REPAIR COST FOR VEHICLE NO. SJP 1336Y

PHOTOGRAPHS FOR VEHICLE NO. SJP 1336Y

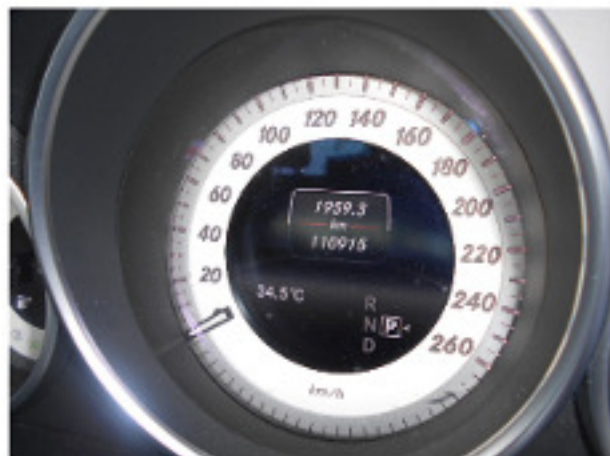
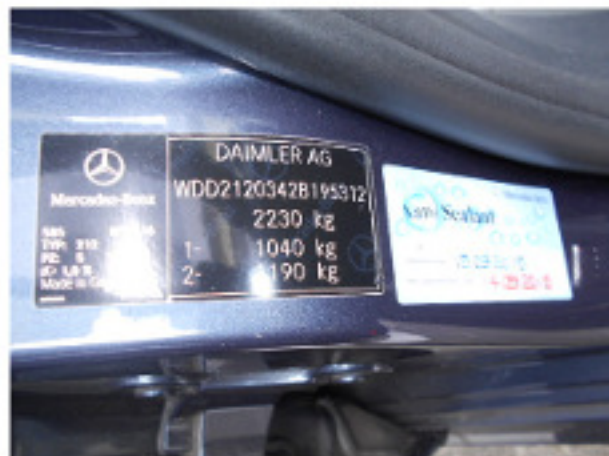
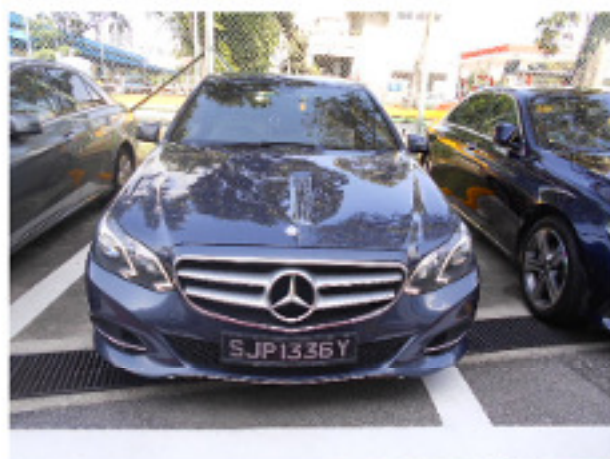
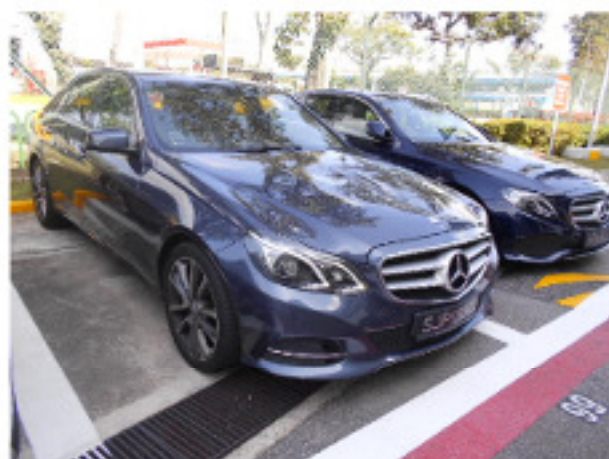
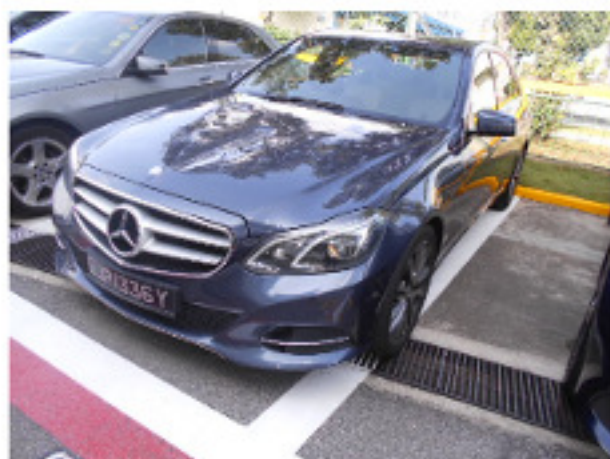
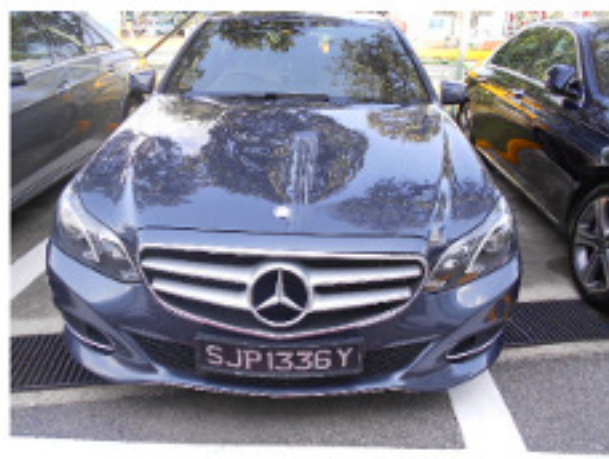
<b>4. Description of Damages</b>				
	THE VEHICLE SUSTAINED DAMAGES AT THE FRONT PORTION. DAMAGES SEE DETAILS.			
<b>5. General Information</b>				
Accident Date	09/01/2020	Inspection Date	03/02/2020	
Survey held at	CYCLE & CARRIAGE INDUSTRIES (1986) PL 188 PANDAN LOOP SINGAPORE 128378 (MERCEDES-BENZ)			
<b>5a. Remarks</b>				
	A)THE INSPECTION WAS CONDUCTED ON A"WITHOUT PREJUDICE" BASIS. B)IN ACCORDANCE TO YOUR INSTRUCTIONS, WE HAVE NOT AUTHORISED REPAIRS.			
<b>5b. Estimate Days of Repair</b>				
	ESTIMATED NORMAL PERIOD FOR REPAIR:		<b>4 Working Days</b>

INSPECTION

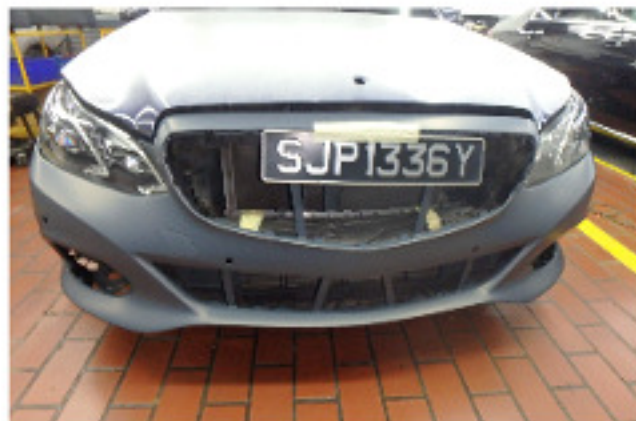
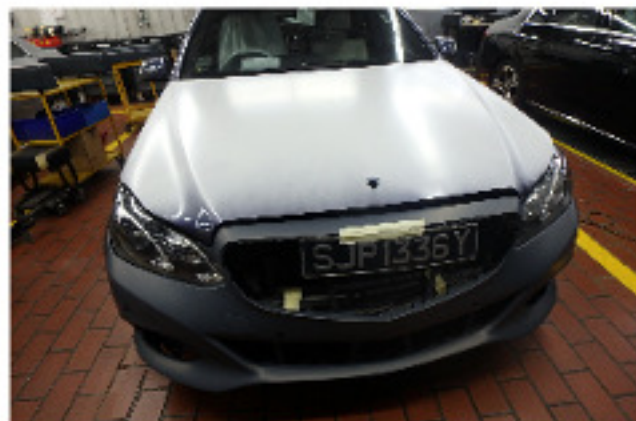
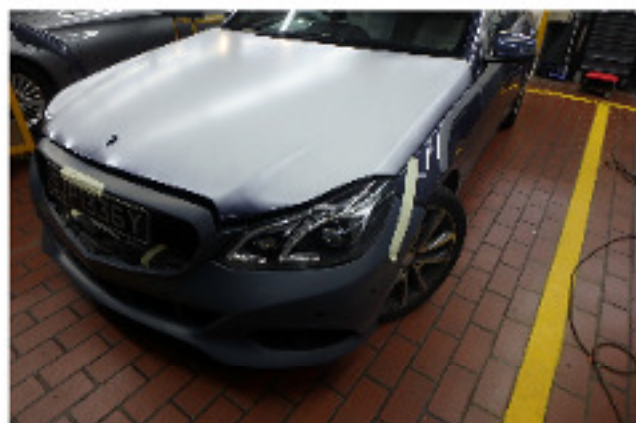
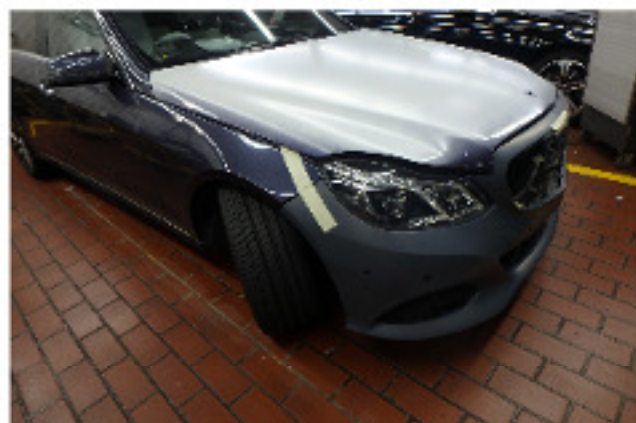
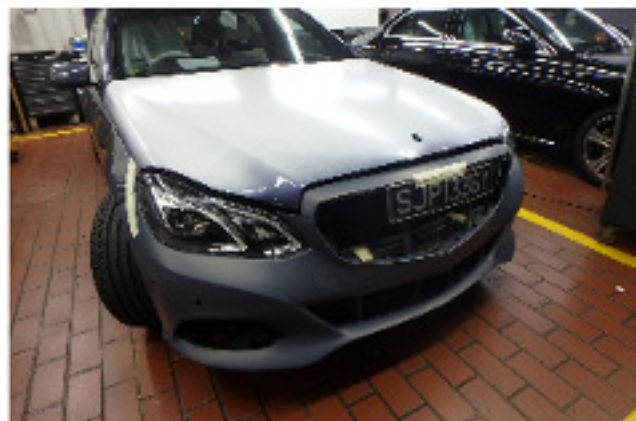
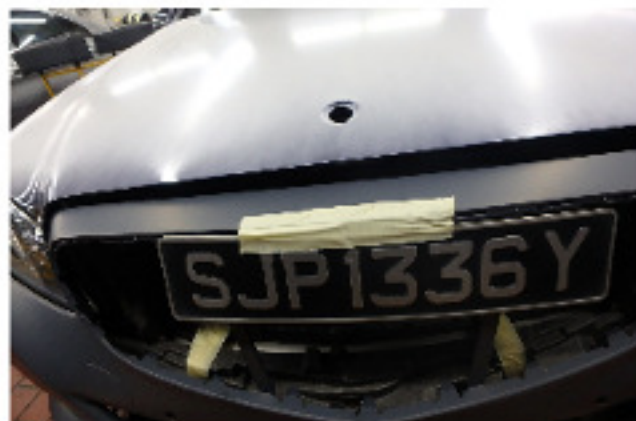
PHOTOGRAPHS FOR VEHICLE NO. SJP 1336Y

RE-INSPECTION
