Reg. No: 199607198R GST Reg. No. 19-9607198-R				
		Affiliated to Federation Internation	nale Des Experts En Automobi	le	
AUTO	TO & GENERAL INSURANCE (S) PL Ref : CS/AGI20000832/Asf3q2				
(BUDGET DIRECT INSURANCE) 190 CLEMENCEAU AVENUE #03-01 SINGAPORE SHOPPING CENTRESINGAPORE 239924		Date: 29-05-2020			
			Code: AGI

## ADJUSTMENT ON REPAIR COST FOR VEHICLE NO. SLG 5245Z

## PHOTOGRAPHS FOR VEHICLE NO. SLG 5245Z

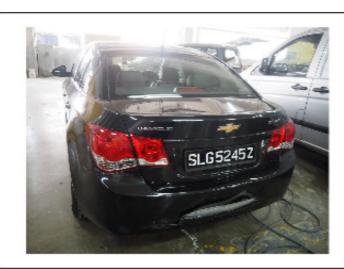
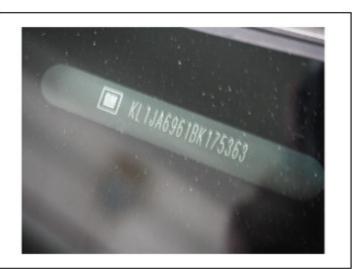
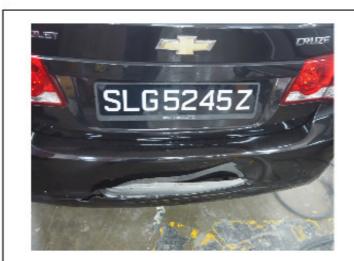
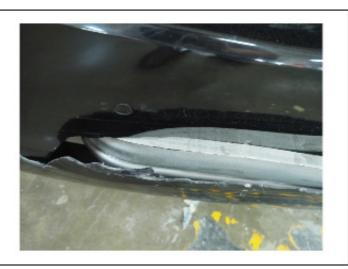
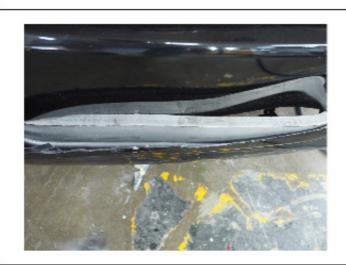
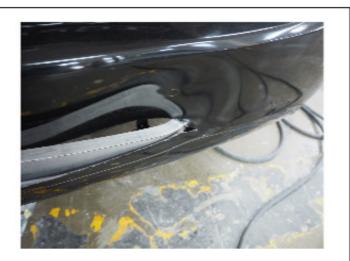
INSPECTION

4.		Description	on of Damages		
	THE VEHICLE SU	STAINED DAMAGES AT THE REA	AR PORTION.		
	DAMAGES SEE D	ETAILS.			
5.	General Information				
	Accident Date	07/01/2020	Inspection Date	15/01/2020	
	Survey held at	1ST AUTOWORKS PTE LTD			
		23 KAKI BUKIT AVE 4 #04-01 (SOUNTH WING) SINGAPORE 415933			
5a.			emarks		
		ON WAS CONDUCTED ON A"WIT CE TO YOUR INSTRUCTIONS, W		REPAIRS.	
5b.		Estimate	Days of Repair
