# LKK Auto Consultants Pte Ltd

## ADJUSTMENT ON REPAIR COST FOR VEHICLE NO. SKS 9694H

**PHOTOGRAPHS FOR VEHICLE NO. SKS 9694H**

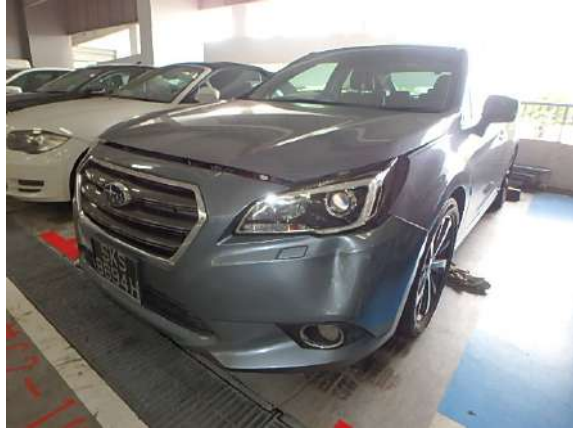
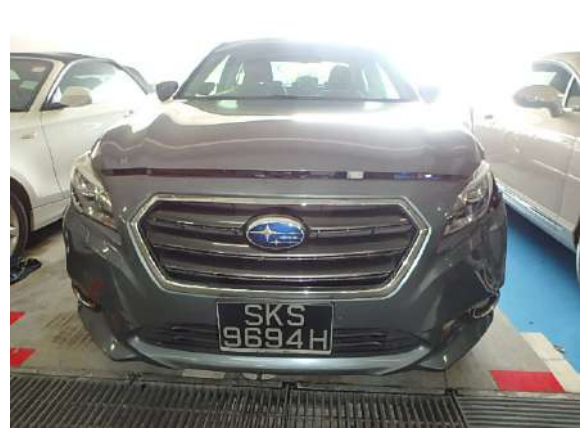
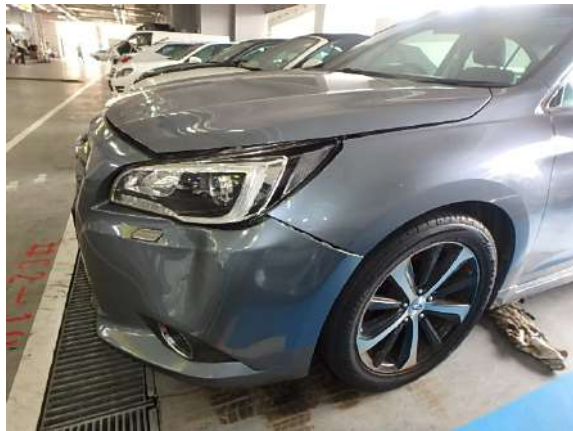
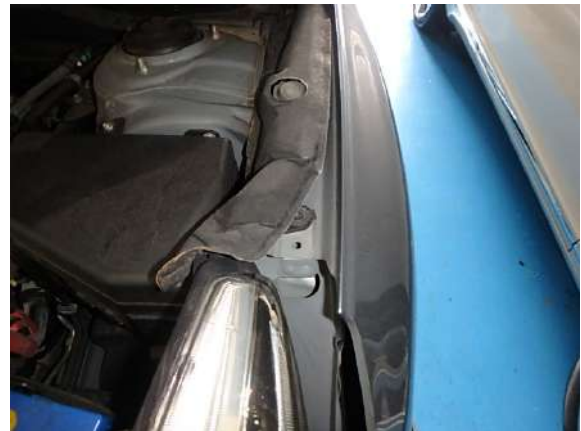
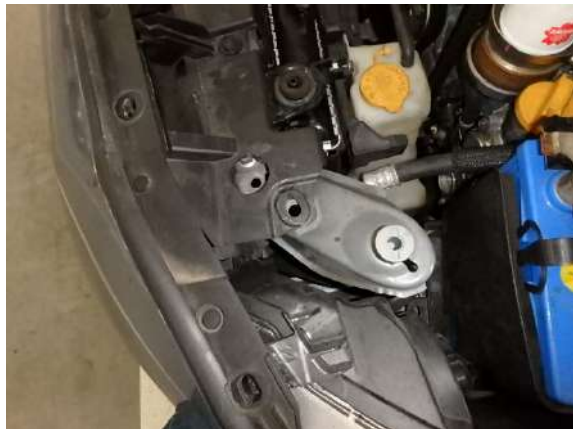
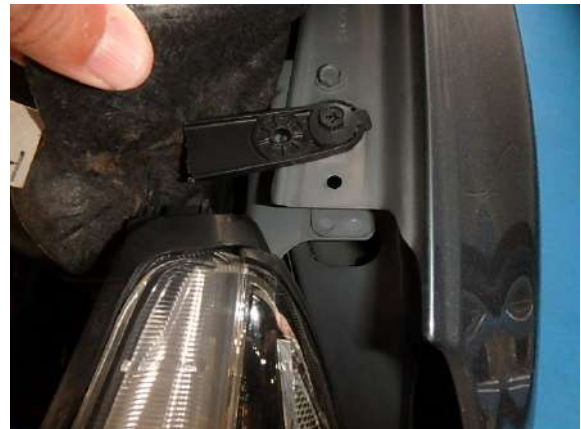
**INSPECTION**

<b>4. Description of Damages</b>				
THE VEHICLE SUSTAINED DAMAGES AT THE FRONT N/S PORTION. DAMAGES SEE DETAILS.				
<b>5. General Information</b>				
Accident Date	09/01/2020	Inspection Date	14/01/2020	
Survey held at	K KIM HIN AUTO PTE LTD 160 SIN MING DRIVE #02-20 SIN MING AUTO CITY SINGAPORE 575722			
<b>5a. Remarks</b>				
A)THE INSPECTION WAS CONDUCTED ON A"WITHOUT PREJUDICE" BASIS. B)IN ACCORDANCE TO YOUR INSTRUCTIONS, WE HAVE NOT AUTHORISED REPAIRS.				
<b>5b. Estimate Days of Repair</b>				
ESTIMATED NORMAL PERIOD FOR REPAIR:			4 Working Days

Qty	Description of Parts	Condition	Estimate By Workshop (\$)	Our Adjusted (\$)
	<b><u>REPLACEMENT OF PARTS</u></b>			
1	FRONT BUMPER	BENT	594.00	594.00
1	FRONT BUMPER SPONGE	SERVICEABLE	57.60	-
1	FRONT BUMPER REINFORCEMENT	TO REPAIR SEE LABOUR	288.30	-
2	FRONT BUMPER SIDE RETAINER (LH/RH) @\$18.30	N/S DISTORTED	36.60	18.30
1	N/S FRONT BUMPER FOG LAMP	SERVICEABLE	272.00	-
1	N/S FRONT BUMPER FOG LAMP COVER	SERVICEABLE	50.40	-
1	N/S FRONT BUMPER SPRAY NOZZLE	CRACKED	86.40	86.40
1	N/S FRONT BUMPER SPRAY NOZZLE PUMP	CRACKED	160.00	160.00
1	N/S FRONT BUMPER SPRAY NOZZLE COVER	SERVICEABLE	54.30	-
1	N/S FRONT BUMPER TOP SEAL	NECESSARY	27.00	27.00
1	FRONT BUMPER CENTRE BRACKET-LOWER	SERVICEABLE	57.60	-
10	FRONT BUMPER CLIPS @\$3.50	NECESSARY	35.00	35.00
1	N/S HEAD LAMP ASSY	MTG BROKEN	1,870.00	1,870.00
1	N/S HEAD LAMP LOWER BRACKET	DISTORTED	32.80	32.80
1	N/S FRONT FENDER	BUCKLED	270.00	270.00
1	N/S FRONT FENDER INNER SHIELD	SERVICEABLE	108.00	-

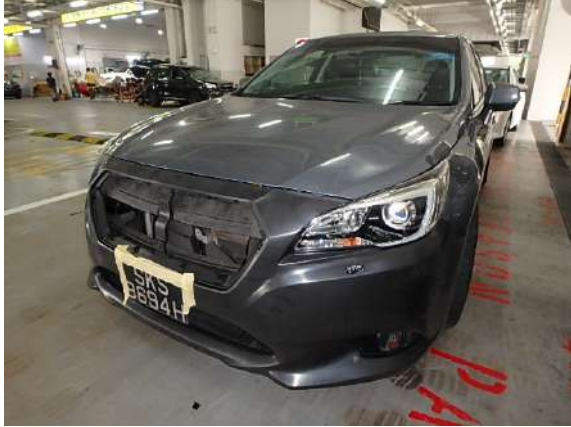
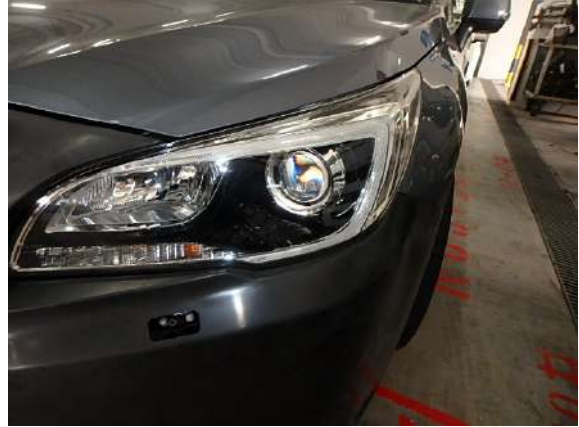
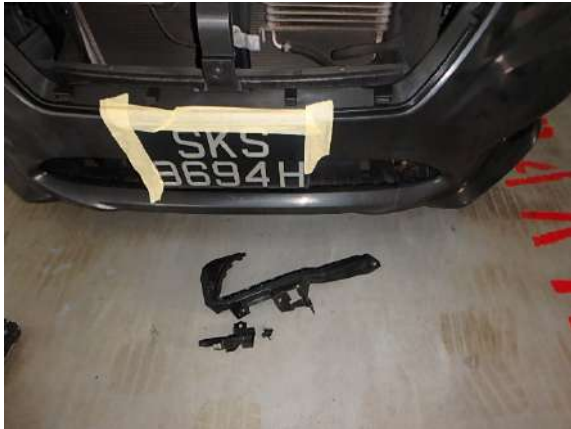
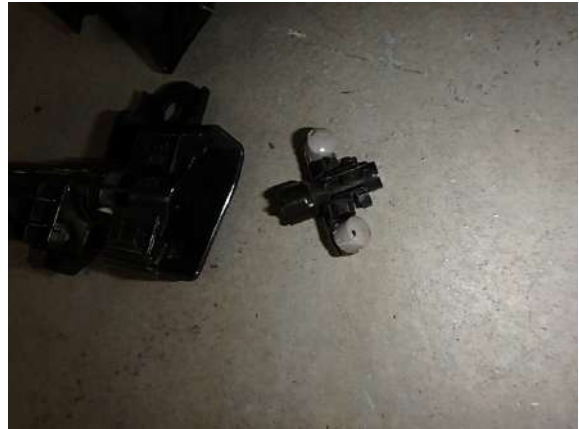
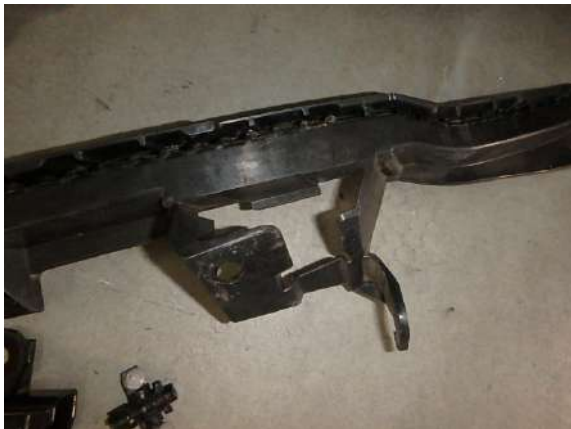
### RE-INSPECTION

### PHOTOGRAPHS FOR VEHICLE NO. SKS 9694H
