## LKK Auto Consultants Pte Ltd

### 1. Policy Particulars :- THIRD PARTY CLAIM

### 4. Description of Damages

### ADJUSTMENT ON REPAIR COST FOR VEHICLE NO. SJW 3563H

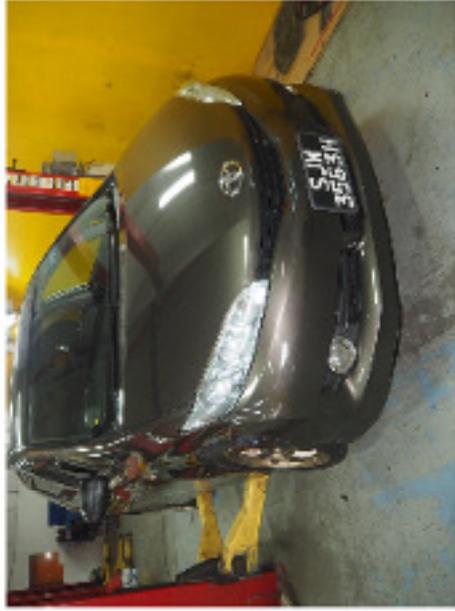
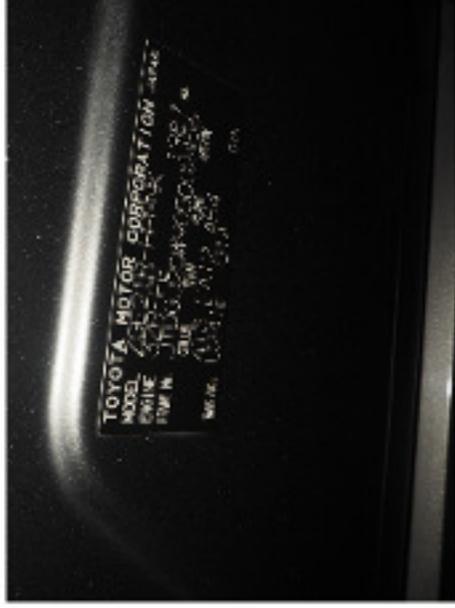
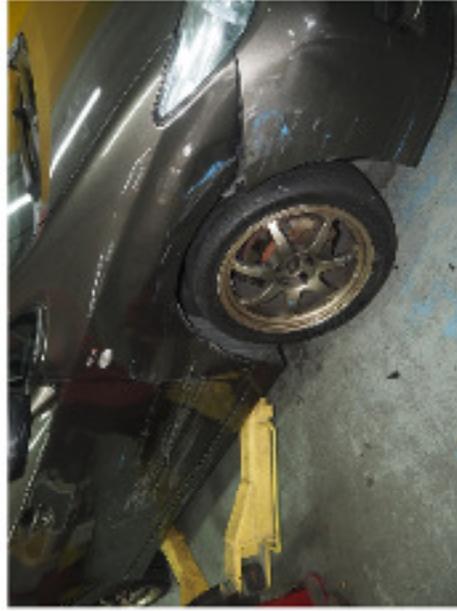
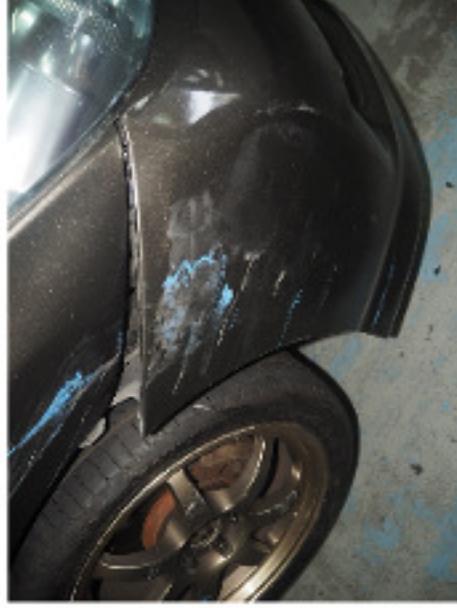
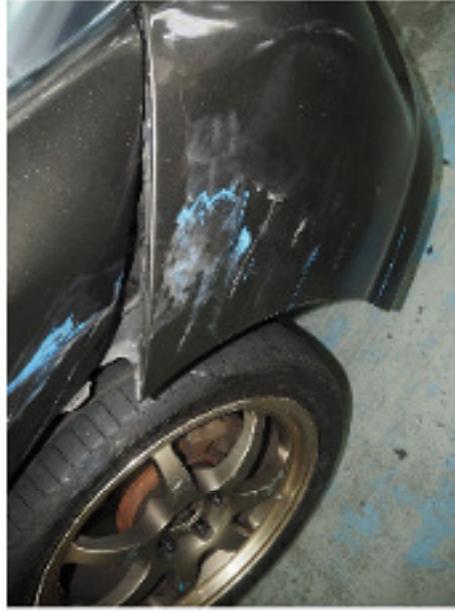
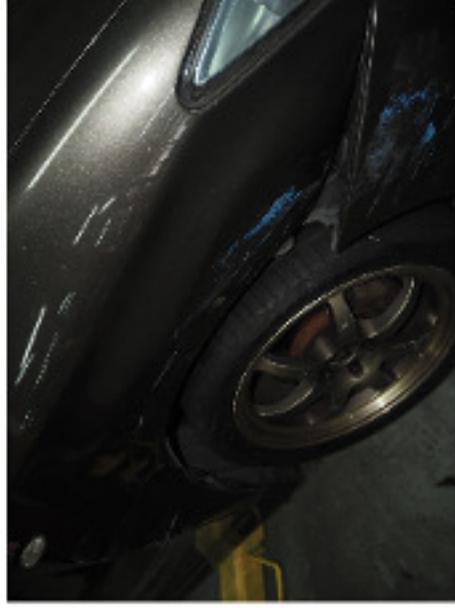
PHOTOGRAPHS FOR VEHICLE NO. SJW 3553H

INSPECTION

THE VEHICLE SUSTAINED DAMAGES AT THE O/S BODY AND UNDERCARRIAGE.  
DAMAGES SEE DETAILS

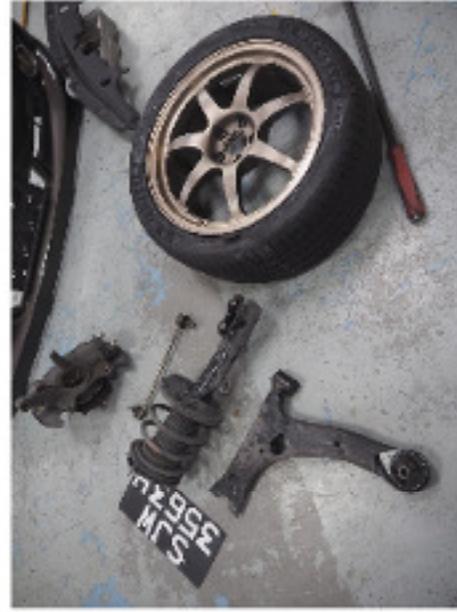
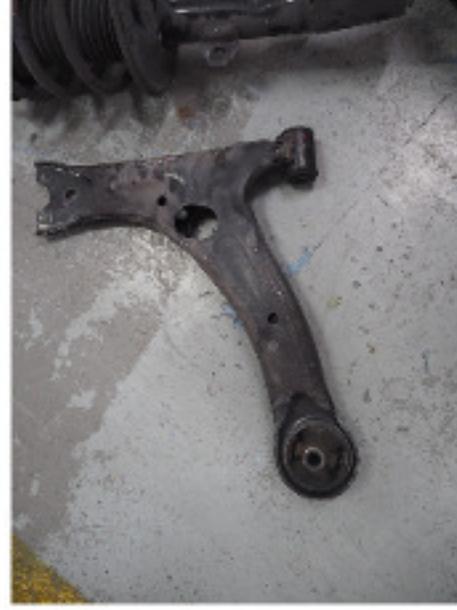
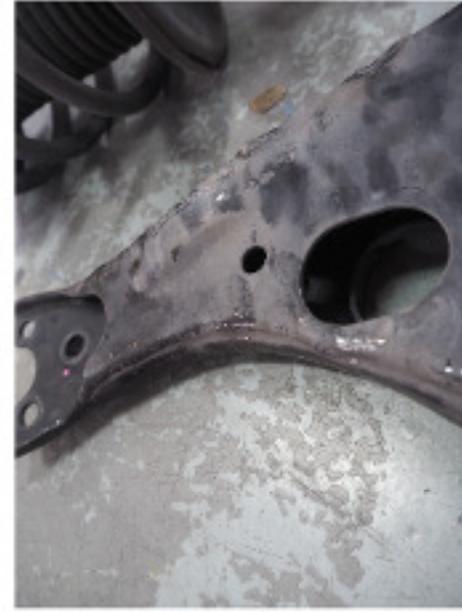
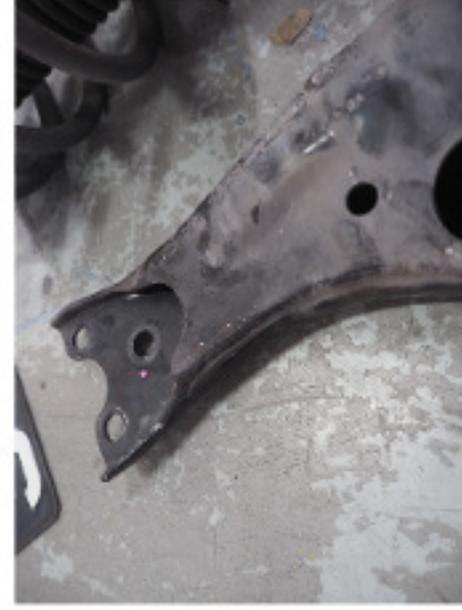
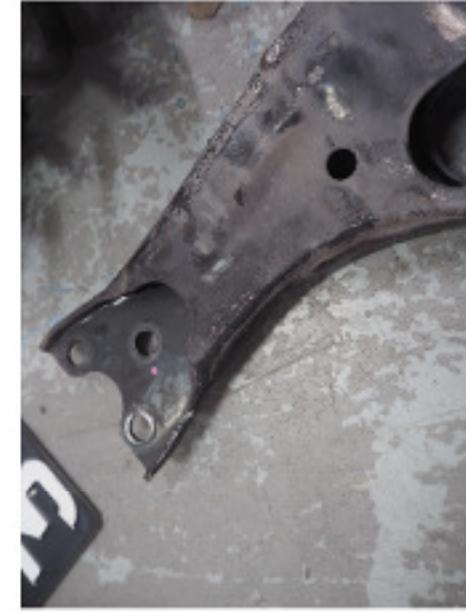
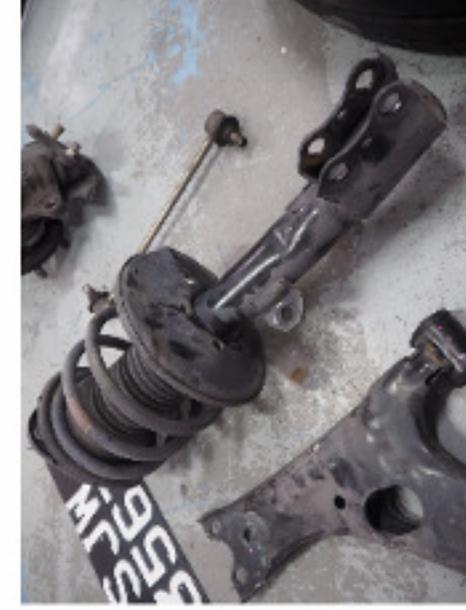
PHOTOGRAPHS FOR VEHICLE NO. SJW 3563H

RE-INSPECTION
