Vehicle No. SHA 7338E  
Insured Veh. GBF 4547H  
Claim No. SNM20D200525  
Policy No. DMCVSN3080921902  
Accident Date 24/01/2020  
Inspection Date 29/01/2020

## ADJUSTMENT ON REPAIR COST FOR VEHICLE NO. SHA 7338E

PHOTOGRAPHS FOR VEHICLE NO. SHA 7338E

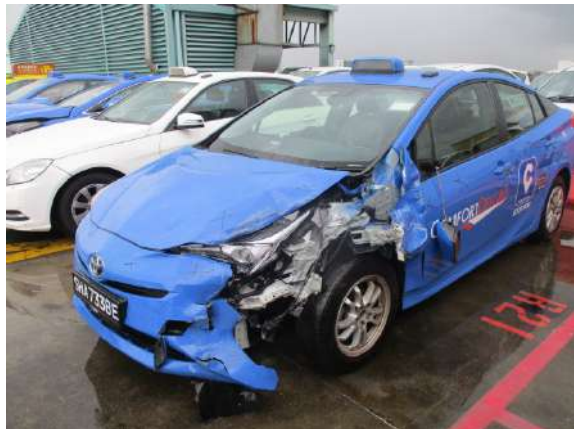
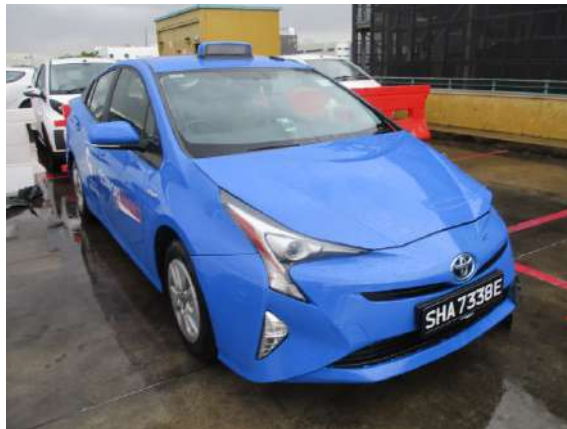
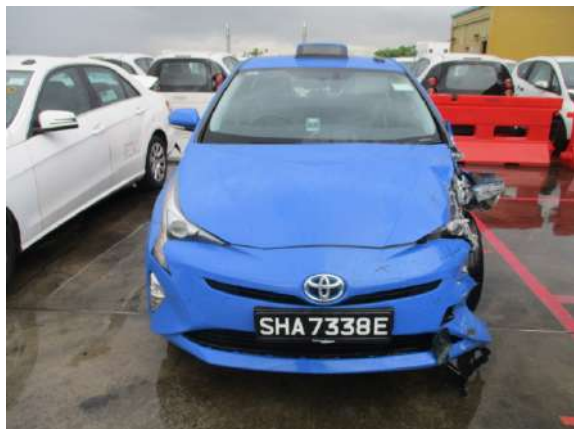
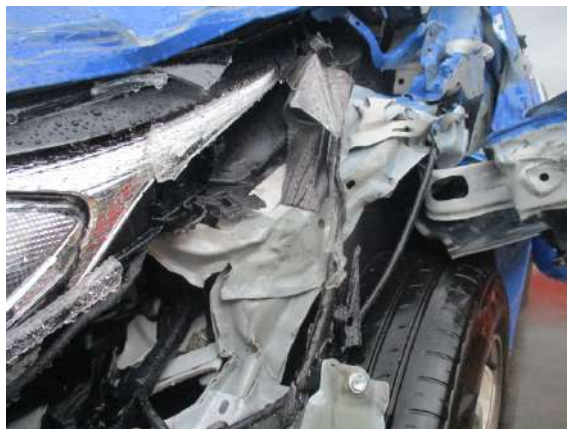
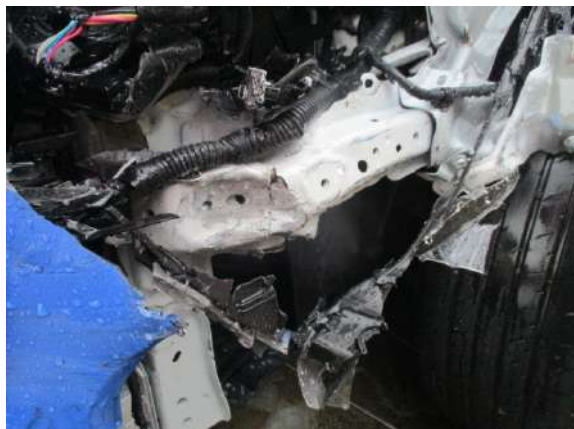
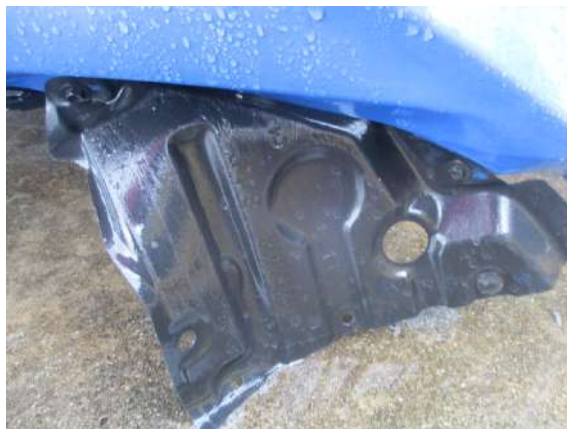
INSPECTION

| Affiliated to Federation Internationale Des Experts En Automobile | | | | |
|---|---|---|---|--|
| THE VEHICLE SUSTAINED DAMAGES AT THE FRONT PORTION AND O/S BODY.<br>DAMAGES SEE DETAILS. | | | | |

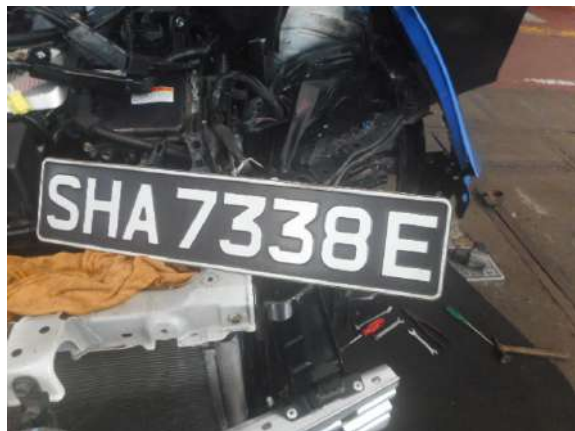
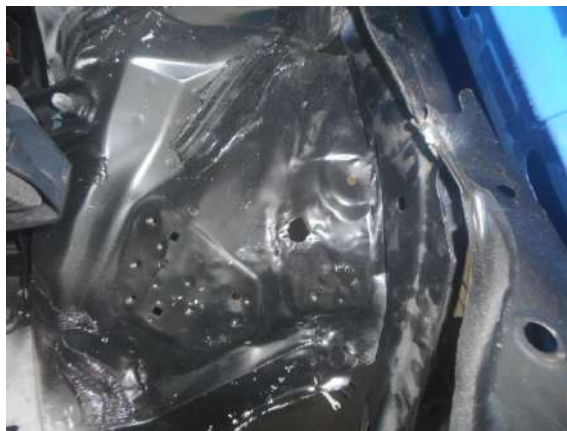
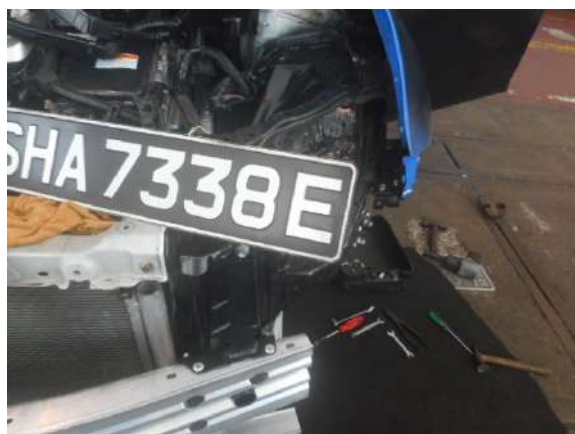
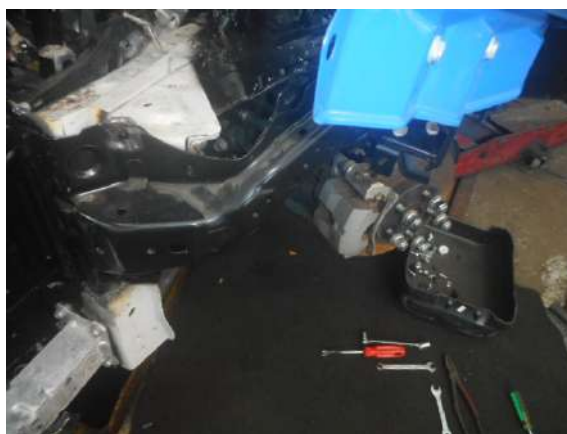
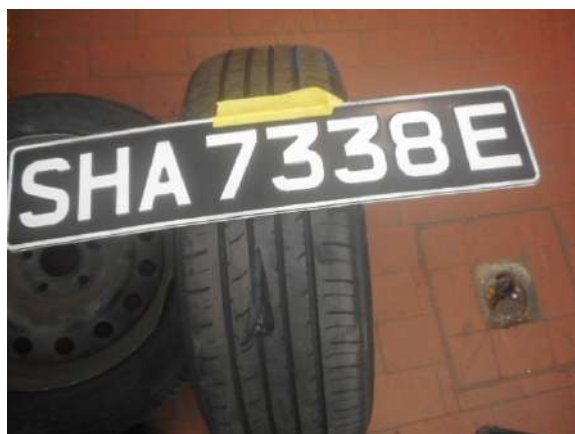
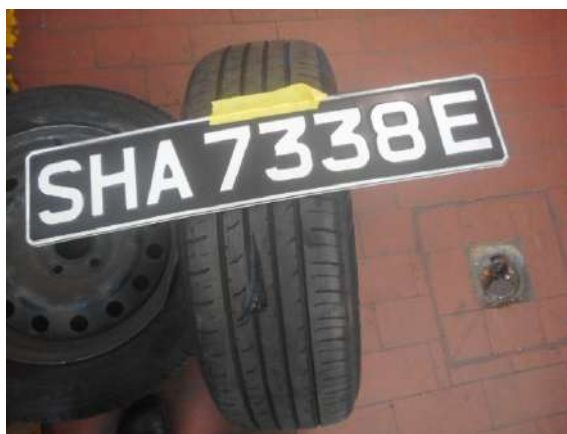
PHOTOGRAPHS FOR VEHICLE NO. SHA 7338E

RE-INSPECTION
