LKK Auto Consultants Pte Ltd

2. Vehicle Particulars & Condition				
Make & Model	TOYOTA HIACE COMMUTER (A)	c.c	2982	
Engine No.	HIDDEN	Year of Reg.	2014	
Chassis No.	JTFST22P200018691	Colour	WHITE	
Odometer	510939	Steering	IN ORDER	
Brakes	IN ORDER	Modification	NIL	
General	GOOD

ADJUSTMENT ON REPAIR COST FOR VEHICLE NO. PC 2261U

PHOTOGRAPHS FOR VEHICLE NO. PC 2261U

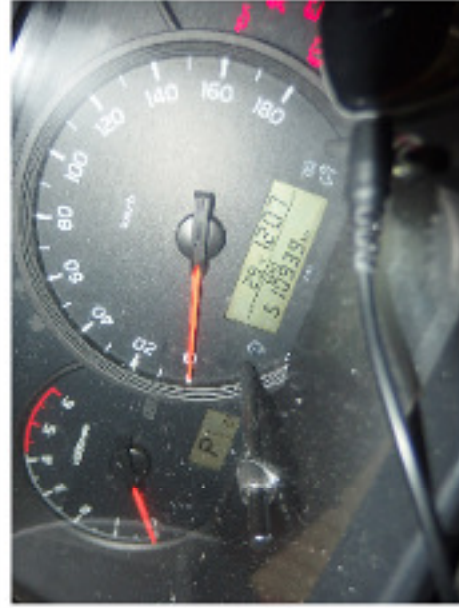
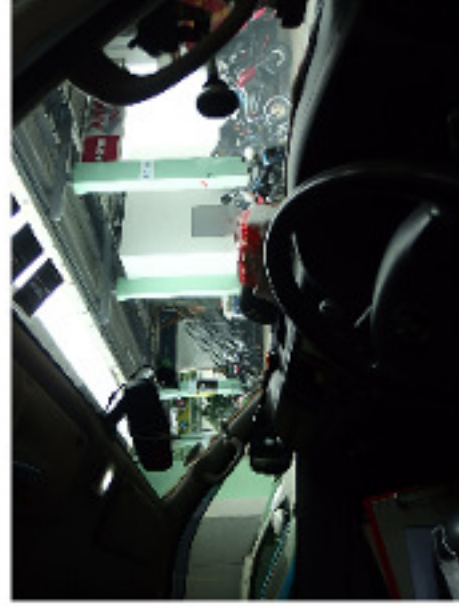
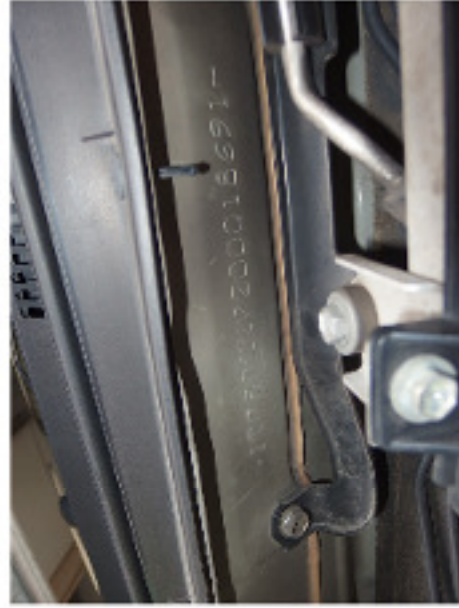
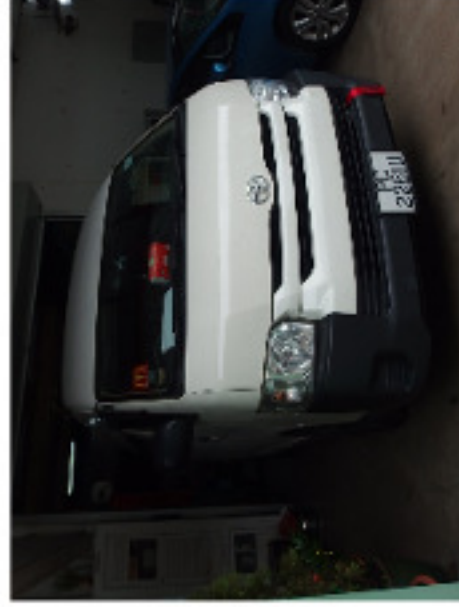
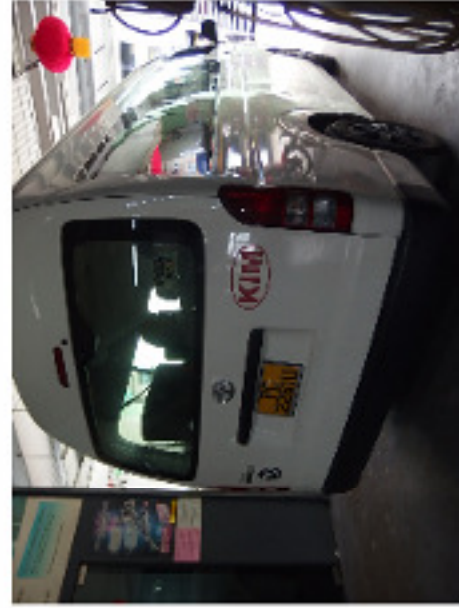
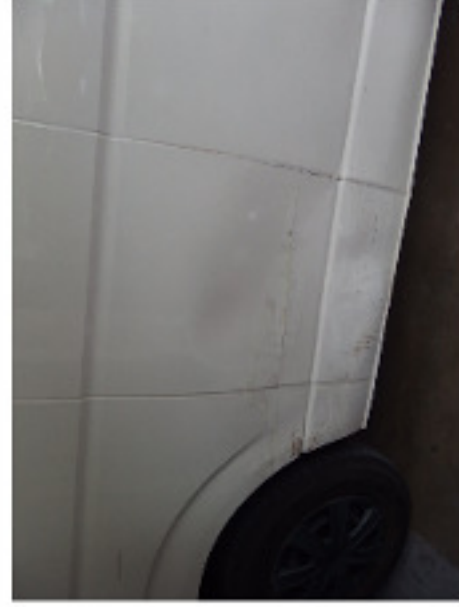
4. Description of Damages				
THE VEHICLE SUSTAINED DAMAGES AT THE O/S BODY. DAMAGES SEE DETAILS.				
5. General Information				
Accident Date	30/01/2020	Inspection Date	30/01/2020	
Survey held at	T K LEE AUTOMOTIVE PTE LTD NO. 1 KAKI BUKIT AVE 6 #02-47 AUTOBAY SINGAPORE 417883			
5a. Remarks				
A)THE INSPECTION WAS CONDUCTED ON A"WITHOUT PREJUDICE" BASIS. B)IN ACCORDANCE TO YOUR INSTRUCTIONS, WE HAVE NOT AUTHORISED REPAIRS.				
5b. Estimate Days of Repair				
ESTIMATED NORMAL PERIOD FOR REPAIR:		5 Working Days

INSPECTION

Qty	Description of Parts	Condition	Estimate By Workshop (\$)	Our Adjusted (\$)
<u>REPLACEMENT OF PARTS</u>				
1	SIDE BODY PANEL RH (FRONT)	TO REPAIR SEE LABOUR	1,601.50	-
1	SIDE BODY PANEL RH (CENTRE)	BADLY DENTED	950.40	950.40
1	SIDE BODY PANEL RH (REAR)	TO REPAIR SEE LABOUR	1,510.10	-
	LESS 25% DISCOUNT		-1,015.50	-237.60
			3,046.50	712.80
<u>SPECIAL NETT ITEMS</u>				
1	SIDE BODY PANEL STICKER EXCURSION BUS RH (SN)	NECESSARY	20.00	20.00
1	SIDE BODY PANEL WINDSCREEN SPONGE TAPE RH (FRONT) (SN)	NECESSARY	20.00	20.00
1	SIDE BODY PANEL WINDSCREEN SEALAT RH (FRONT) (SN)	NECESSARY	60.00	40.00
1	SIDE BODY PANEL WINDSCREEN SPONGE TAPE RH (CENTRE) (SN)	NECESSARY	10.00	10.00
1	SIDE BODY PANEL WINDSCREEN SEALANT RH (CENTRE) (SN)	NECESSARY	30.00	30.00
1	SIDE BODY PANEL WINDSCREEN SPONGE TAPE RH (REAR) (SN)	NECESSARY	20.00	20.00
1	SIDE BODY PANEL WINDSCREEN SEALANT RH (REAR) (SN)	NECESSARY	60.00	40.00
1	REAR WHEEL HUB CAP RH (SN)	CUT	150.00	150.00

370.00	330.00
<u>LABOUR</u>				
	TO KNOCK OUT DENT ,CUT/WELD SIDE BODY PANEL AND REPLACE ACCIDENT PARTS.INCLUSIVE OF THE REPAIR OF SIDE BODY PANEL RH (FRONT) AND SIDE BODY PANEL RH (REAR).		1,500.00	800.00
	TO SPRAY PAINTING ON ACCIDENT PORTION .		1,000.00	480.00
	TO REMOVE AND REFIX SIDE BODY WINDSCREEN.		280.00	250.00
	TO REMOVE AND REFIX TAPE TRIM .		150.00	80.00
	TO TUFF KOTE.		100.00	50.00
			3,030.00	1,660.00

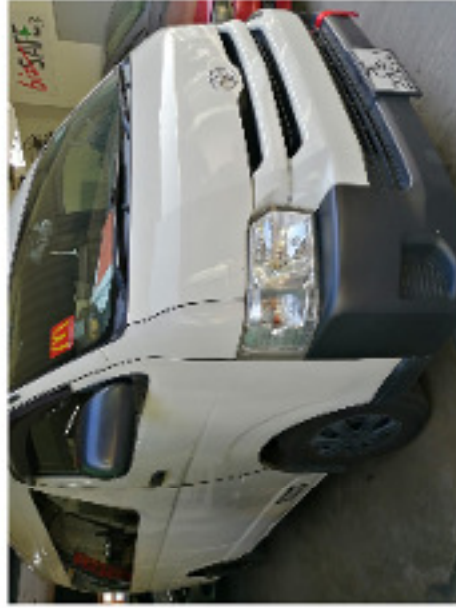
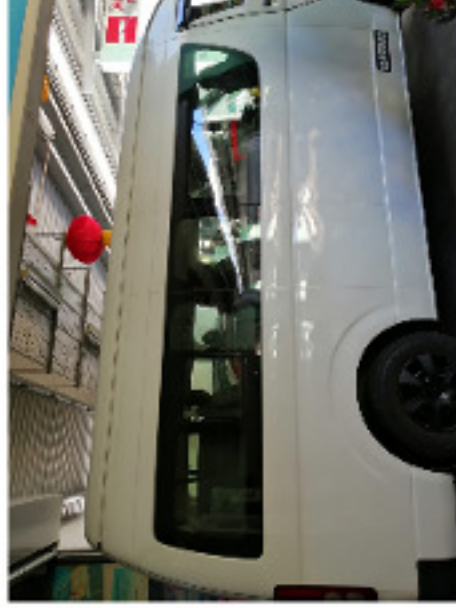
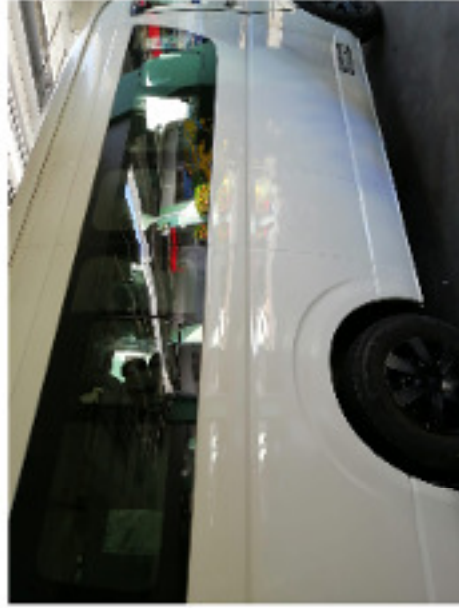
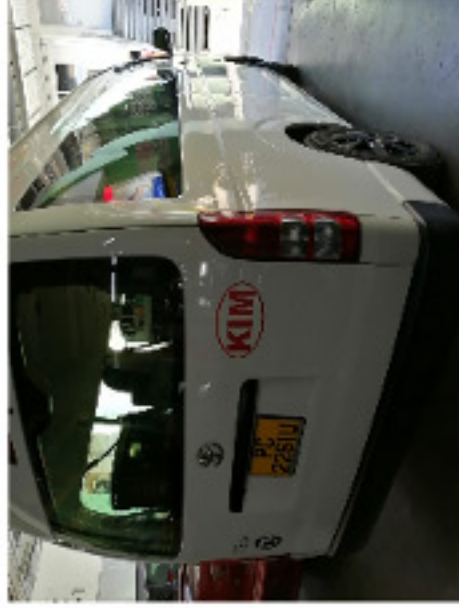
PHOTOGRAPHS FOR VEHICLE NO. PC 2261U

RE-INSPECTION
