LKK Auto Consultants Pte Ltd

ADJUSTMENT ON REPAIR COST FOR VEHICLE NO. SJW 8875A

PHOTOGRAPHS FOR VEHICLE NO. SJW 8875A

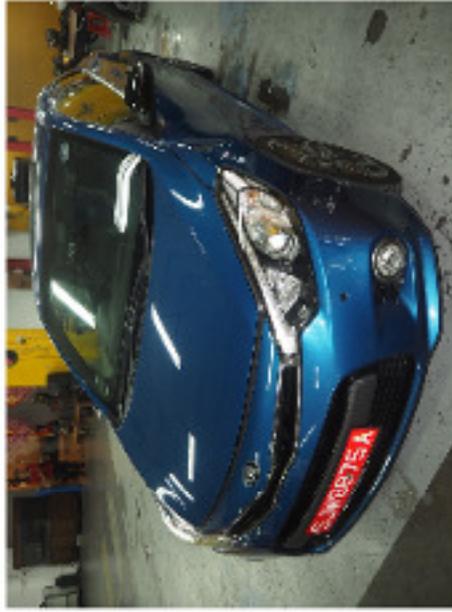
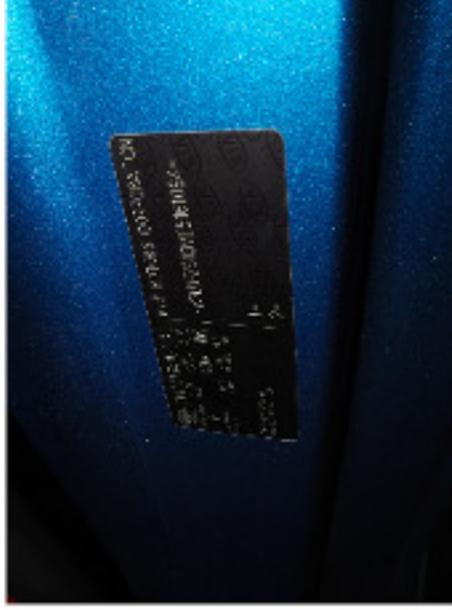
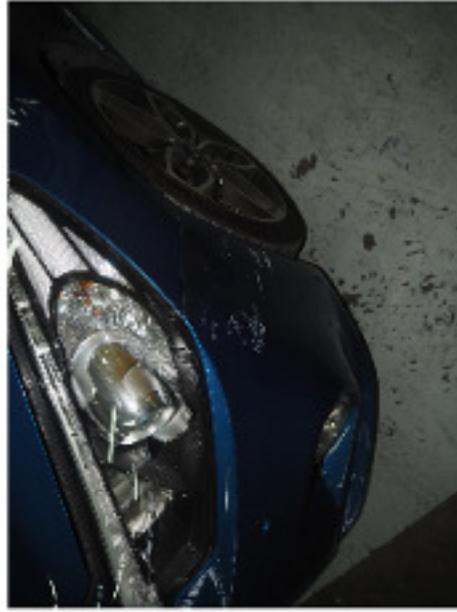
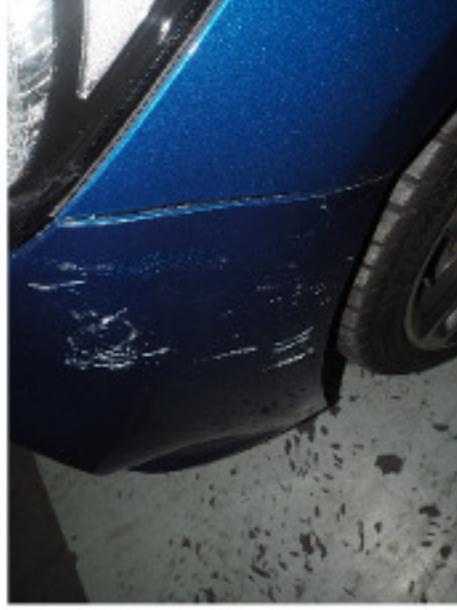
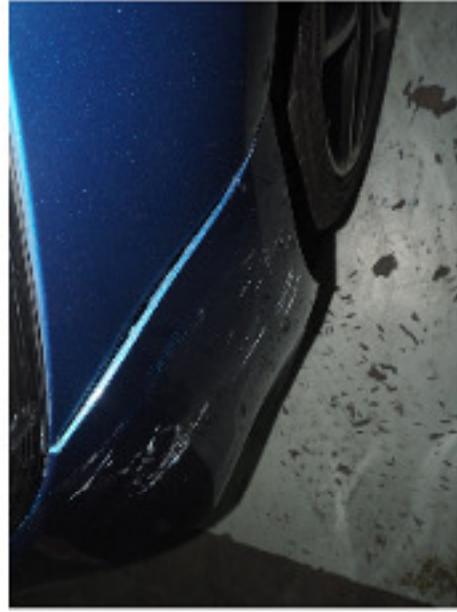
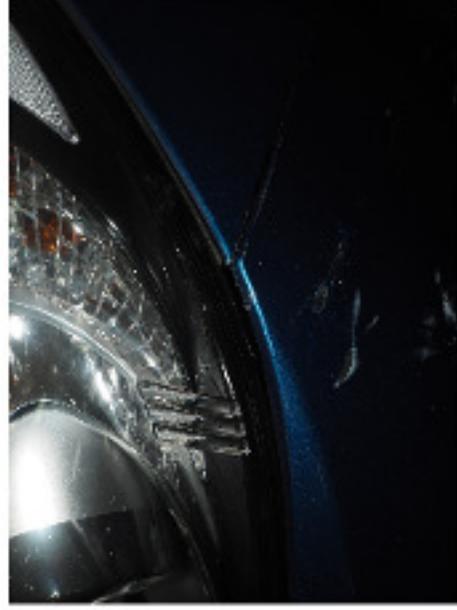
INSPECTION

THE VEHICLE SUSTAINED DAMAGES AT THE FRONT N/S PORTION.
DAMAGES SEE DETAILS.

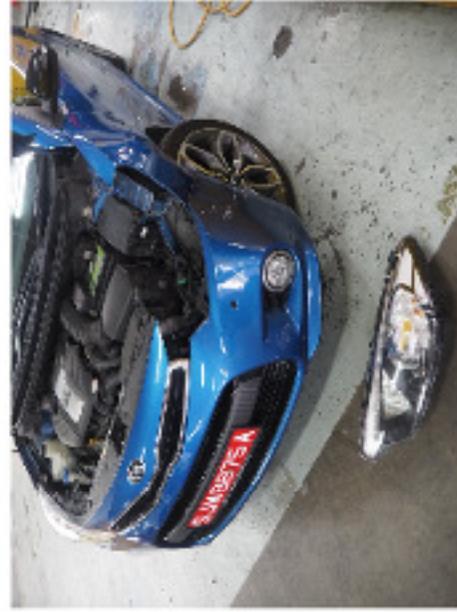
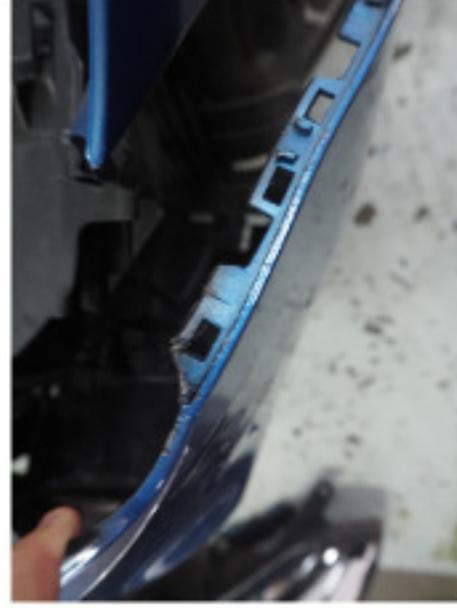
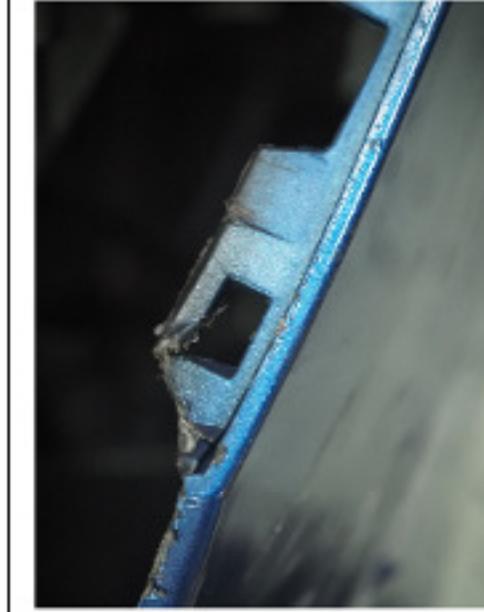
RE-INSPECTION

PHOTOGRAPHS FOR VEHICLE NO. SJW 8875A
