Vehicle No. FBF 9530Y

Inspection Date 04/02/2020

ADJUSTMENT ON REPAIR COST FOR VEHICLE NO. FBF 9530Y

PHOTOGRAPHS FOR VEHICLE NO. FBF 9530Y

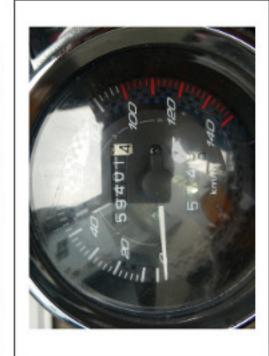
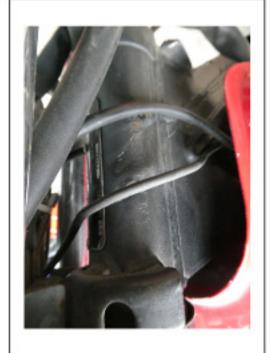
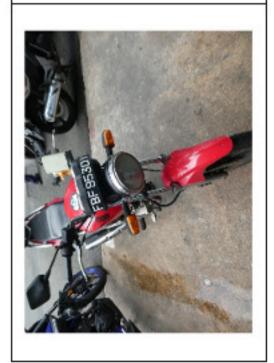
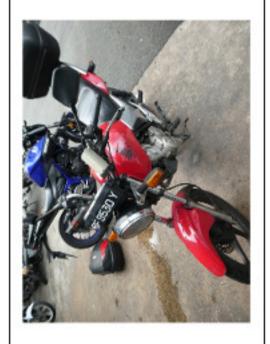
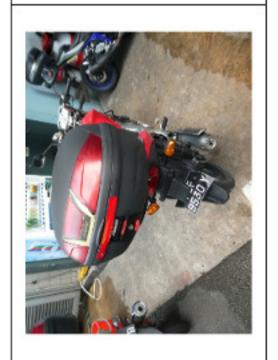
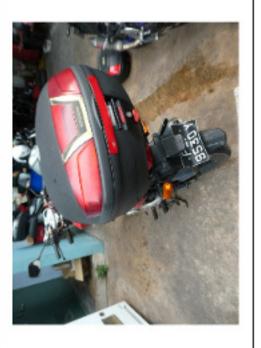
| | Affiliated to Federation Internationale Des Experts En Automobile | | | |
|---|---|---|---|---|
| | THE VEHICLE SU | STAINED DAMAGES AT THE REA | AR PORTION AND N/S BOD | Y |
