# LKK Auto Consultants Pte Ltd

### ADJUSTMENT ON REPAIR COST FOR VEHICLE NO. SLE 965Y

**PHOTOGRAPHS FOR VEHICLE NO. SLE 965Y**

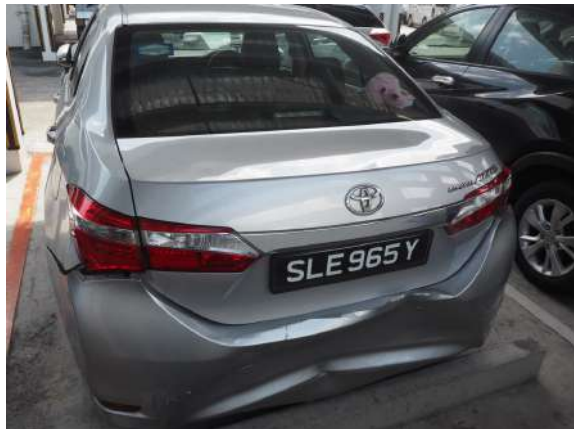
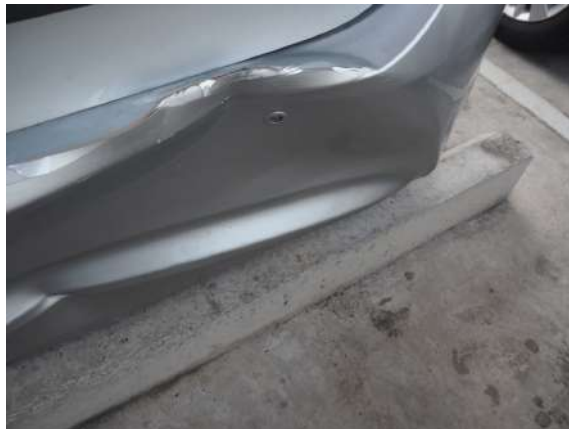
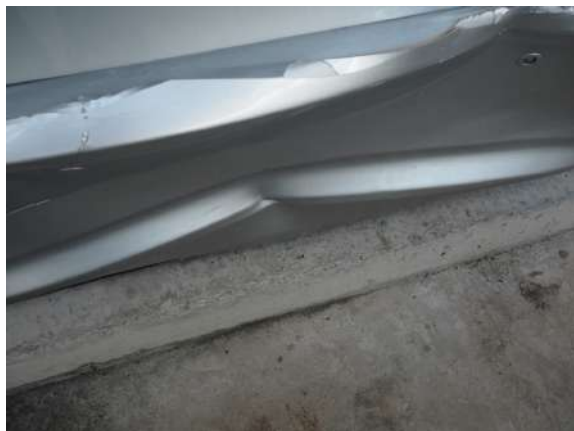
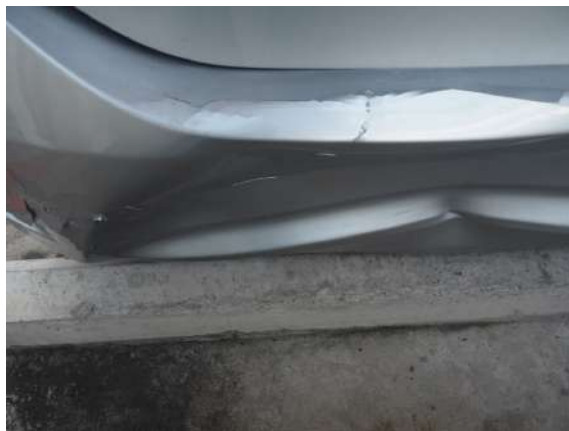
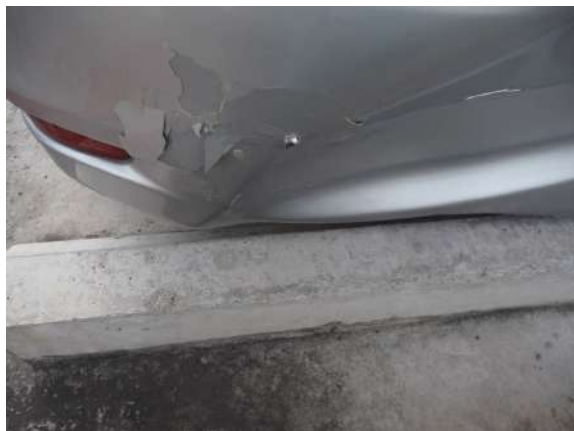
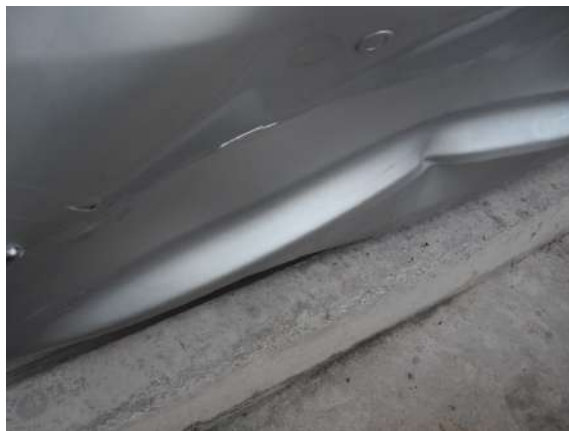
| Affiliated to Federation Internationale Des Experts En Automobile | | | | |
|---|---|---|---|--|
| THE VEHICLE SUSTAINED DAMAGES AT THE FRONT AND REAR PORTION.<br>DAMAGEE SEE DETAILS. | | | | |

**INSPECTION**
