REF: CS / MSG 20002063 / D1 f30

To Inspect Vehicle No: SH 9637L

## REPAIR ESTIMATE

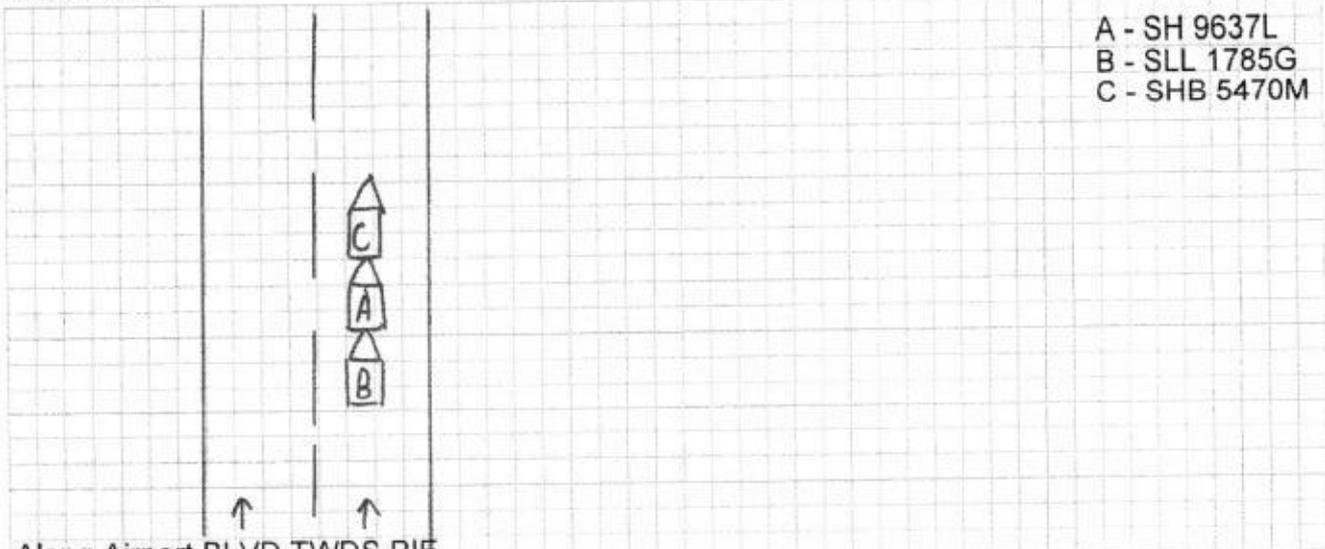
SKETCH PLAN

A - SH 9637L  
B - SLL 1785G  
C - SHB 5470M

Along Airport BLVD TWDS PIE

On 29/1/2020 at about 2330hrs, I was driving my car - SH9637L along lane 1 of Airport Boulevard (towards PIE). I spotted another car - SHB5470M stopped ahead of me. So I applied my brakes, but just before my car came to a stop, I felt an impact from the rear and the impact caused my car to surge forward and collide with SHB5470M. I checked and discovered that another car - SLL1785G had collided on to the rear of my car. There is a camera installed at the front of my car.
