REF: CS/CTI 20002238/Ey f302

ASSIGNMENT (Office)

To Inspect Vehicle No:

GBH 63644

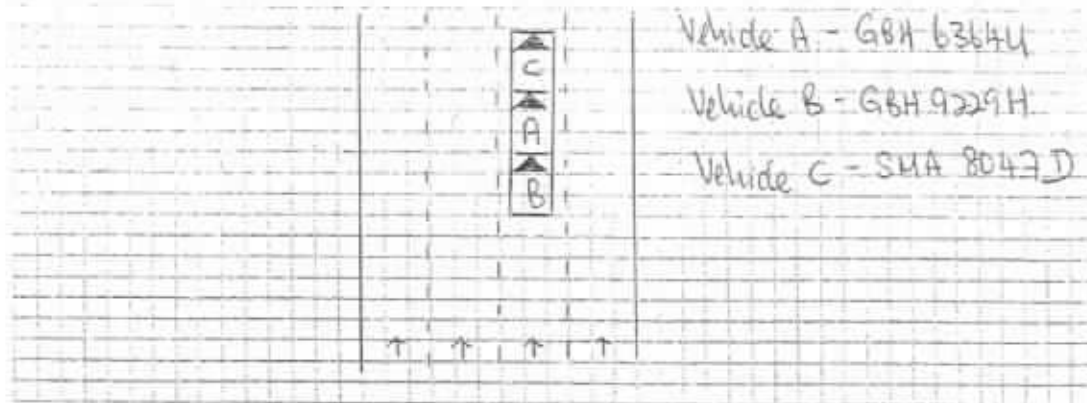
SKETCH PLAN TPE towards Pasir Ris before Tampines Ave 10 Exit

On the stated date and time at the stated venue, my vehicle 'A' GBH 6364U was travelling straight on my rightful lane. Vehicle 'C' SMA 8047D in front of me stopped so I followed suit. Moments later, I felt a great impact on the rear portion of my stationary vehicle. Vehicle 'B' GBH 9229H could not make it to stopped, hence collided onto the rear portion of my vehicle causing my vehicle to propel forward against vehicle 'C'.
