Vehicle No. SLB 7882Y  
Insured Veh. SHD 3127H  
Claim No. D20000797MFSH  
Policy No. D-20094922MFSH  
Accident Date 01/02/2020  
Inspection Date 10/02/2020

### ADJUSTMENT ON REPAIR COST FOR VEHICLE NO. SLB 7882Y

PHOTOGRAPHS FOR VEHICLE NO. SLB 7882Y

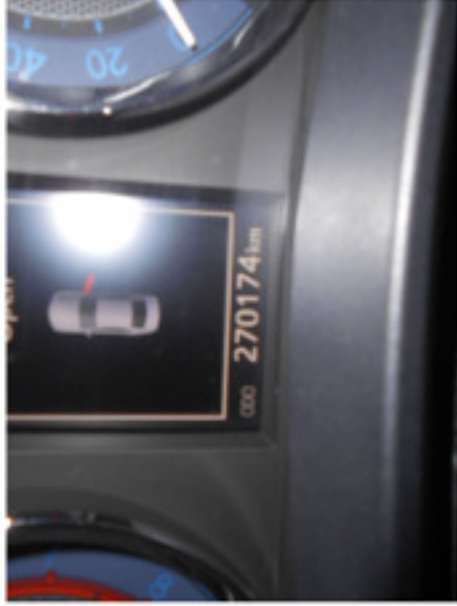
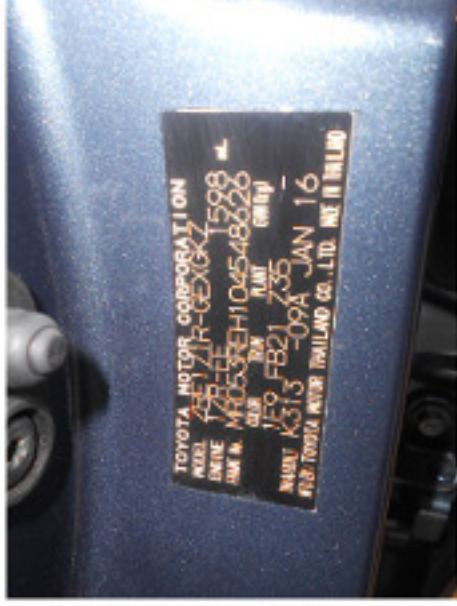
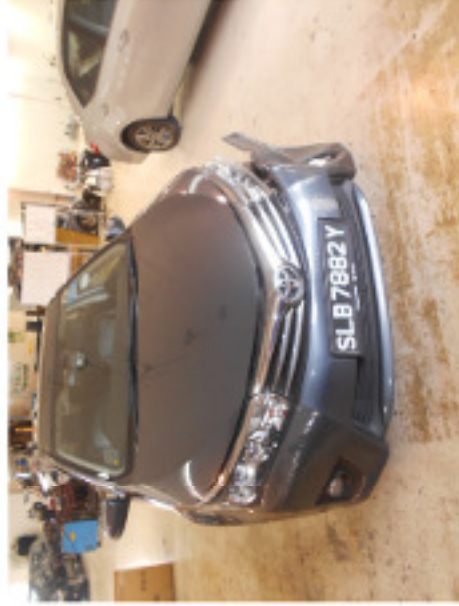
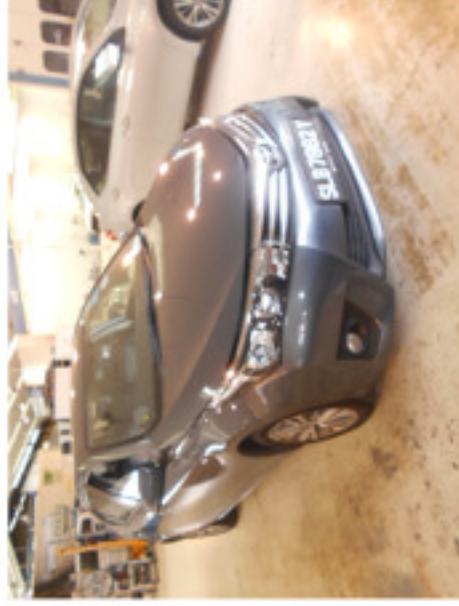
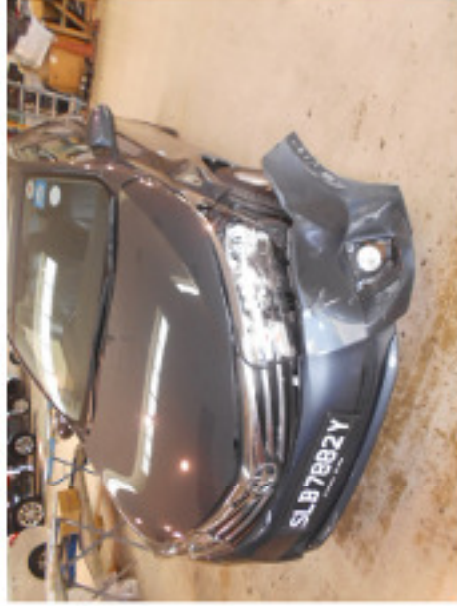
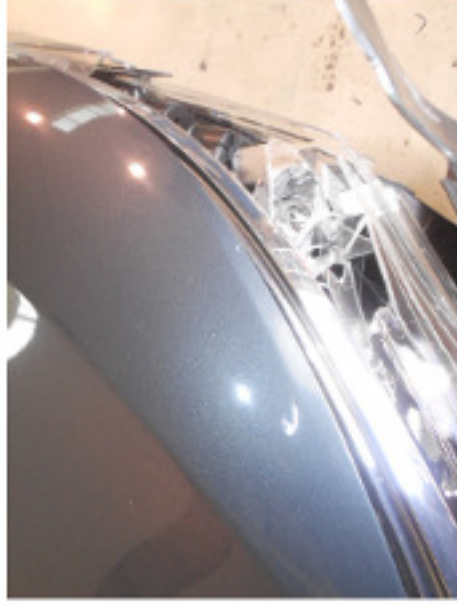
INSPECTION

| Affiliated to Federation Internationale Des Experts En Automobile | | | | |
|---|---|---|---|---|
| THE VEHICLE SUSTAINED DAMAGES AT THE N/S FRONT PORTION.<br>DAMAGES SEE DETAILS. | | | | |
