TAX INVOICE

Vehicle No. GBH 767E

ADJUSTMENT ON REPAIR COST FOR VEHICLE NO. GBH 767E

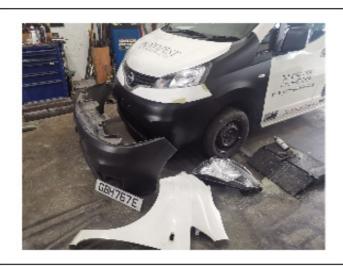
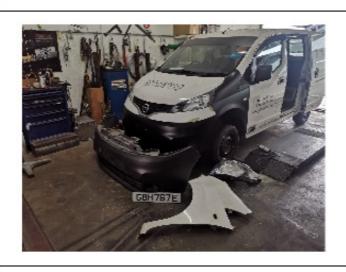
PHOTOGRAPHS FOR VEHICLE NO. GBH 767E

RE-INSPECTION

4.		Description					
	THE VEHICLE SU	STAINED DAMAGES AT THE N/S	FRONT	AND FRONT PORT	TION.		
	DAMAGES SEE D	ETAILS.					
5.		General	Inform	ation			
	Accident Date	21/01/2020	Inspec	tion Date	23/04/2020		
	Survey held at	EFFICIENT MOTOR & ENGINEE	ERING W	ORKS PTE LTD			
	56 LOYANG WAY #06-07 LOYANG ENTERPRISE BUILDING SINGAPORE 508775						
5a.		Re	emarks				
	A)THE INSPECTION WAS CONDUCTED ON A"WITHOUT PREJUDICE" BASIS. B)IN ACCORDANCE TO YOUR INSTRUCTIONS, WE HAVE NOT AUTHORISED REPAIRS.				REPAIRS.		
5b.	b. Estimate Days of Repair						
	ESTIMATED NORI	MAL PERIOD FOR REPAIR:		3 Working Days
