LKK Auto Consultants Pte Ltd

ADJUSTMENT ON REPAIR COST FOR VEHICLE NO. SMS 6668E

PHOTOGRAPHS FOR VEHICLE NO. SMS 6668E

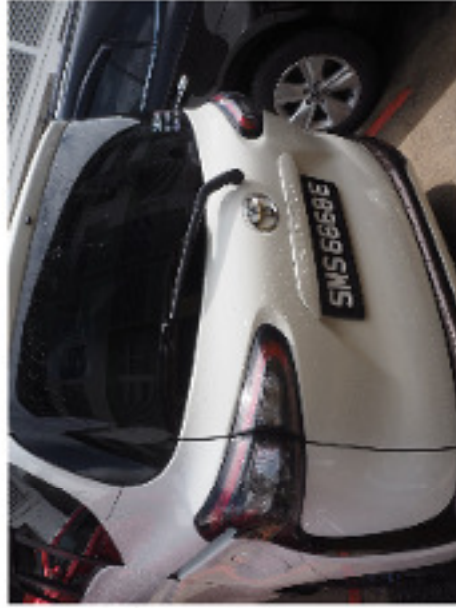
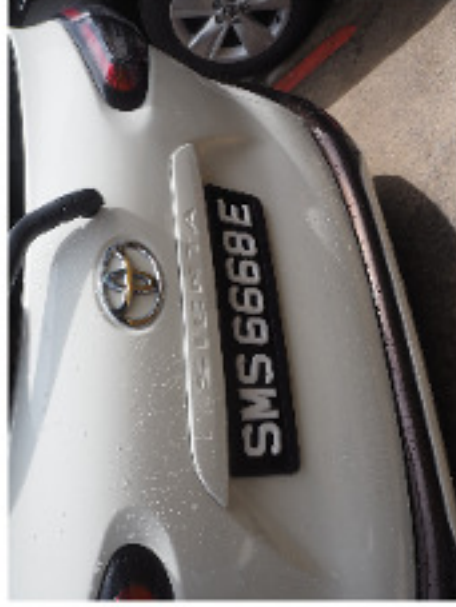
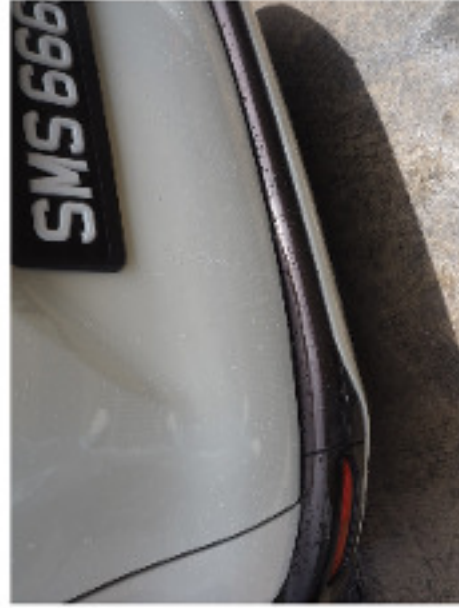
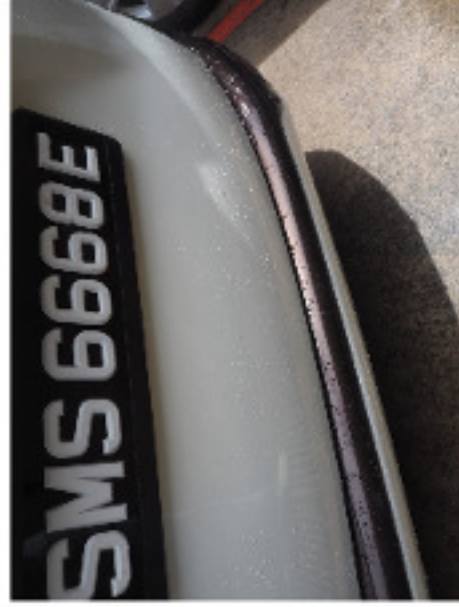
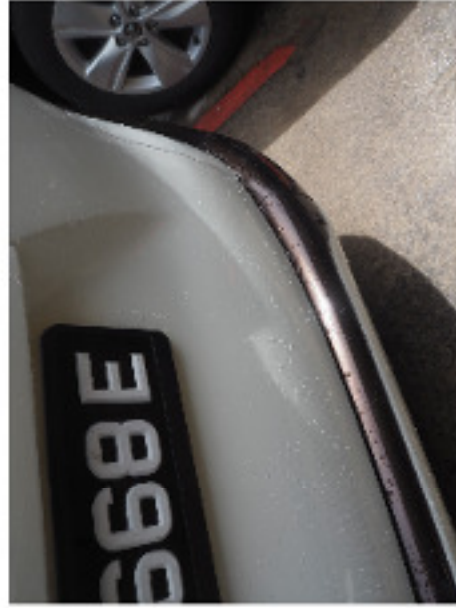
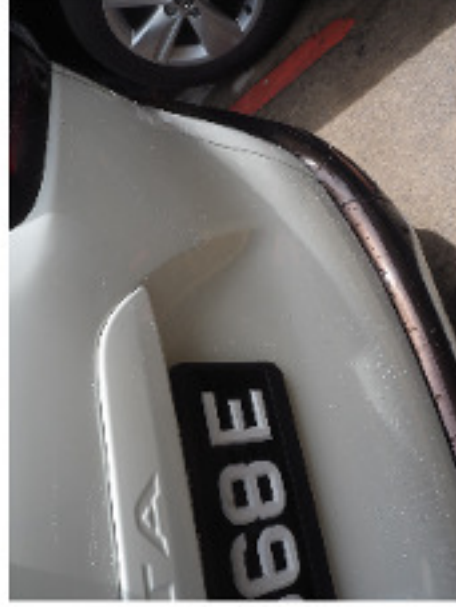
PHOTOGRAPHS FOR VEHICLE NO. SMS 6668E

RE-INSPECTION

THE VEHICLE SUSTAINED DAMAGES AT THE REAR PORTION. DAMAGES SEE DETAILS.
--
