PROFESSIONAL SERVICE FEE

Vehicle No. SFB 7372Z
Insured Veh. SHB 4918X
Claim No. D20001013MFSH
Policy No. D-20094921MFSH
Accident Date 12/02/2020
Inspection Date 17/02/2020

ADJUSTMENT ON REPAIR COST FOR VEHICLE NO. SFB 7372Z

PHOTOGRAPHS FOR VEHICLE NO. SFB 7372Z

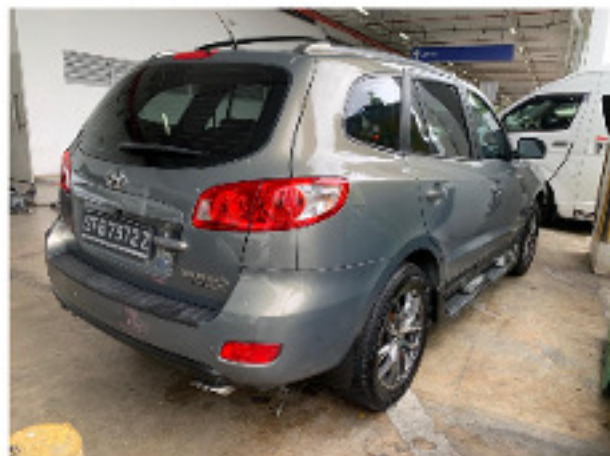
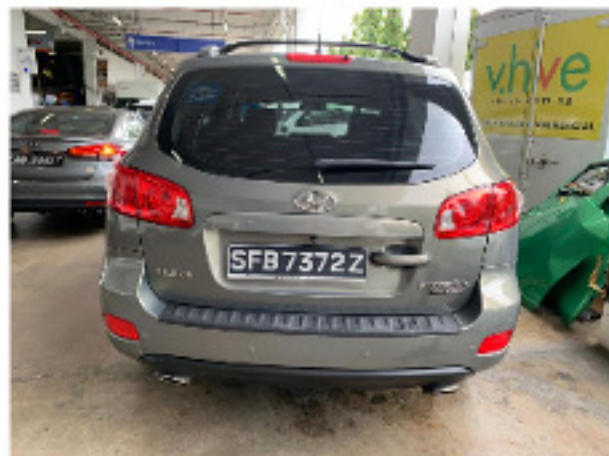
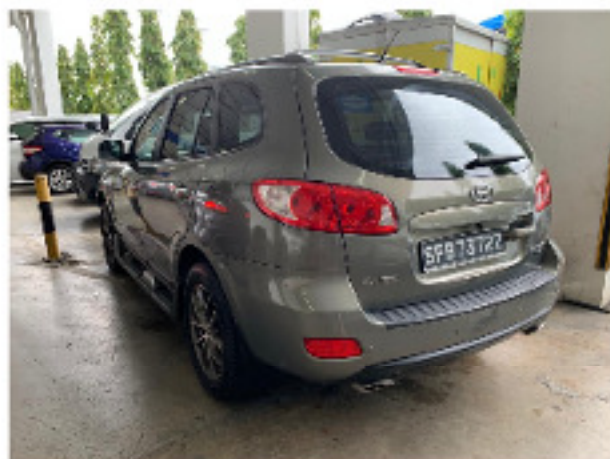
PHOTOGRAPHS FOR VEHICLE NO. SFB 7372Z

RE-INSPECTION

THE VEHICLE SUSTAINED DAMAGES AT THE O/S BODY. DAMAGES SEE DETAILS.
--
