Vehicle No. SKN 7818H

### ADJUSTMENT ON REPAIR COST FOR VEHICLE NO. SKN 7818H

# PHOTOGRAPHS FOR VEHICLE NO. SKN 7818H

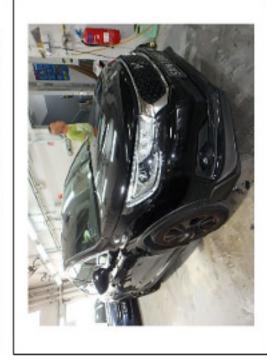
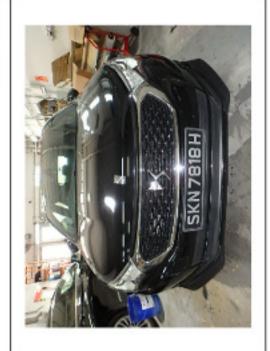
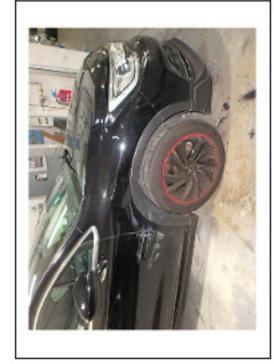
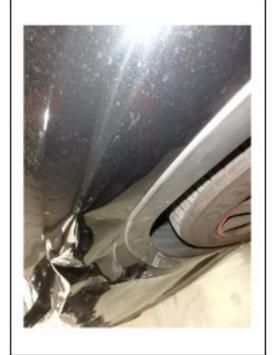
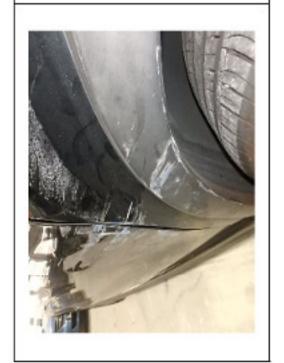
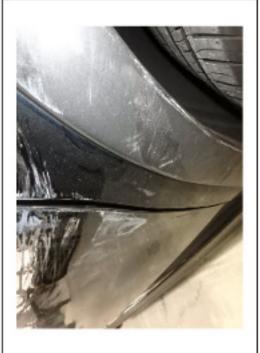
| | Affiliated to Federation Internationale Des Experts En Automobile | | | | | | | |
|---|---|---|---|---|--|--|--|--|
| | THE VEHICLE SU | STAINED DAMAGES AT THE O/S | FRONT BODY. | | | | | |
