Vehicle No. SLW 6757Y
Insured Veh. SHC 7597M

### ADJUSTMENT ON REPAIR COST FOR VEHICLE NO. SLW 6757Y

# PHOTOGRAPHS FOR VEHICLE NO. SLW 6757Y

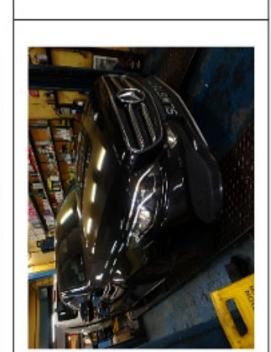
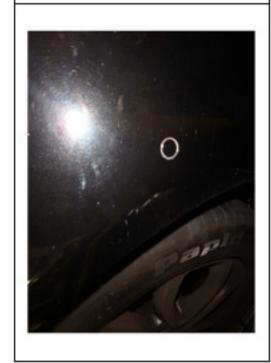
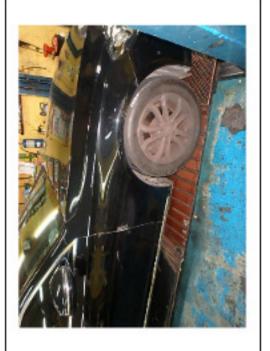
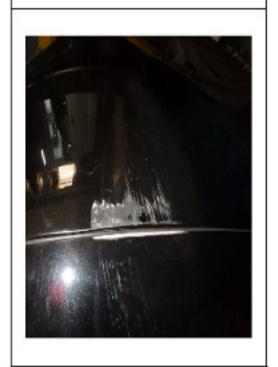
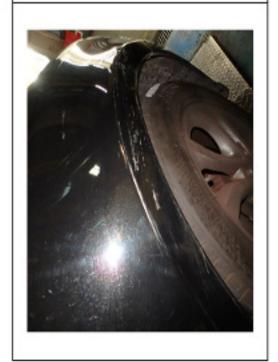
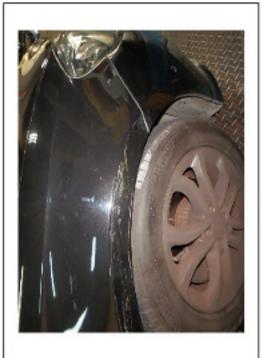
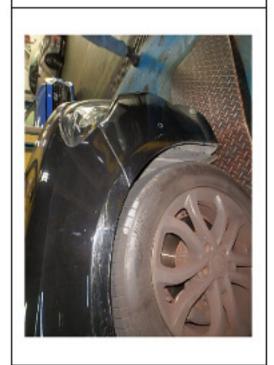
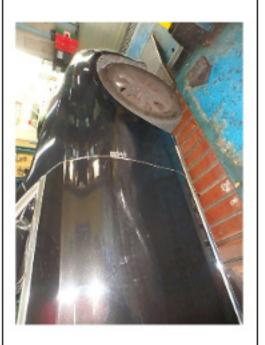
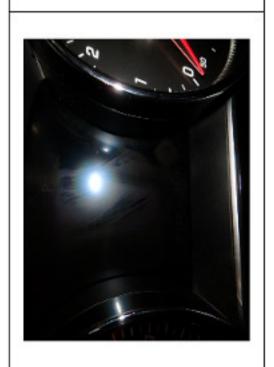
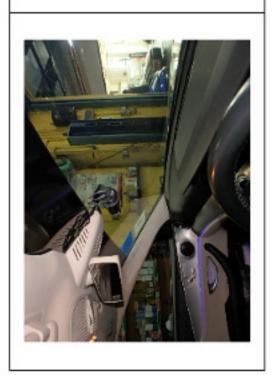
4.		•	on of Damages			
	THE VEHICLE SU	STAINED DAMAGES AT THE O/S	FRONT PORTION.			
	DAMAGES SEE D	ETAILS.				
5.		General	Information			
	Accident Date	24/01/2020	Inspection Date	26/02/2020		
	Survey held at	LIM TAN MOTOR PTE LTD				
		BLK 176 SIN MING DRIVE #03-09 SIN MING AUTOCARE SINGAPORE 575721				
5a.		Re	emarks			
	A)THE INSPECTION WAS CONDUCTED ON A"WITHOUT PREJUDICE" BASIS. B)IN ACCORDANCE TO YOUR INSTRUCTIONS, WE HAVE NOT AUTHORISED REPAIRS.					
5b.	5b. Estimate Days of Repair					
	ESTIMATED NOR	MAL PERIOD FOR REPAIR:	3 Working Days
