DAMAGE ASSESSMENT REPORT

ADJUSTMENT ON REPAIR COST FOR VEHICLE NO. SLF 7188Y

PHOTOGRAPHS FOR VEHICLE NO. SLF 7188Y

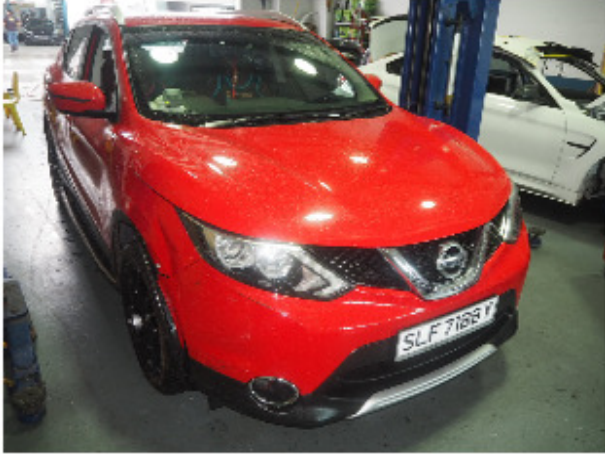
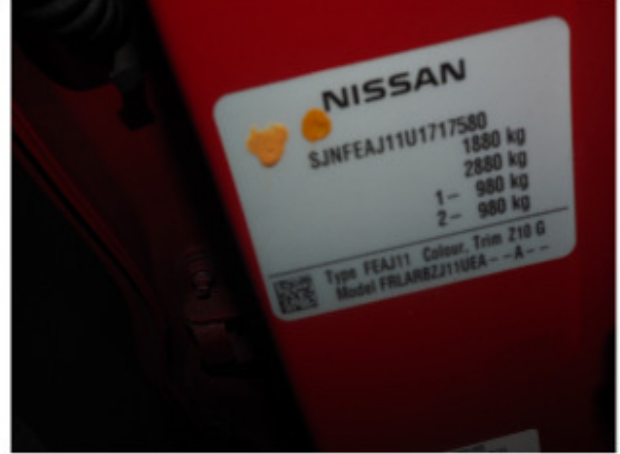
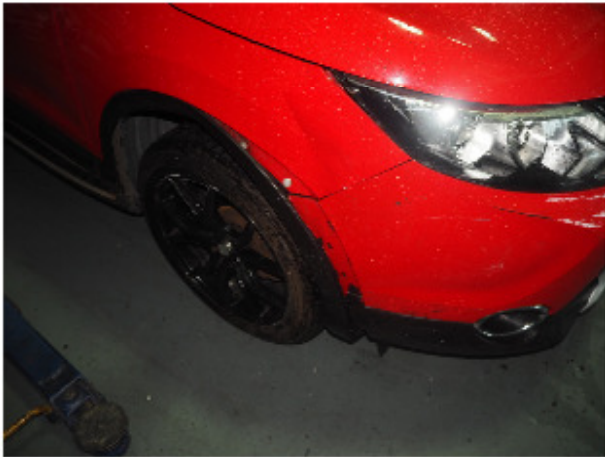
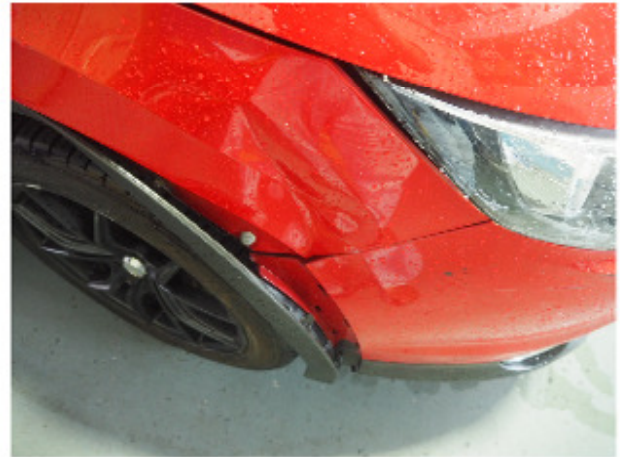
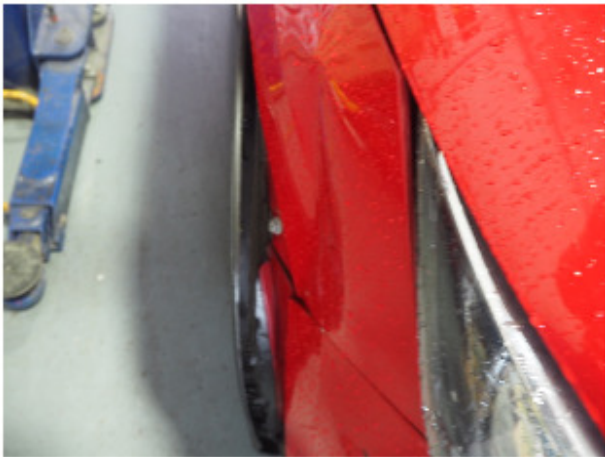
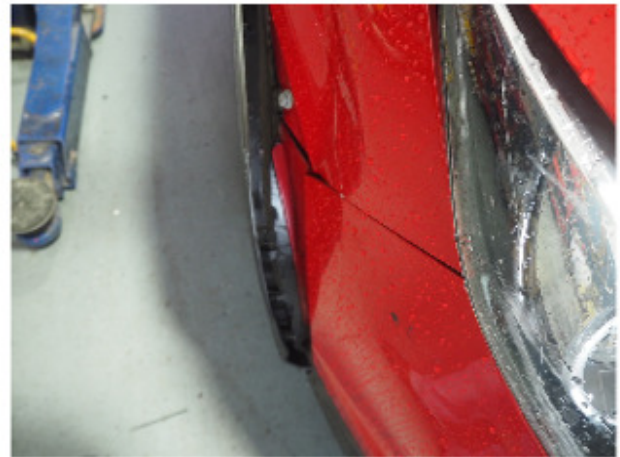
INSPECTION

THE VEHICLE SUSTAINED DAMAGES AT THE FRONT O/S PORTION. DAMAGES SEE DETAILS.
