2.		Vehicle Partic	culars & Condition		
	Make & Model	HONDA FJS400A	c.c	399	
	Engine No.	HIDDEN	Year of Reg.	2016	
	Chassis No.	JH2NF039X9K000241	Colour	GREY	
	Odometer	45299	Steering	IN ORDER	
	Brakes	IN ORDER	Modification	SPORTS RIM	
	General	GOOD

ADJUSTMENT ON REPAIR COST FOR VEHICLE NO. FW 180X

PHOTOGRAPHS FOR VEHICLE NO. FW 180X

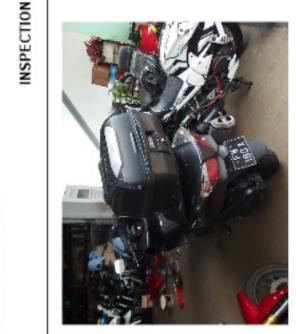
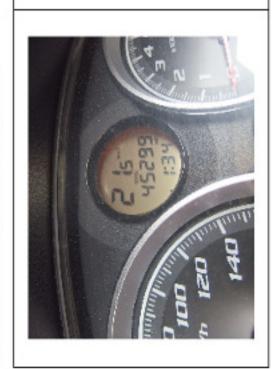
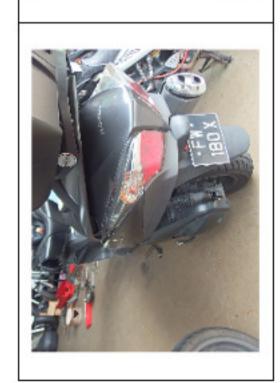
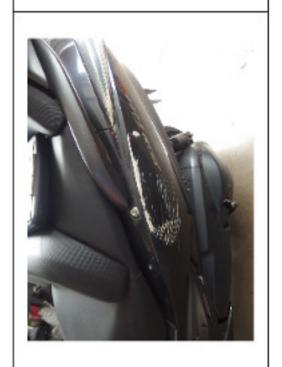
4.		•	on of Damages		
	THE VEHICLE SUS	STAINED DAMAGES AT THE N/S	REAR PORTION AND N/S E	BODY.	
	DAMAGES SEE DI	ETAILS.			
5.		General	Information		
	Accident Date	24/02/2020	Inspection Date	04/03/2020	
	Survey held at	at EROFIA MOTOR TRADING PTE LTD			
		1 KAKI BUKIT AVENUE 6 #02-62 SINGAPORE 417883			
5a.		Re	emarks		
	A)THE INSPECTION WAS CONDUCTED ON A"WITHOUT PREJUDICE" BASIS. B)IN ACCORDANCE TO YOUR INSTRUCTIONS, WE HAVE NOT AUTHORISED REPAIRS.				
5b.	Estimate Days of Repair				
	ESTIMATED NORI	MAL PERIOD FOR REPAIR:	4 Working Days
