LKK Auto Consultants Pte Ltd

ADJUSTMENT ON REPAIR COST FOR VEHICLE NO. GBD 2836Y

PHOTOGRAPHS FOR VEHICLE NO. GBD 2836Y

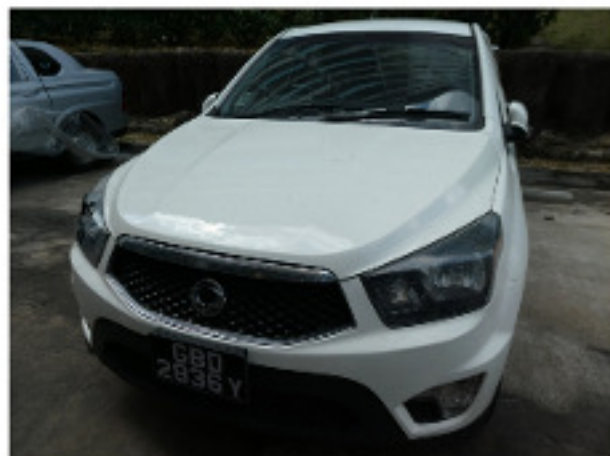
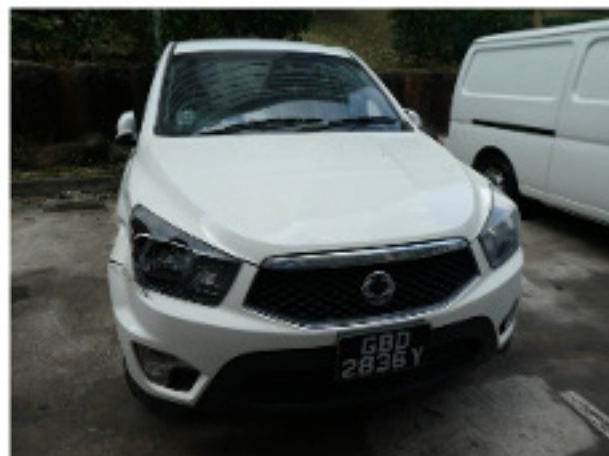
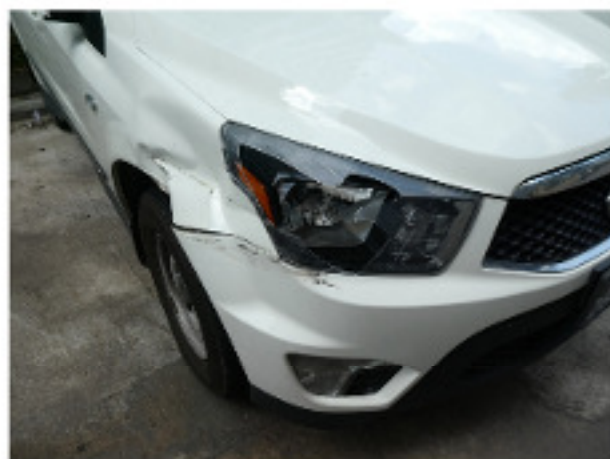
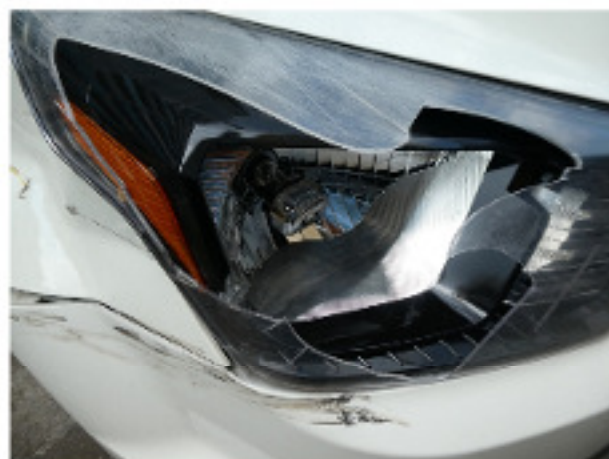
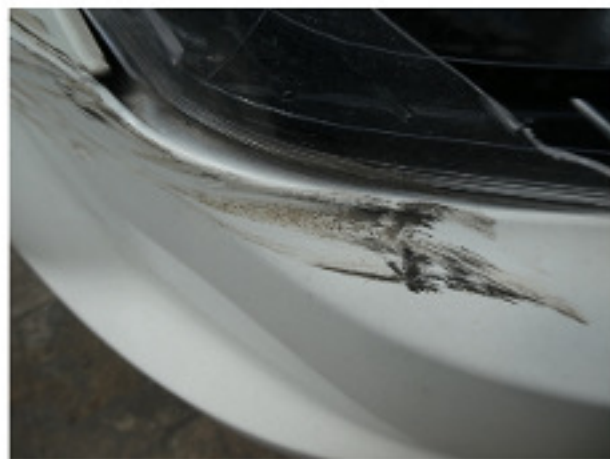
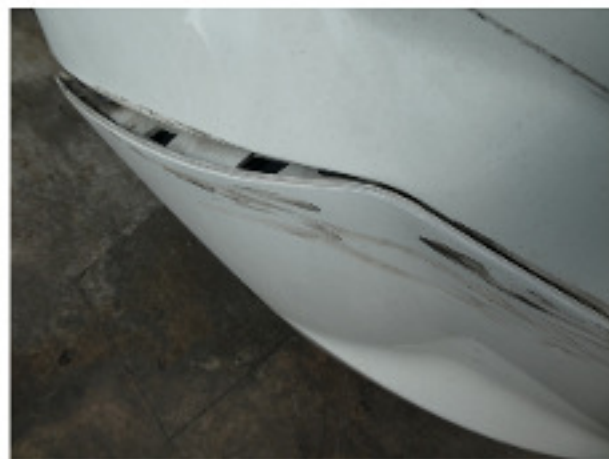
INSPECTION

THE VEHICLE SUSTAINED DAMAGES AT THE FRONT O/S PORTION. DAMAGES SEE DETAILS.

Qty	Description of Parts	Condition	Estimate By Workshop (\$)	Our Adjusted (\$)
	<u>REPLACEMENT OF PARTS</u>			
1	FRONT BUMPER	DEFORMED	1,150.00	1,150.00
1	FRONT BUMPER RETAINER RH	NECESSARY	89.00	89.00
1	FRONT HEADLAMP RH	CRACKED	1,500.00	1,500.00
1	FRONT FENDER RH	BENT	580.00	580.00
1	FRONT FENDER UNDER-DUST COVER RH	NOT NECESSARY	190.00	-
1	FRONT FOGLAMP RH	NOT NECESSARY	250.00	-
	LESS 10% DISCOUNT		-375.90	-331.90
			3,383.10	2,987.10
	<u>SPECIAL NETT ITEMS</u>			
1	FRONT BUMPER CLIPS (SN)	NECESSARY	40.00	30.00
1	FRONT FENDER UNDER-DUST COVER CLIPS (SN)	NOT NECESSARY	40.00	-

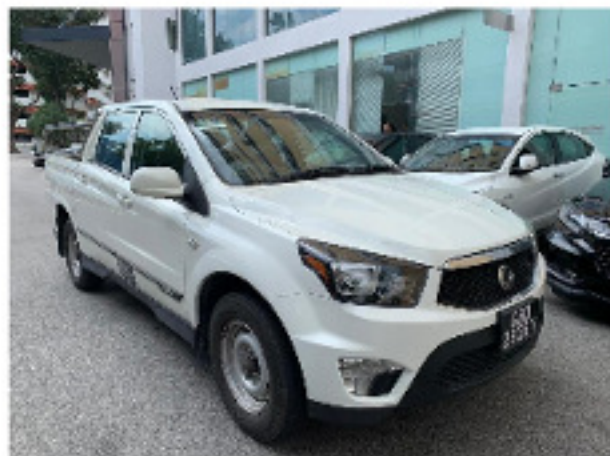
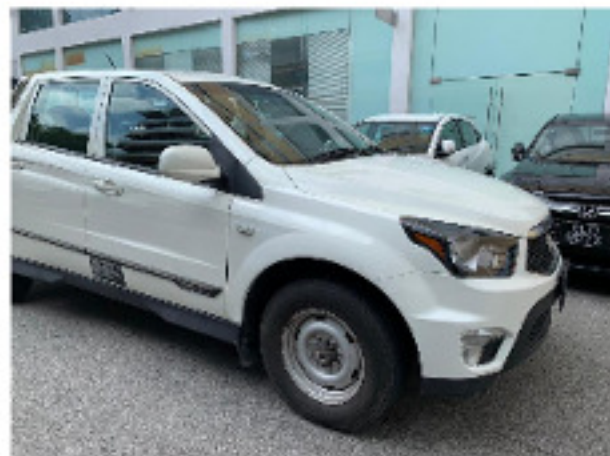
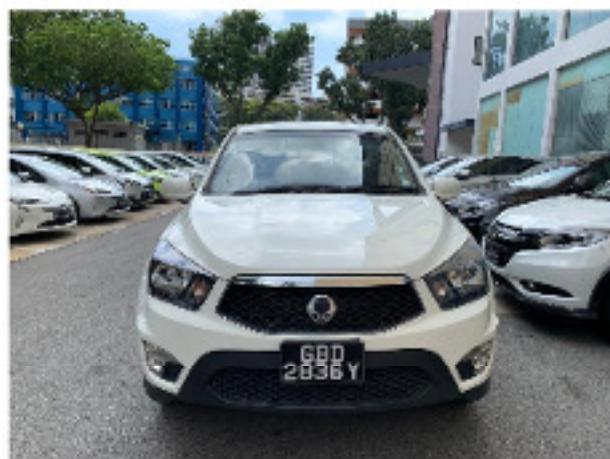
RE-INSPECTION

PHOTOGRAPHS FOR VEHICLE NO. GBD 2836Y
