LKK Auto Consultants Pte Ltd

ADJUSTMENT ON REPAIR COST FOR VEHICLE NO. SLU 5464J

PHOTOGRAPHS FOR VEHICLE NO. SLU 5464J

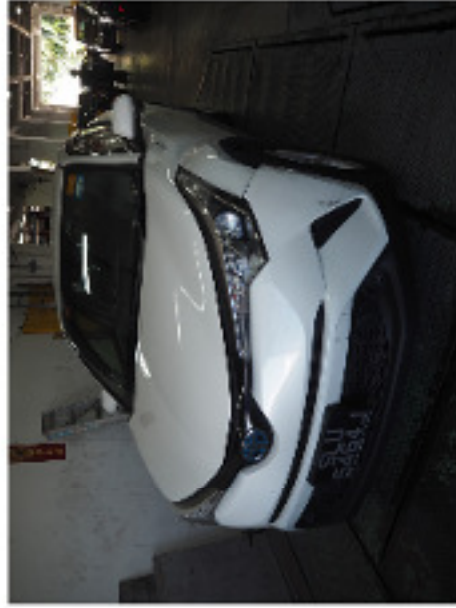
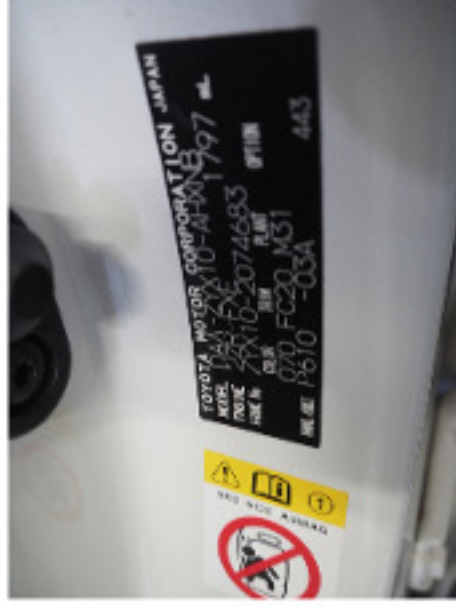
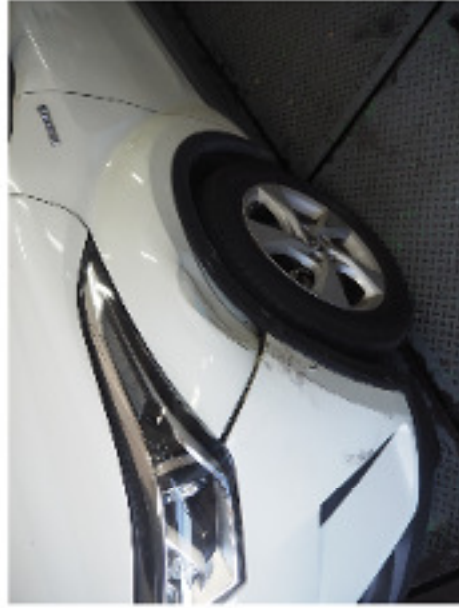
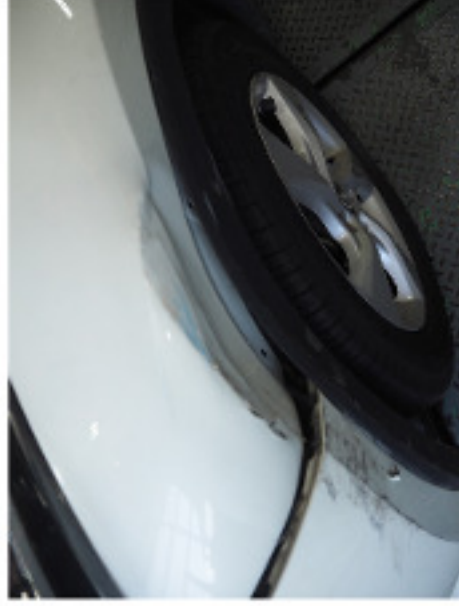
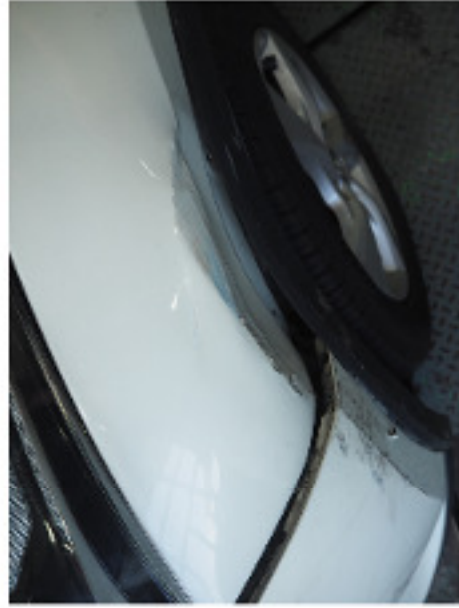
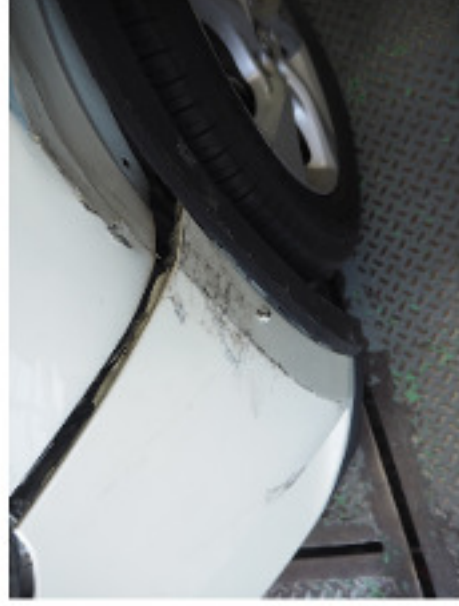
INSPECTION

4. Description of Damages				
	THE VEHICLE SUSTAINED DAMAGES AT THE N/S BODY AND UNDERCARRIAGE. DAMAGES SEE DETAILS.			
5. General Information				
Accident Date	28/02/2020	Inspection Date	02/03/2020	
Survey held at	MG SOLUTION PTE LTD 23 KAKI BUKIT AVE 4 (SOUTH WING) #02-03B VICOM INSPECTION CENTRE, SINGAPORE 415933			
5a. Remarks				
	A)THE INSPECTION WAS CONDUCTED ON A"WITHOUT PREJUDICE" BASIS. B)IN ACCORDANCE TO YOUR INSTRUCTIONS, WE HAVE NOT AUTHORISED REPAIRS.			
5b. Estimate Days of Repair				
	ESTIMATED NORMAL PERIOD FOR REPAIR:		5 Working Days

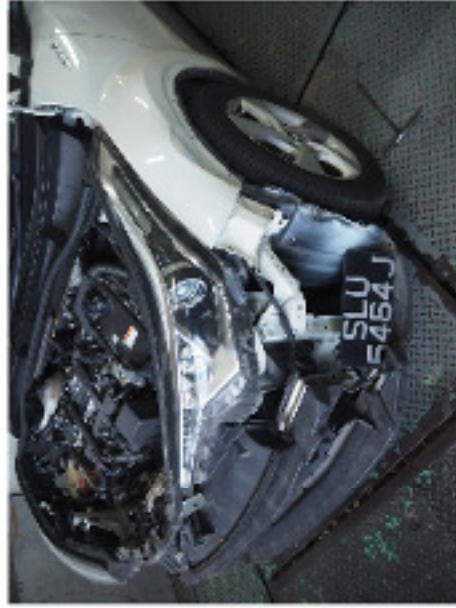
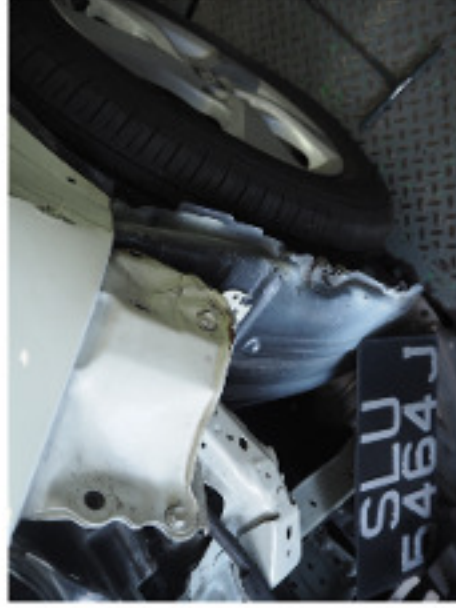
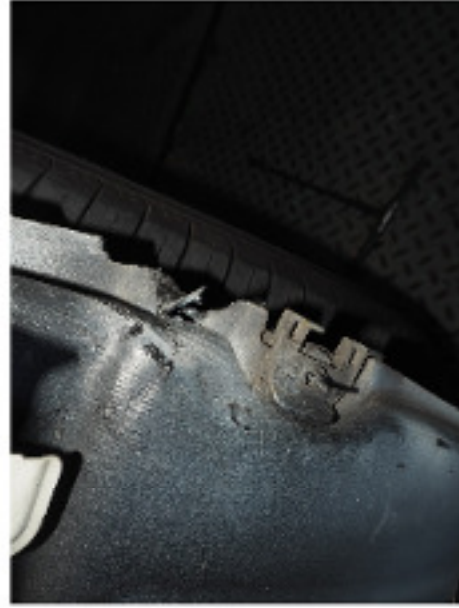
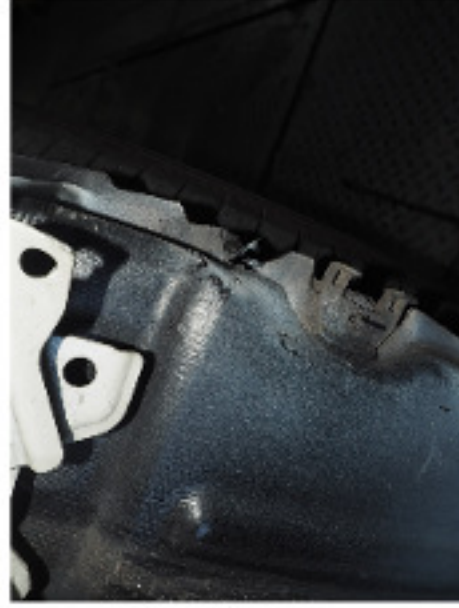
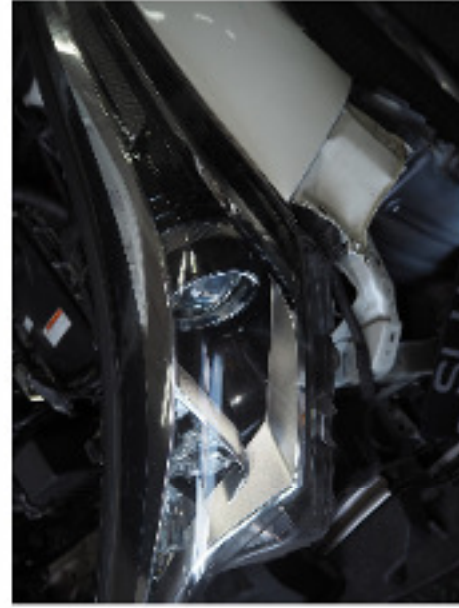
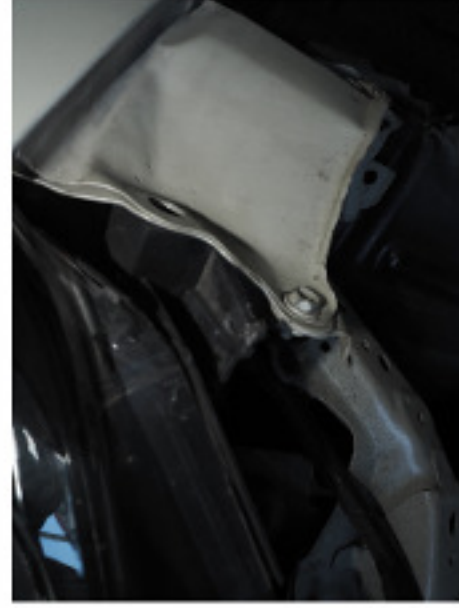
PHOTOGRAPHS FOR VEHICLE NO. SLU 5464J

RE-INSPECTION
