## **TAX INVOICE**

## **PROFESSIONAL SERVICE FEE**

Vehicle No. YP 5071G

## ADJUSTMENT ON REPAIR COST FOR VEHICLE NO. YP 5071G

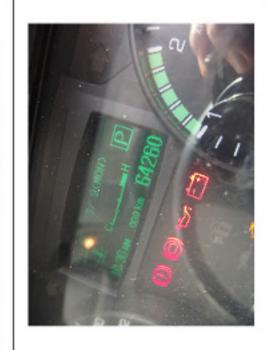
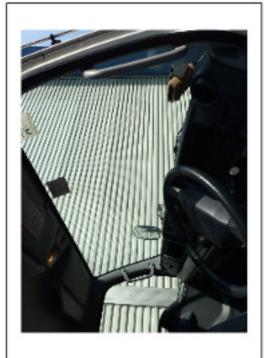
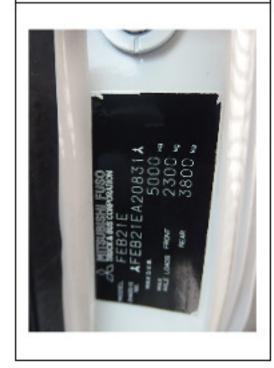
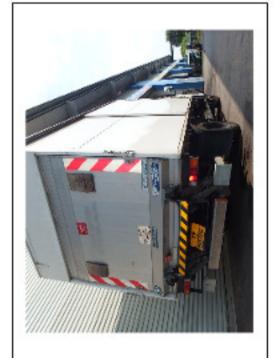
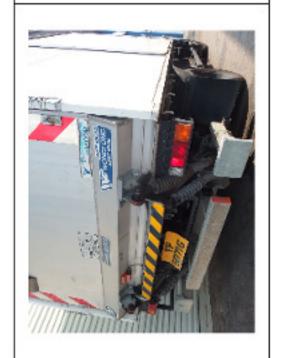
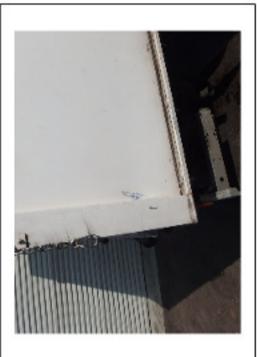
# PHOTOGRAPHS FOR VEHICLE NO. YP 5071G

4.		Description	on of Damages					
	THE VEHICLE SU	STAINED DAMAGES AT THE O/S	REAR PORTION.					
	DAMAGES SEE D	ETAILS.						
5.		General	Information					
	Accident Date	20/01/2020	Inspection Date	09/03/2020				
	Survey held at	rey held at LIU'S BROTHER AUTO ENGINEERING WORKSHOP						
	1 KAKI BUKIT AVENUE 6 #01-01 AUTOBAY @ KAKI BUKIT SINGAPORE 417883							
5a.		Re	emarks					
	A)THE INSPECTION WAS CONDUCTED ON A"WITHOUT PREJUDICE" BASIS. B)IN ACCORDANCE TO YOUR INSTRUCTIONS, WE HAVE NOT AUTHORISED REPAIRS.							
5b.	5b. Estimate Days of Repair							
	ESTIMATED NORMAL PERIOD FOR REPAIR: 3 Working Days

Qty	Description of Parts	Condition	Estimate By Workshop (\$))	Our Adjusted (\$)
	LABOUR			
	LABOR FOR PANEL BEATING REAR CARGO BOX PANEL.		500.00	250.00
	TO PUTTY & SPRAY PAINTING & INCLUDING TOUCH UP PAINT ON ACCIDENT AFFECTED AREA.		500.00	400.00
			1,000.00	650.00
	GRAND TOTAL		1,000.00	650.00
