2.		Vehicle Partic	culars & Condition	
	Make & Model	RENAULT LATITUDE (A)	c.c	1995
	Engine No.	HIDDEN	Year of Reg.	2016
	Chassis No.	VF1ABL15AUC282195	Colour	METALLIC WHITE / RED
	Odometer	546156	Steering	IN ORDER
	Brakes	IN ORDER	Modification	NIL
	General	GOOD

ADJUSTMENT ON REPAIR COST FOR VEHICLE NO. SHD 342Y

PHOTOGRAPHS FOR VEHICLE NO. SHD 342Y

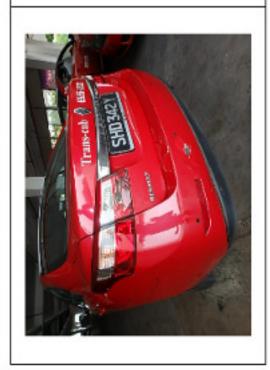
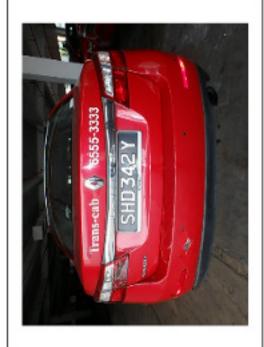
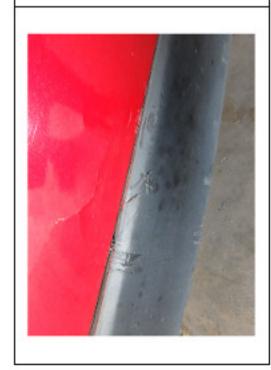
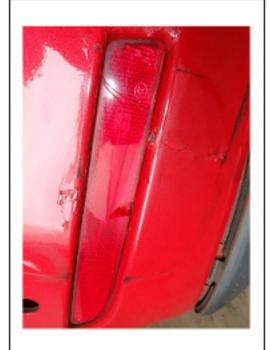
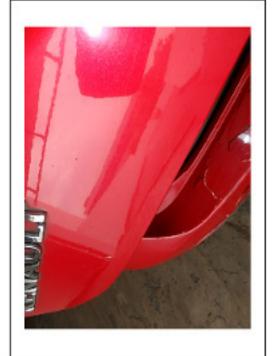
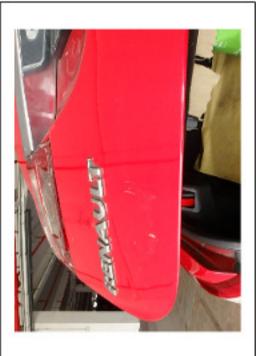
4.		Description	on of Damages	
	THE VEHICLE SU	STAINED DAMAGES AT THE REA	AR N/S PORTION.	
	DAMAGES SEE D	ETAILS.		
5.		General	Information	
	Accident Date	04/03/2020	Inspection Date	06/03/2020
	Survey held at	TRANS-CAB AUTO SERVICES	PTE LTD	
		NO.2 ANG MO KIO ST 63 SINGAPORE 569111		
5a.		Re	emarks	
		ON WAS CONDUCTED ON A"WIT CE TO YOUR INSTRUCTIONS, W		REPAIRS.
5b.	Estimate Days of Repair			
	ESTIMATED NORI	MAL PERIOD FOR REPAIR:	2.500 Working Da	ys
