LKK Auto Consultants Pte Ltd

Vehicle No. SLN 1699L
Insured Veh. SMA 1828M
Claim No. C10005844
Policy No.
Accident Date 07/03/2020
Inspection Date 10/03/2020

PHOTOGRAPHS FOR VEHICLE NO. SLN 1699L

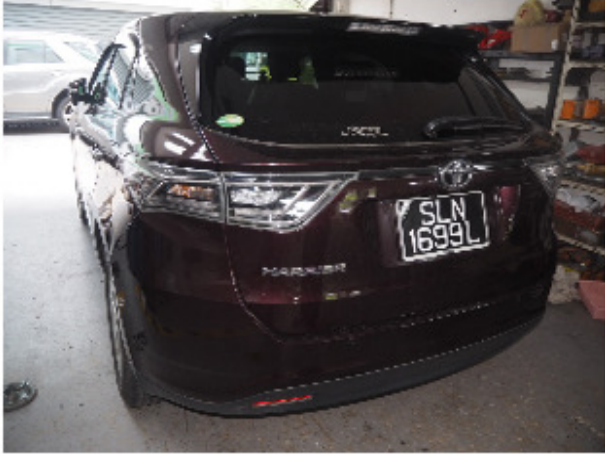
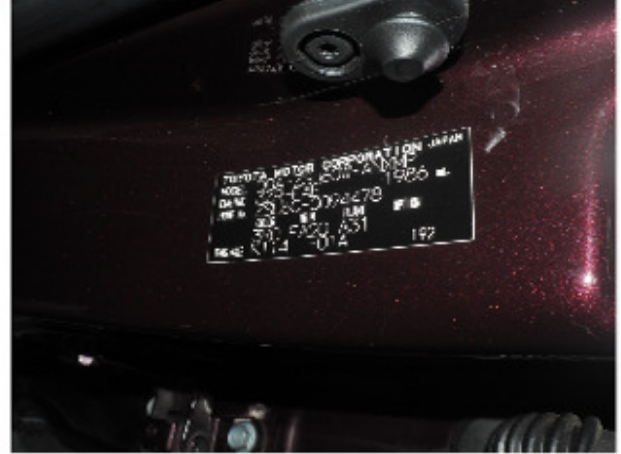
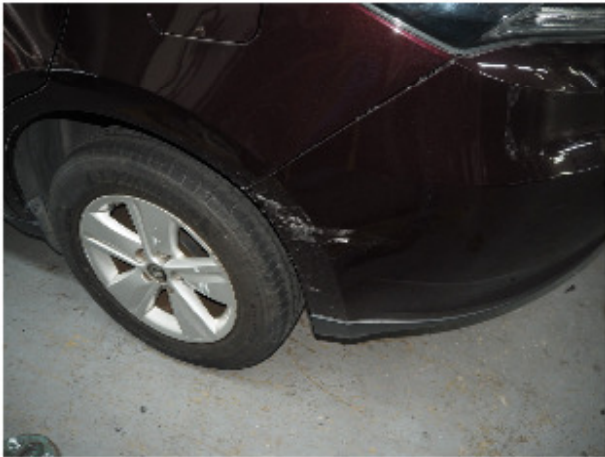
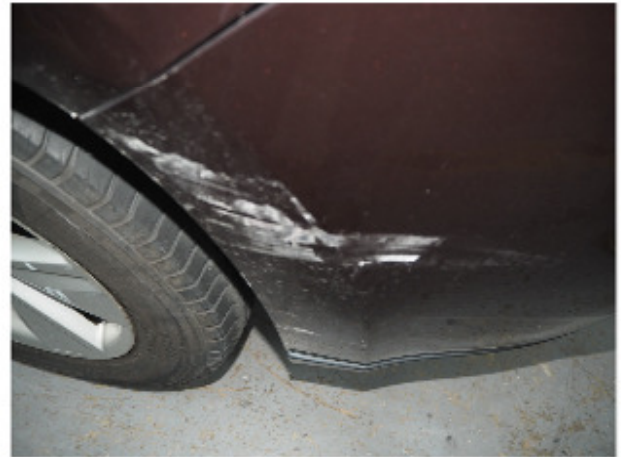
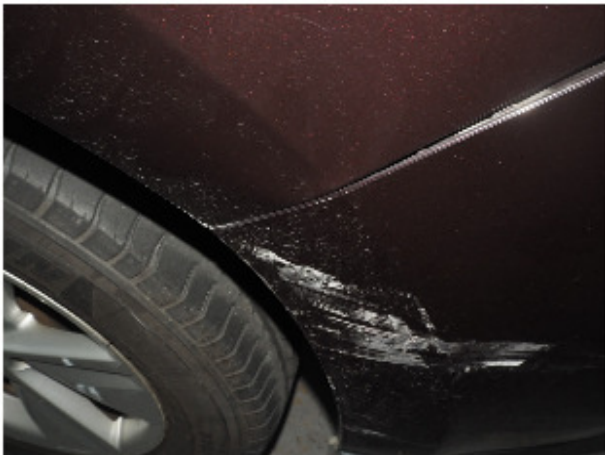
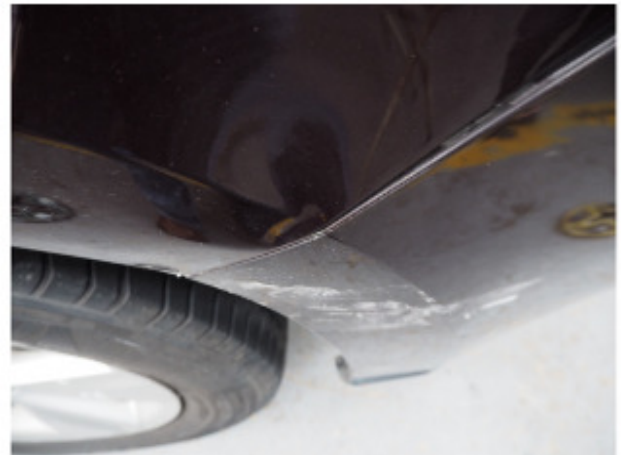
THE VEHICLE SUSTAINED DAMAGES AT THE REAR N/S PORTION.
DAMAGES SEE DETAILS.

INSPECTION

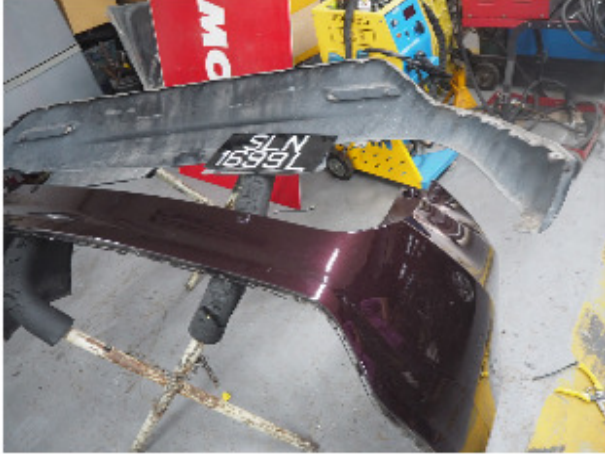
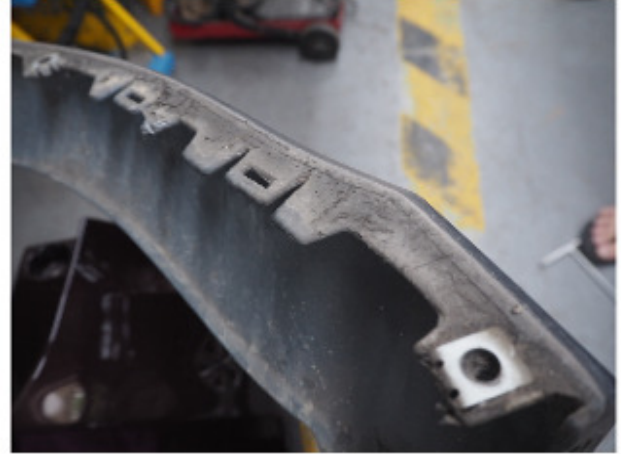
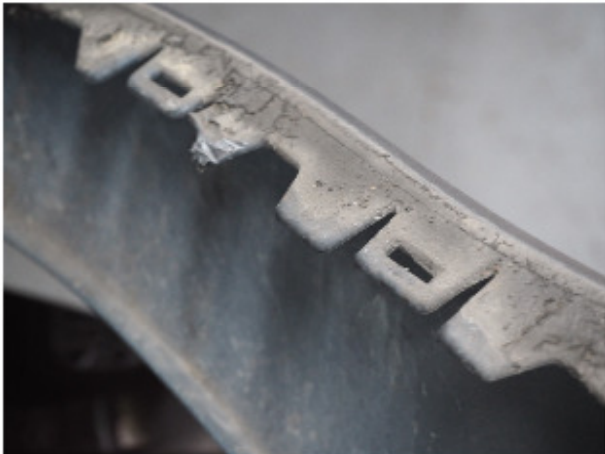
PHOTOGRAPHS FOR VEHICLE NO. SLN 1699L

RE-INSPECTION
