ADJUSTMENT ON REPAIR COST FOR VEHICLE NO. SHD 9785T

PHOTOGRAPHS FOR VEHICLE NO. SHD 9785T

INSPECTION

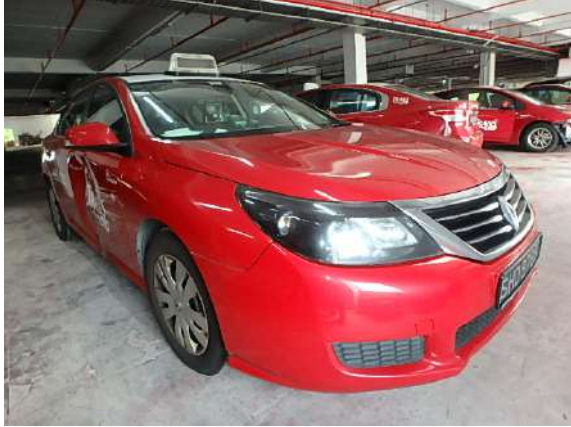
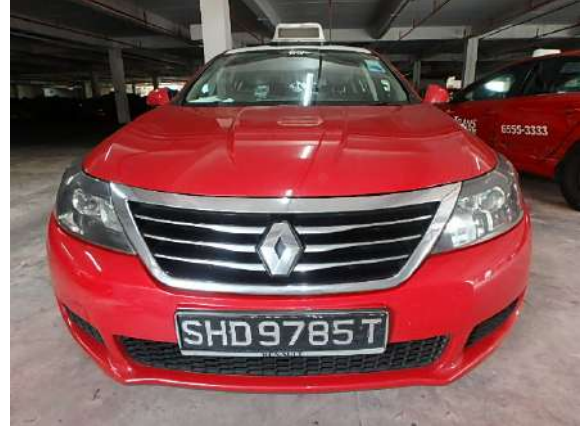
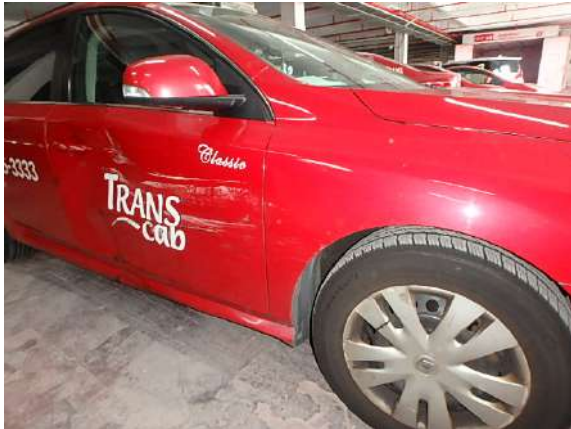
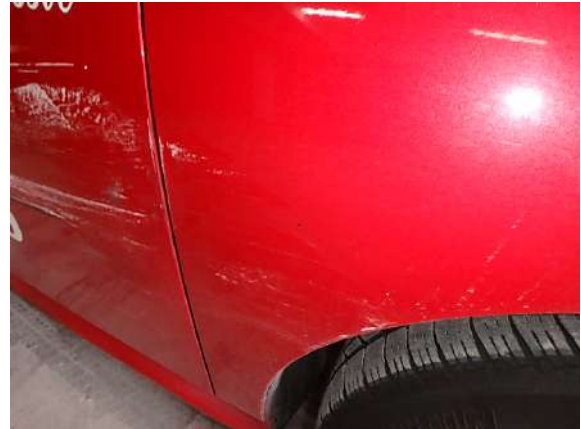
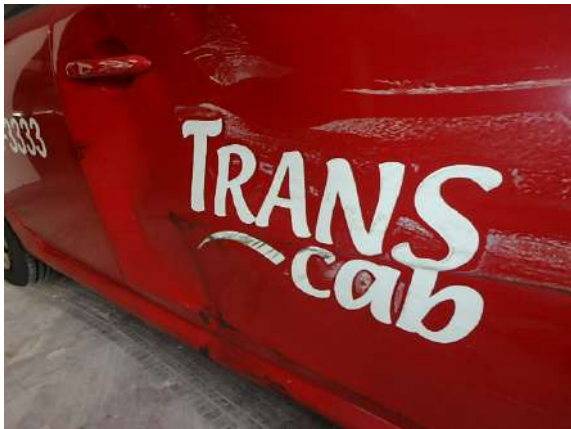
4. Description of Damages				
	THE VEHICLE SUSTAINED DAMAGES AT THE O/S BODY. DAMAGES SEE DETAILS.			
5. General Information				
	Accident Date	08/03/2020	Inspection Date	09/03/2020
	Survey held at	TRANS-CAB AUTO SERVICES PTE LTD NO.2 ANG MO KIO ST 63 SINGAPORE 569111		
5a. Remarks				
	A)THE INSPECTION WAS CONDUCTED ON A"WITHOUT PREJUDICE" BASIS. B)IN ACCORDANCE TO YOUR INSTRUCTIONS, WE HAVE NOT AUTHORISED REPAIRS.			
5b. Estimate Days of Repair				
	ESTIMATED NORMAL PERIOD FOR REPAIR:		5 Working Days

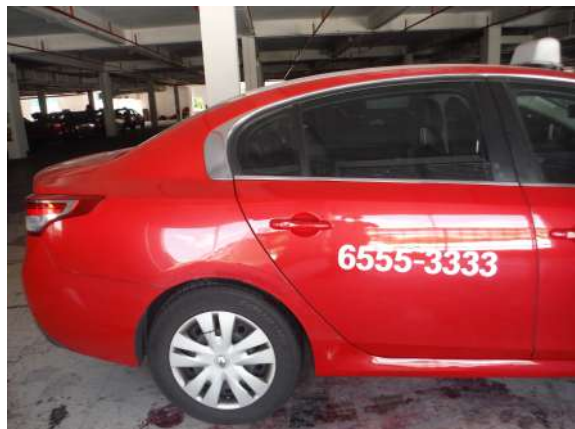
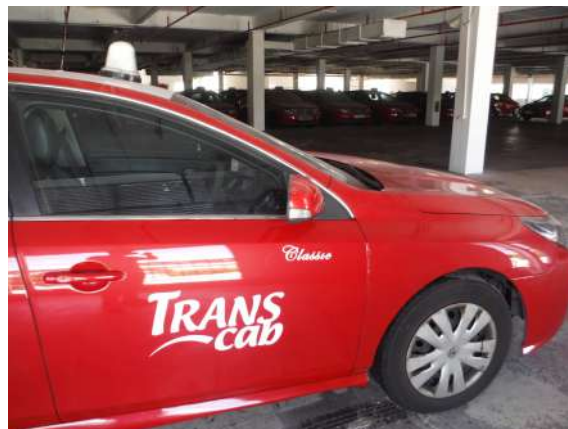
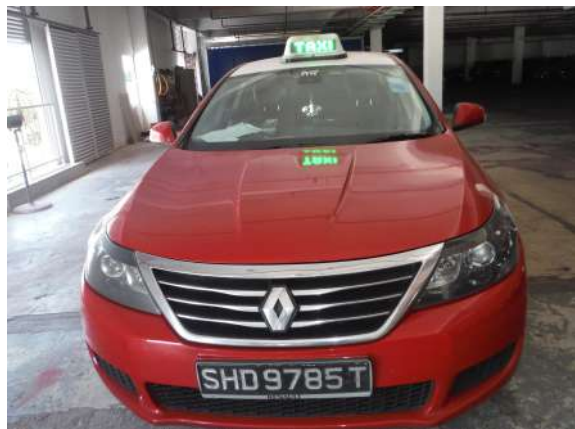
RE-INSPECTION

PHOTOGRAPHS FOR VEHICLE NO. SHD 9785T
