LKK Auto Consultants Pte Ltd

1. Policy Particulars :- THIRD PARTY CLAIM

4. Description of Damages

ADJUSTMENT ON REPAIR COST FOR VEHICLE NO. GBG 3964M

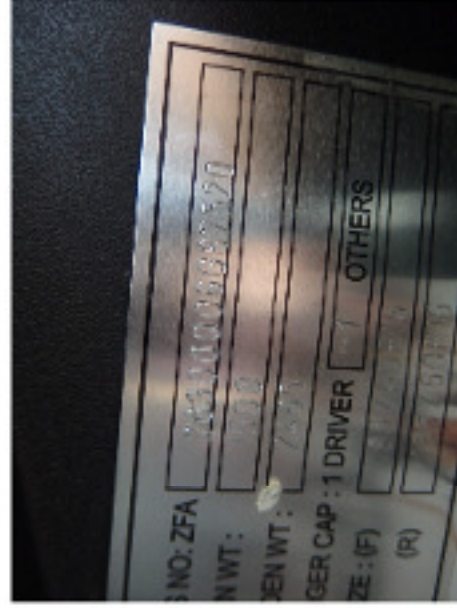
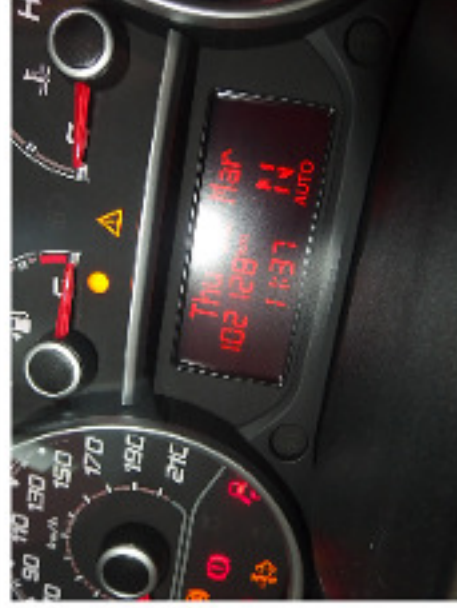
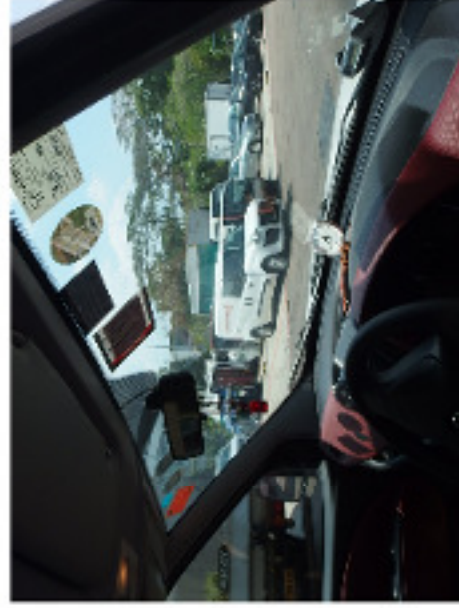
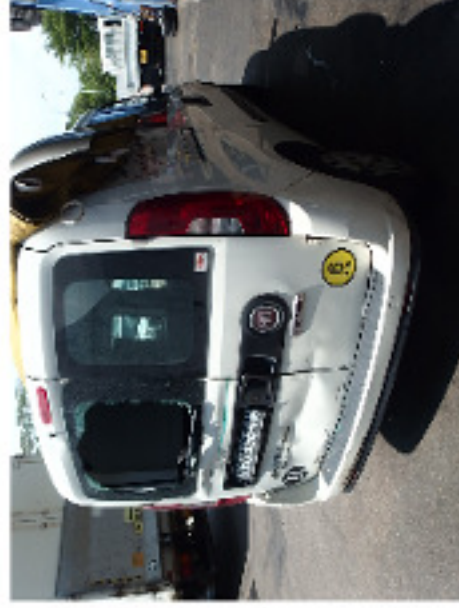
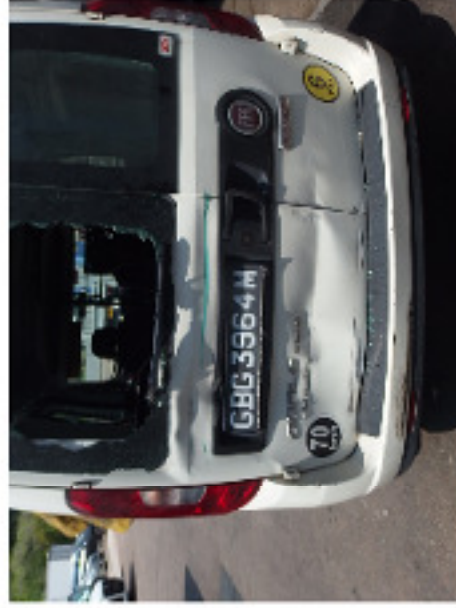
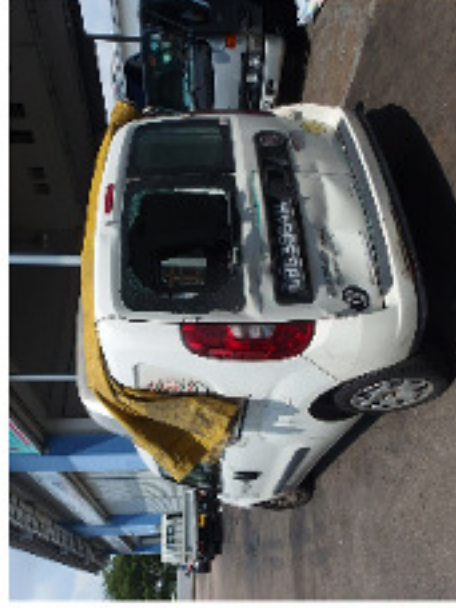
PHOTOGRAPHS FOR VEHICLE NO. GBG 3964M

INSPECTION

THE VEHICLE SUSTAINED DAMAGES AT THE REAR PORTION & REAR WINDSCREEN SHATTERED. DAMAGES SEE DETAILS.
--
