## **PROFESSIONAL SERVICE FEE**

## ADJUSTMENT ON REPAIR COST FOR VEHICLE NO. SJZ 2123K

# PHOTOGRAPHS FOR VEHICLE NO. SJZ 2123K

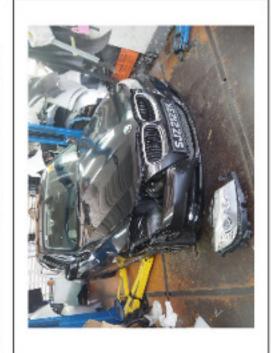
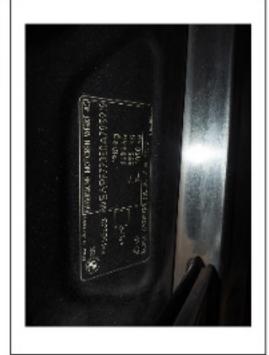
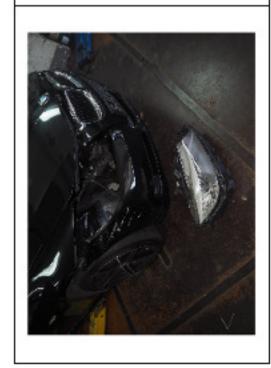
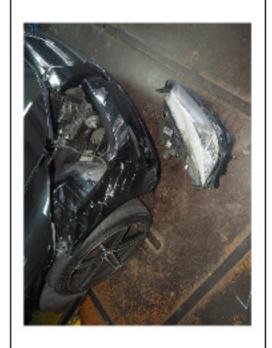
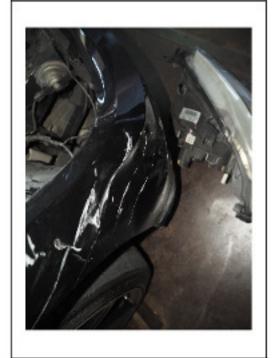
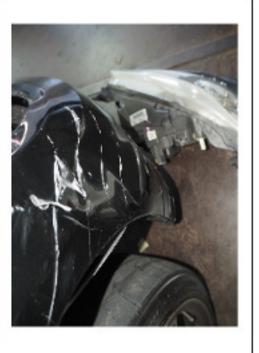
4.		Description	on of Damages		
	THE VEHICLE SU	STAINED DAMAGES AT THE FRO	ONT O/S PORTION.		
	DAMAGES SEE D	ETAILS.			
5.		General	Information		
	Accident Date	12/03/2020	Inspection Date	13/03/2020	
	Survey held at	KANG CAR REPAIRERS PTE LTD  NO.1 KAKI BUKIT AVE 6  #02-06 AUTOBAY @ KAKI BUKIT SINGAPORE 417883			
5a.		Re	emarks		
	A)THE INSPECTION WAS CONDUCTED ON A"WITHOUT PREJUDICE" BASIS. B)IN ACCORDANCE TO YOUR INSTRUCTIONS, WE HAVE NOT AUTHORISED REPAIRS.				
5b.	Estimate Days of Repair				
	ESTIMATED NORMAL PERIOD FOR REPAIR: 5 Working Days
