## LKK Auto Consultants Pte Ltd

## ADJUSTMENT ON REPAIR COST FOR VEHICLE NO. GBD 7642G

## PHOTOGRAPHS FOR VEHICLE NO. GBD 7642G

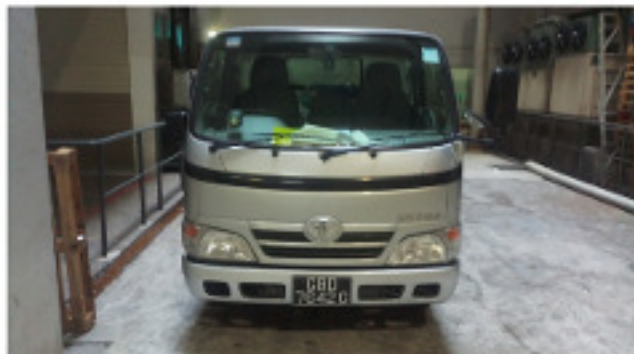
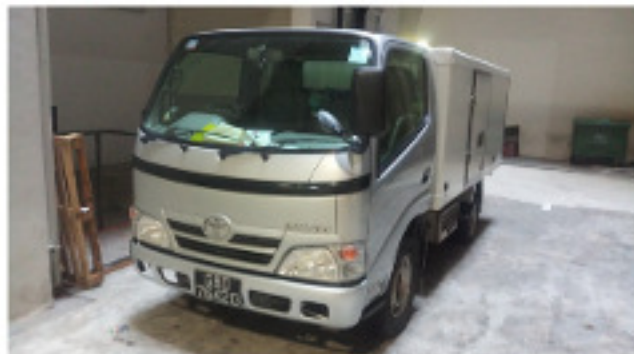
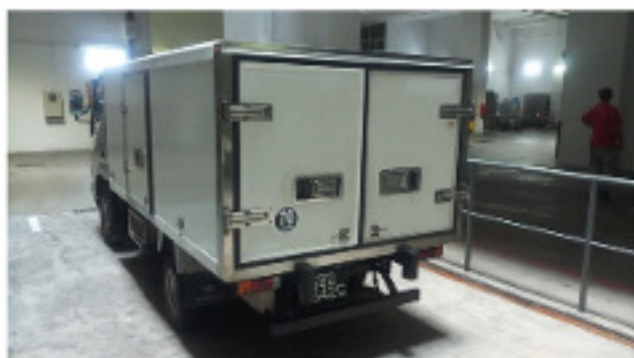
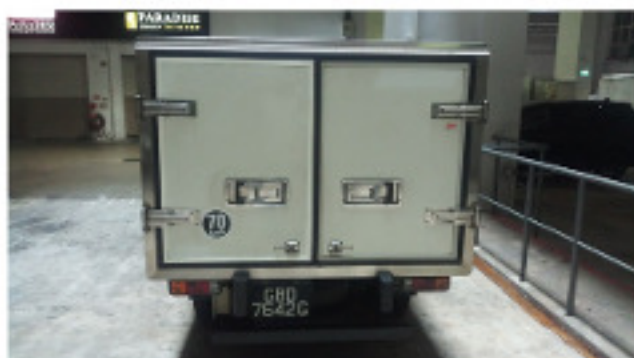
PHOTOGRAPHS FOR VEHICLE NO. GBD 7642G

RE-INSPECTION

<b>4. Description of Damages</b>				
THE VEHICLE SUSTAINED DAMAGES AT THE N/S FRONT PORTION AND REAR N/S PORTION. DAMAGES SEE DETAILS.				
<b>5. General Information</b>				
Accident Date	20/03/2020	Inspection Date	24/03/2020	
Survey held at	18 PANDAN LOOP #01-18 (BLK K) SINGAPORE 128236			
Repairer	LI SHENG AUTOMOBILE TRADING			
<b>5a. Remarks</b>				
A)THE INSPECTION WAS CONDUCTED ON A"WITHOUT PREJUDICE" BASIS. B)IN ACCORDANCE TO YOUR INSTRUCTIONS, WE HAVE NOT AUTHORISED REPAIRS.				
<b>5b. Estimate Days of Repair</b>				
ESTIMATED NORMAL PERIOD FOR REPAIR:		<b>9 Working Days</b>
