LKK Auto Consultants Pte Ltd

ADJUSTMENT ON REPAIR COST FOR VEHICLE NO. SLH 3290A

PHOTOGRAPHS FOR VEHICLE NO. SLH 3290A

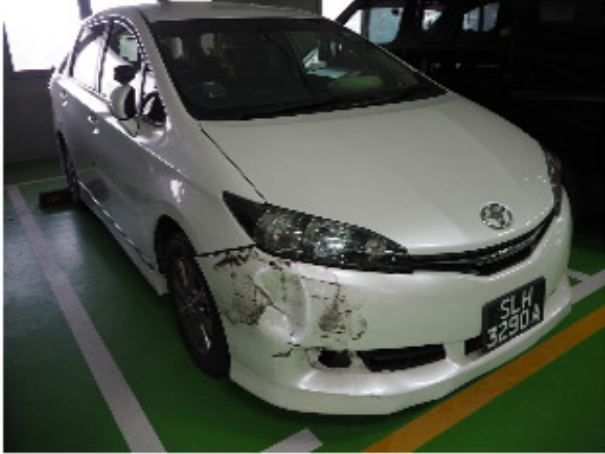
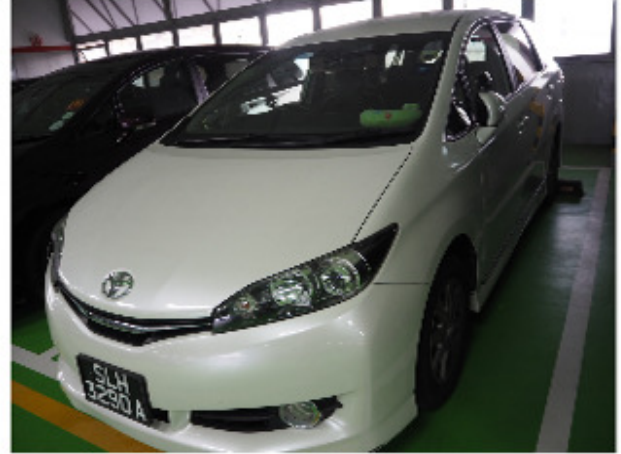
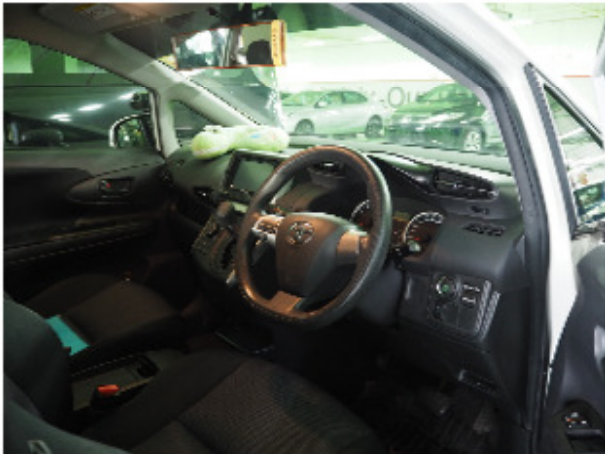
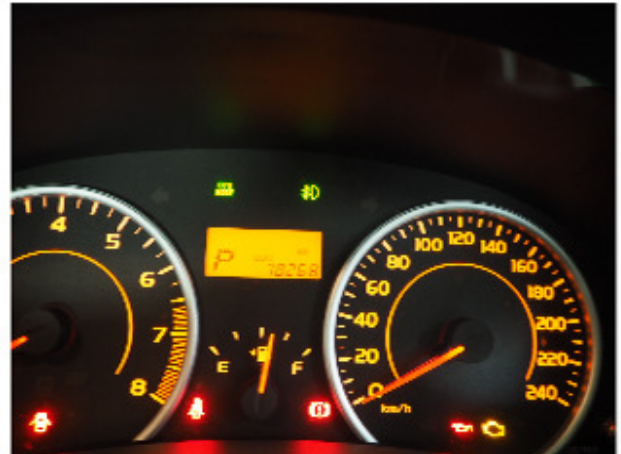
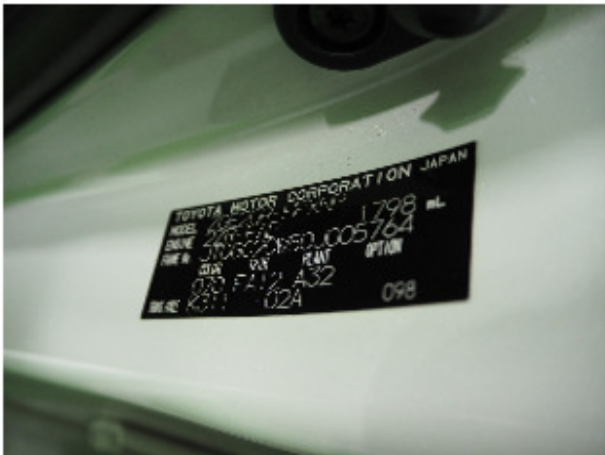
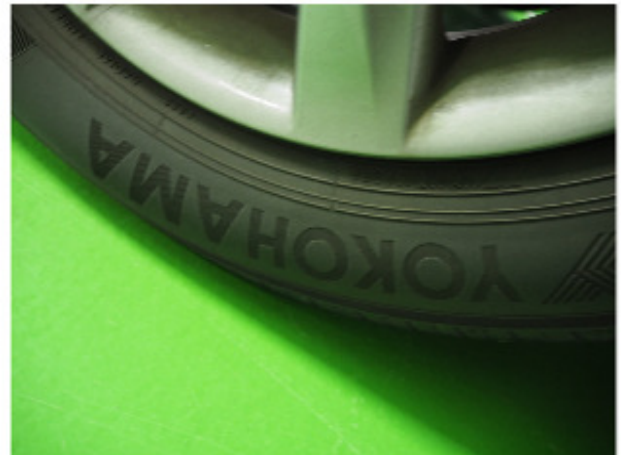
INSPECTION

THE VEHICLE SUSTAINED DAMAGES AT THE FRONT O/S PORTION.

DAMAGES SEE DETAILS.
