LKK Auto Consultants Pte Ltd

ADJUSTMENT ON REPAIR COST FOR VEHICLE NO. SLF 5940E

PHOTOGRAPHS FOR VEHICLE NO. SLF 5940E

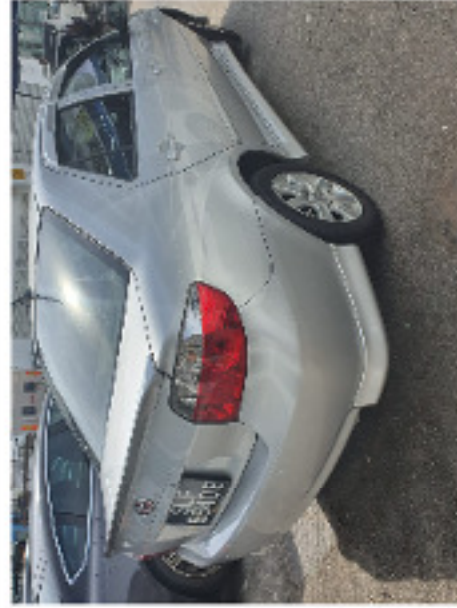
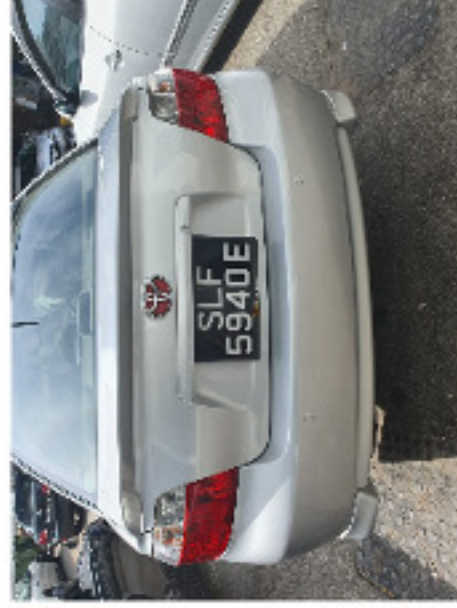
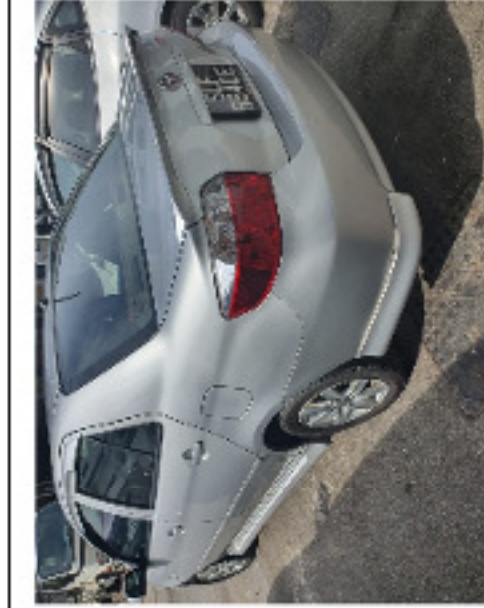
PHOTOGRAPHS FOR VEHICLE NO. SLF 5940E

RE-INSPECTION

THE VEHICLE SUSTAINED DAMAGES AT THE REAR PORTION. DAMAGES SEE DETAILS.
--
