## ADJUSTMENT ON REPAIR COST FOR VEHICLE NO. SJS 4492T

### PHOTOGRAPHS FOR VEHICLE NO. SJS 4492T

### INSPECTION

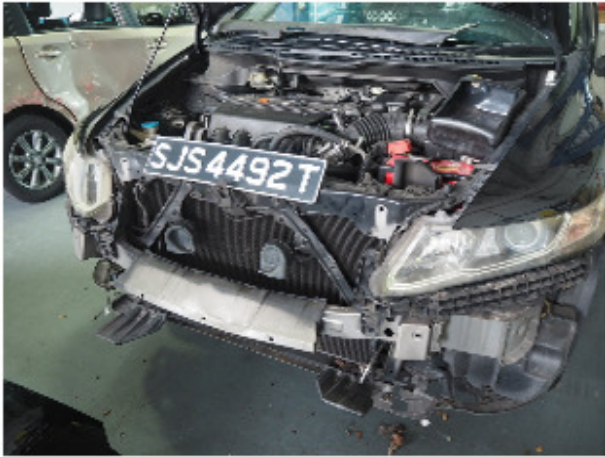
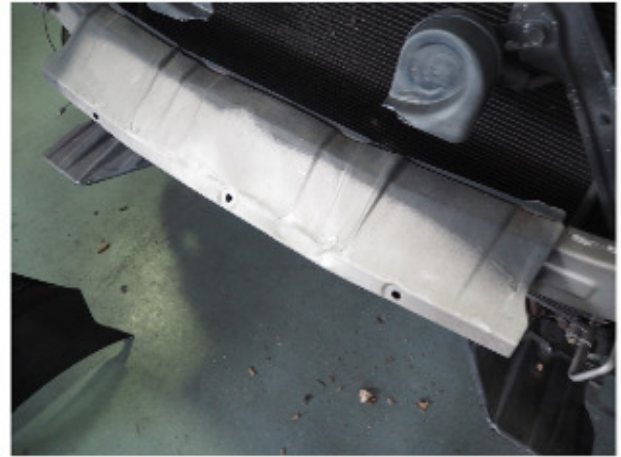
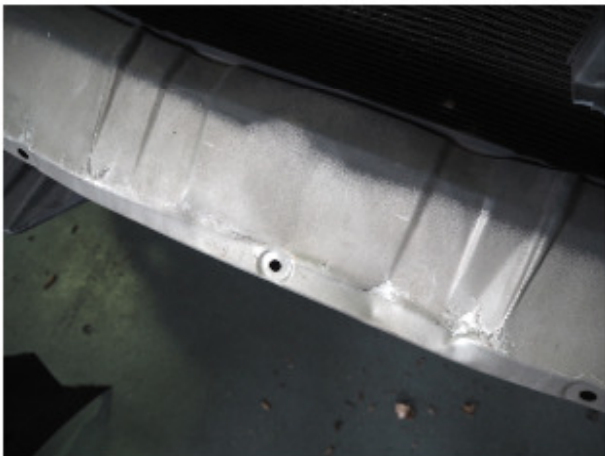
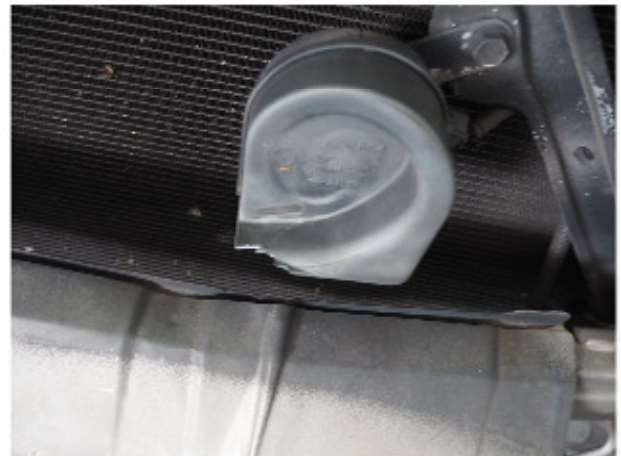
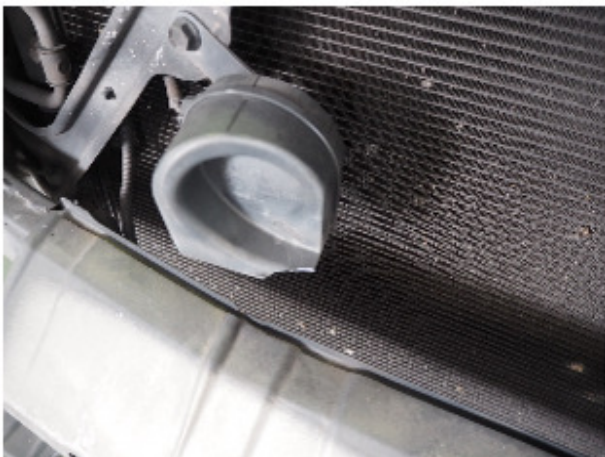
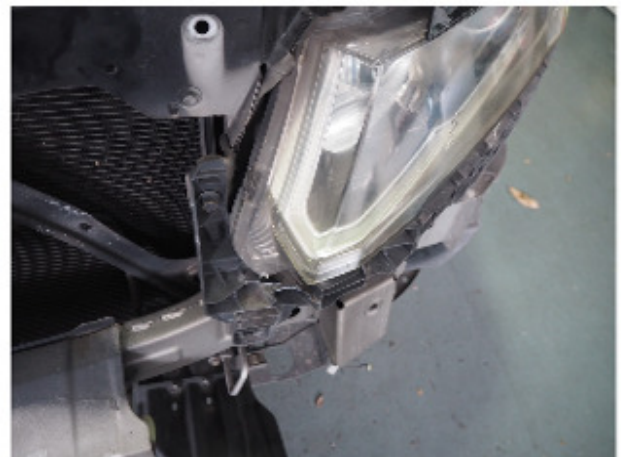
PHOTOGRAPHS FOR VEHICLE NO. SJS 4492T

RE-INSPECTION

<b>4. Description of Damages</b>				
THE VEHICLE SUSTAINED DAMAGES AT THE FRONT AND REAR PORTION. DAMAGES SEE DETAILS.				
<b>5. General Information</b>				
Accident Date	04/04/2020	Inspection Date	07/04/2020	
Survey held at	SK AUTOMOBILE PTE LTD 23 KAKI BUKIT AVE 4 # 03-01 SINGAPORE 415933			
<b>5a. Remarks</b>				
A)THE INSPECTION WAS CONDUCTED ON A"WITHOUT PREJUDICE" BASIS. B)IN ACCORDANCE TO YOUR INSTRUCTIONS, WE HAVE NOT AUTHORISED REPAIRS.				
<b>5b. Estimate Days of Repair</b>				
ESTIMATED NORMAL PERIOD FOR REPAIR:		<b>11 Working Days</b>
