National Assessment Centre Services

ADJUSTMENT ON REPAIR COST FOR VEHICLE NO. SHC 2639J

PHOTOGRAPHS FOR VEHICLE NO. SHC 2639J

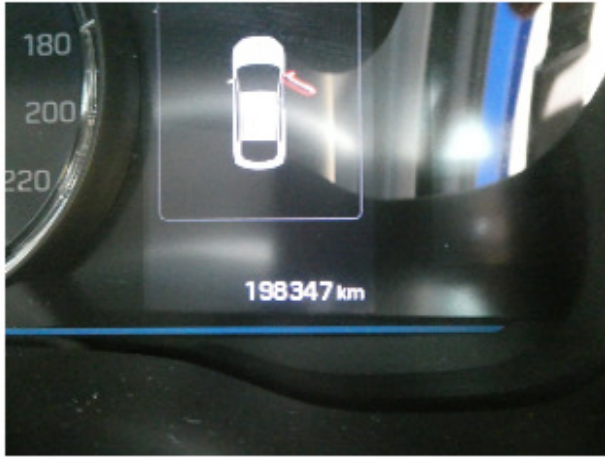
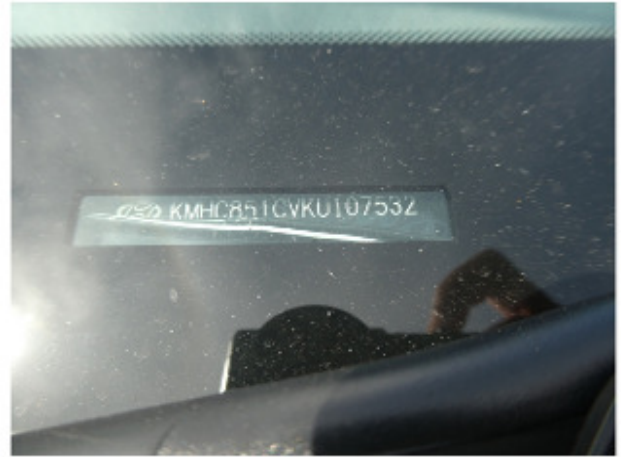
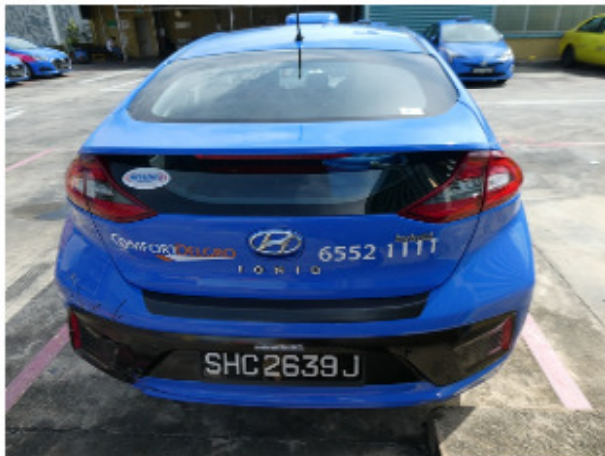
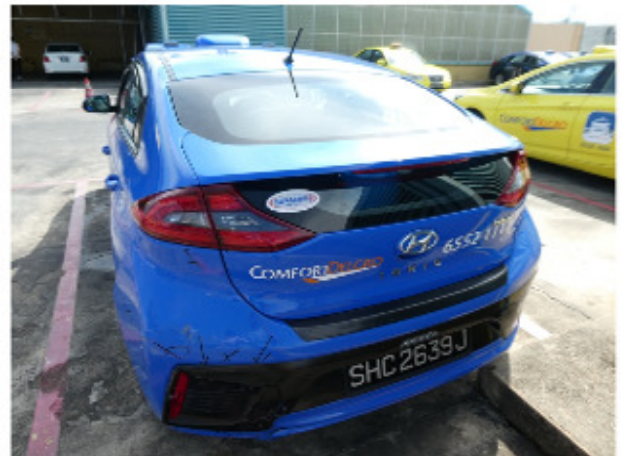
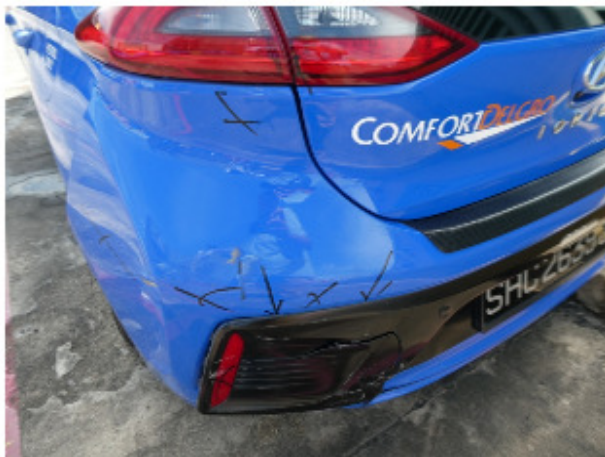
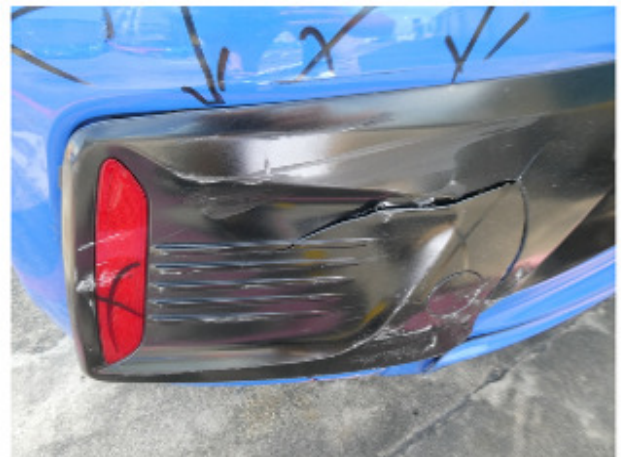
INSPECTION

4. Description of Damages				
	THE VEHICLE SUSTAINED DAMAGES AT THE REAR PORTION. DAMAGES SEE DETAILS.			
5. General Information				
Accident Date	04/04/2020	Inspection Date	06/04/2020	
Survey held at	COMFORTDELGRO ENGINEERING PTE LTD 59 LOYANG DRIVE SINGAPORE 508969			
5a. Remarks				
	A)THE INSPECTION WAS CONDUCTED ON A"WITHOUT PREJUDICE" BASIS. B)IN ACCORDANCE TO YOUR INSTRUCTIONS, WE HAVE NOT AUTHORISED REPAIRS.			
5b. Estimate Days of Repair				
	ESTIMATED NORMAL PERIOD FOR REPAIR: 2 Working Days

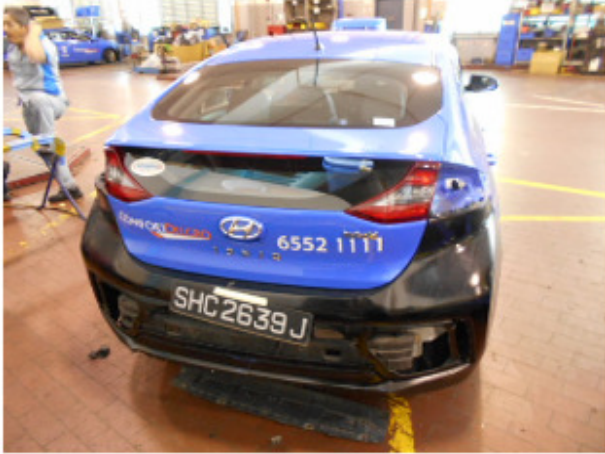
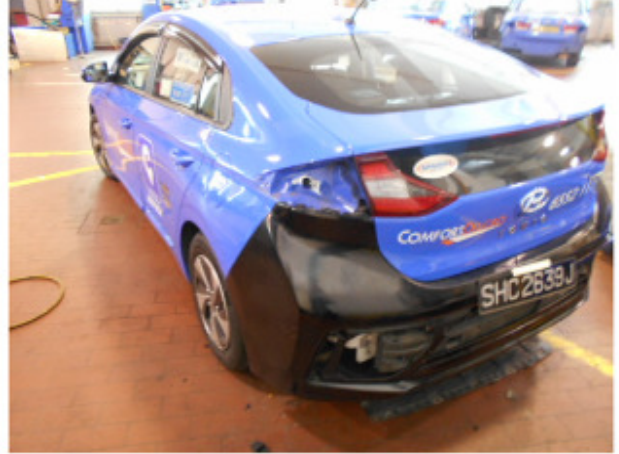
PHOTOGRAPHS FOR VEHICLE NO. SHC 2639J

RE-INSPECTION

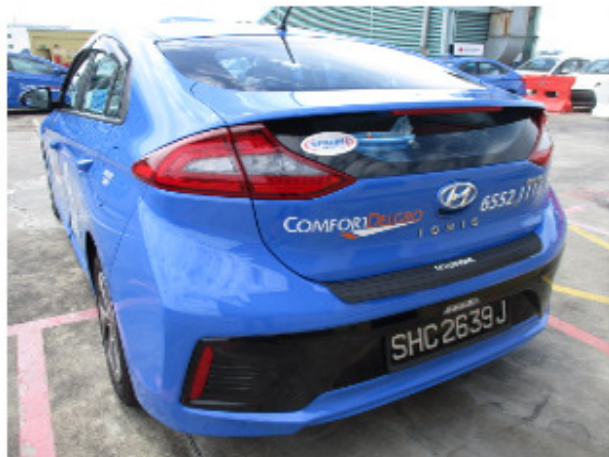
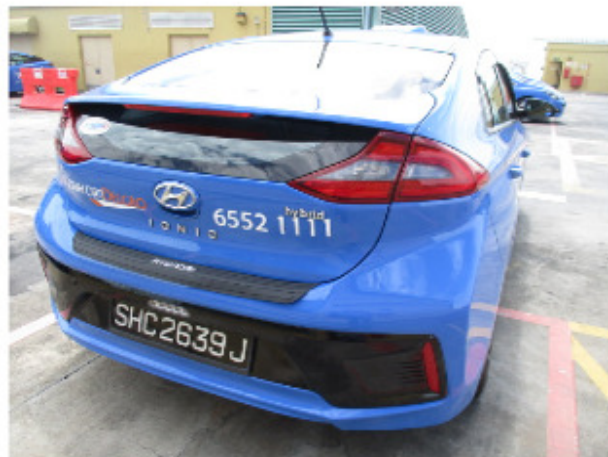
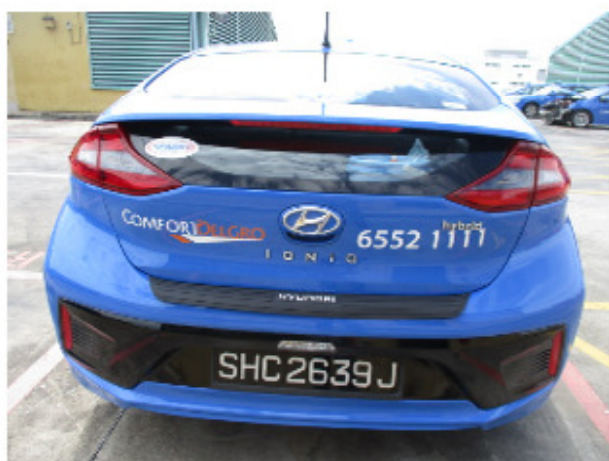
PHOTOGRAPHS FOR VEHICLE NO. SHC 2639J

RE-INSPECTION
