Vehicle No. SHB 6336L

Claim No. MT/1090831-002

#### ADJUSTMENT ON REPAIR COST FOR VEHICLE NO. SHB 6336L

### PHOTOGRAPHS FOR VEHICLE NO. SHB 6336L

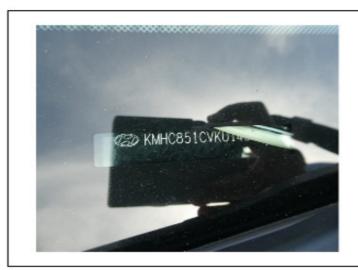
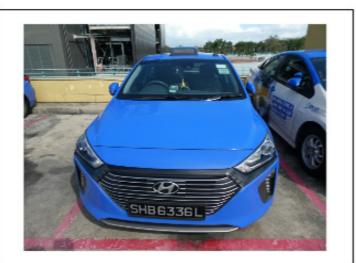
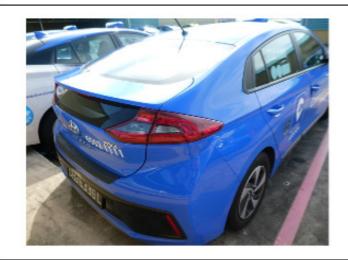
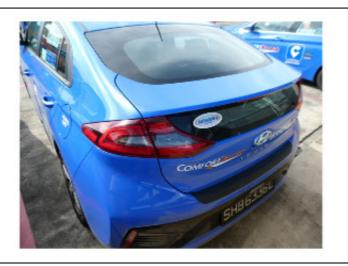
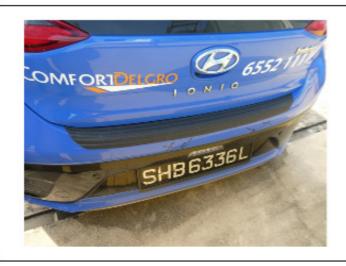
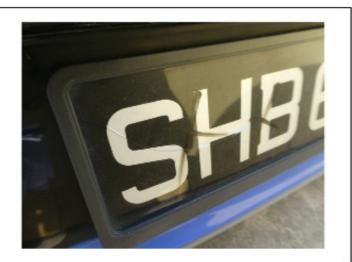
INSPECTION

| NTUC INCOME INSURANCE CO-OPERATIVE LTD | | Ref: | NS/INC20005070/T1qf3n2 | | | | | | |
|--|--|---|---|---|---|--|--|--|--|
| | THE VEHICLE SU | STAINED DAMAGES AT THE REA | AR POR | TION. | | | | | |

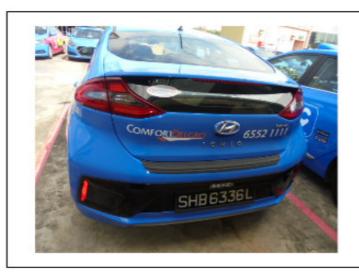
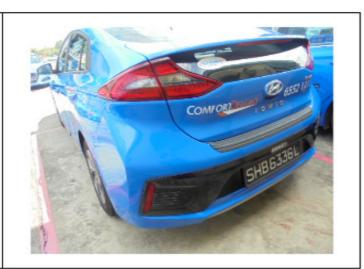
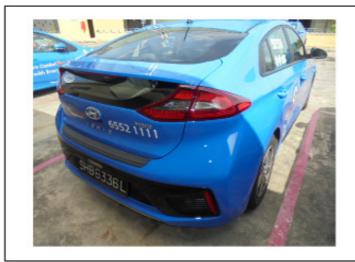
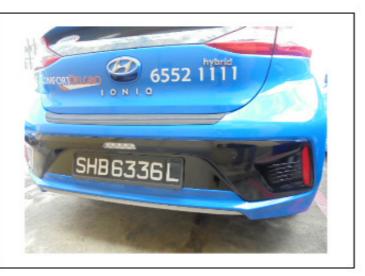
#### PHOTOGRAPHS FOR VEHICLE NO. SHB 6336L

#### RE-INSPECTION
