2.	Vehicle Partic	culars & Condition					
Make & Model	VOLKSWAGEN GOLF (A)	c.c	1395				
Engine No.	HIDDEN	Year of Reg.	2015				
Chassis No.	WVWZZZAUZFW174417	Colour	BLUE				
Odometer	144607	Steering	IN ORDER				
Brakes	IN ORDER	Modification	SPORTS RIM				
General	GOOD

4.	•	on of Damages					
THE VEHICLE SU	STAINED DAMAGES AT THE FR	ONT O/S PORTION.					
DAMAGES SEE D	ETAILS.						
5.	Genera	I Information					
Accident Date	13/04/2020	Inspection Date	17/04/2020				
Survey held at	BLUWEL AUTOMOTIVE SERVI	CE PTE LTD					
	BLK 1 KAKI BUKIT AVE 6 #01-28/51/53/55(MAIN OFFICE) SINGAPORE 417883						
5a.	Re	emarks					
	A)THE INSPECTION WAS CONDUCTED ON A"WITHOUT PREJUDICE" BASIS. B)IN ACCORDANCE TO YOUR INSTRUCTIONS, WE HAVE NOT AUTHORISED REPAIRS.						
5b. Estimate Days of Repair							
ESTIMATED NOR	ESTIMATED NORMAL PERIOD FOR REPAIR: 5 Working Days

ADJUSTMENT ON REPAIR COST FOR VEHICLE NO. SKR 6845P

PHOTOGRAPHS FOR VEHICLE NO. SKR 6845P

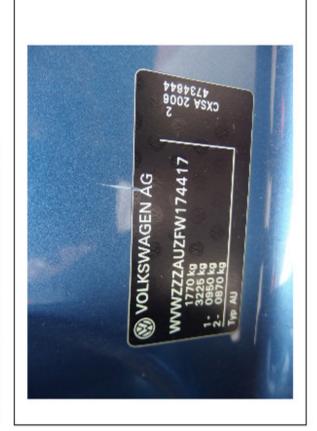
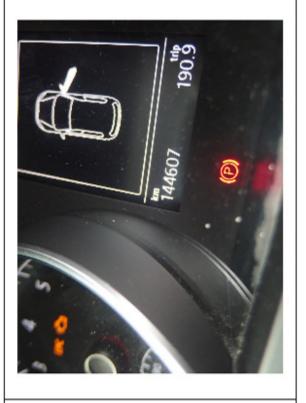
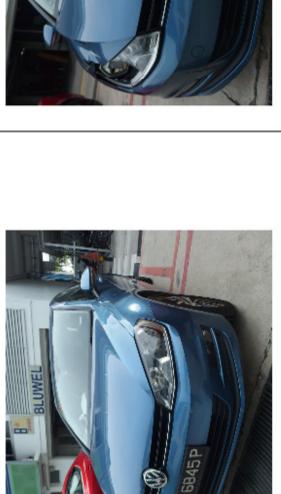
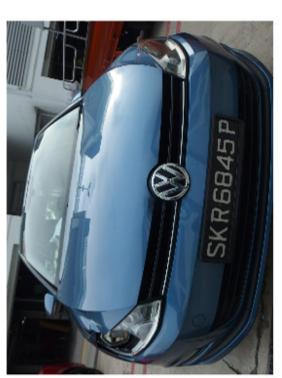
INSPECTION

Qty	Description of Parts	Condition	Estimate By Workshop (\$))	Our Adjusted (\$)
	REPLACEMENT OF PARTS			
1	BONNET	DENTED / BUCKLED	1,380.97	1,380.97
2	BONNET HINGES @\$64.89	SERVICEABLE	129.78	-
1	BONNET RUBBER	NECESSARY	63.79	63.79
1	BONNET INSULATOR	NOT NECESSARY	205.30	-
1	FRONT BUMPER	TO REPAIR SEE LABOUR	1,076.45	-
1	HEADLAMP O/S	BROKEN	2,009.71	2,009.71
1	HEADLAMP TOP PANEL O/S	BENT	199.00	199.00
1	FRONT FENDER O/S	BUCKLED	594.12	594.12
1	FRONT FENDER INNER SHIELD O/S	DEFORMED	188.20	188.20
1	SET FRONT FENDER INNER SHIELD CLIPS O/S	NECESSARY	50.00	50.00
1	FRONT FENDER INNER PANEL O/S	BENT	699.10	699.10
1	FRONT DOOR O/S	TO REPAIR SEE LABOUR	1,002.65	-
1	FRONT RETAINER O/S	CRACKED	65.12	65.12
	LESS 10% DISCOUNT		-	-525.00
			7,664.19	4,725.01
	<u>LABOUR</u>			
	TO CHECK WIRING.		50.00	20.00
	TO SPRAY RUST PROOFING.		80.00	80.00
	TO REFILL AIR CON GAS.	NOT NECESSARY	120.00	-
	LABOUR FOR PANEL BEATING & REPLACING PARTS.INCLUSIVE OF THE REPAIR OF FRONT BUMPER AND FRONT DOOR O/S.		800.00	700.00

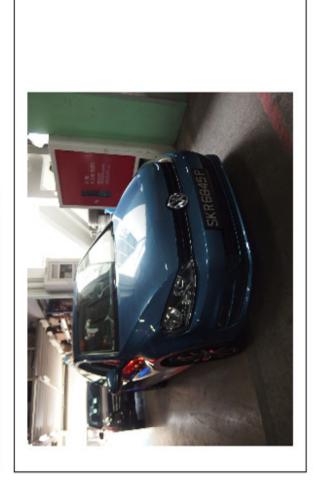
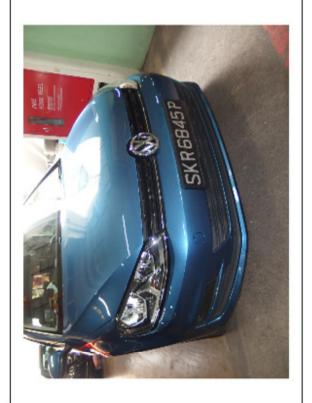
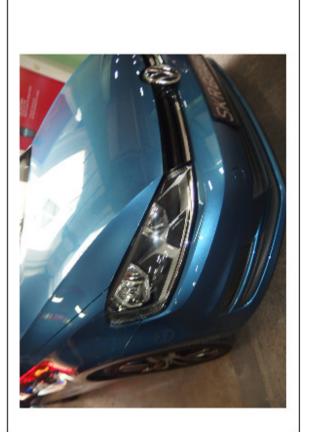
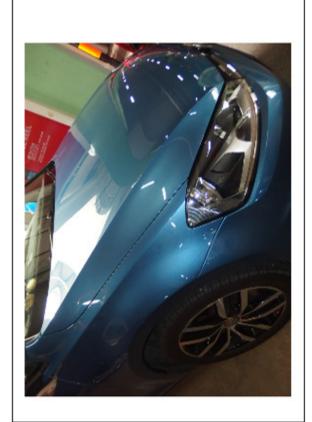
PHOTOGRAPHS FOR VEHICLE NO. SKR 6845P

RE-INSPECTION
