PROFESSIONAL SERVICE FEE

Vehicle No. SDJ 8282A
Insured Veh. SKM 8361G
Claim No. C10006202
Policy No.
Accident Date 19/04/2020
Inspection Date 21/04/2020

4. Description of Damages

PHOTOGRAPHS FOR VEHICLE NO. SDJ 8282A

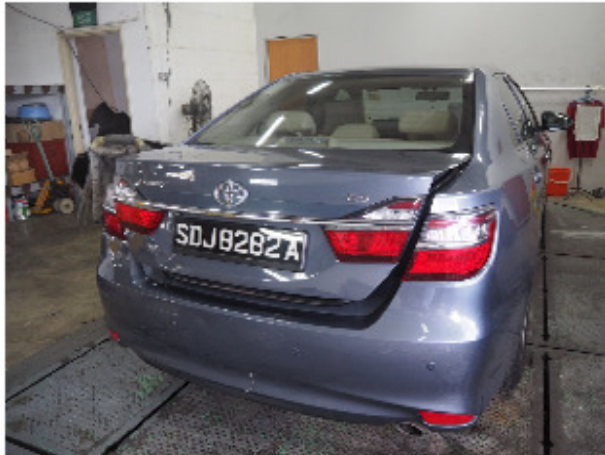
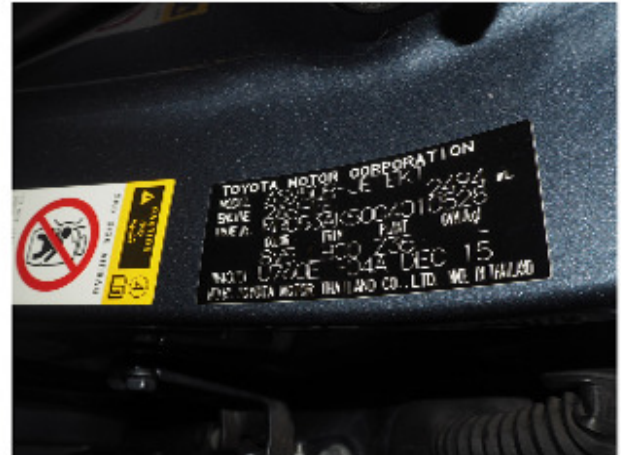
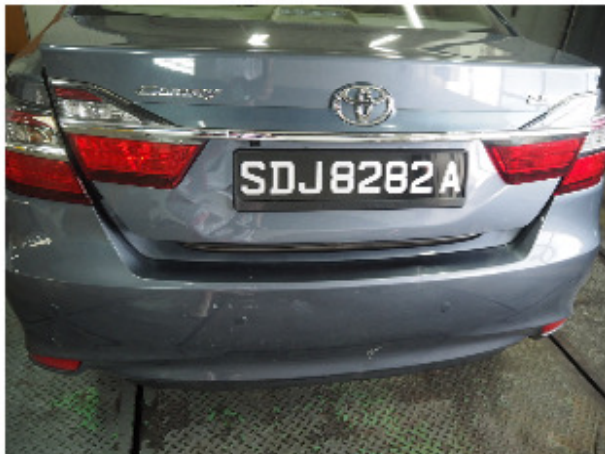
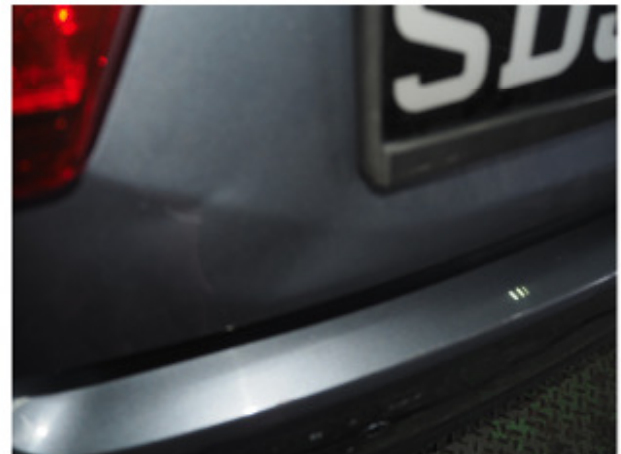
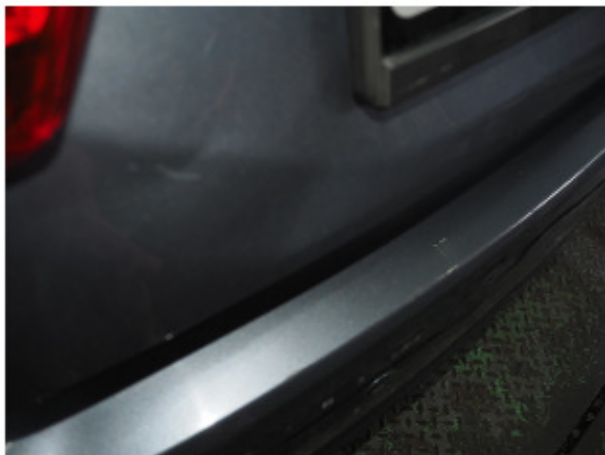
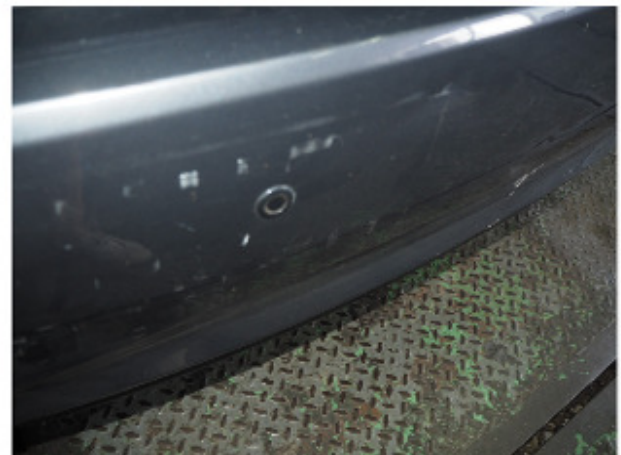
INSPECTION

THE VEHICLE SUSTAINED DAMAGES AT THE REAR PORTION. DAMAGES SEE DETAILS.
--

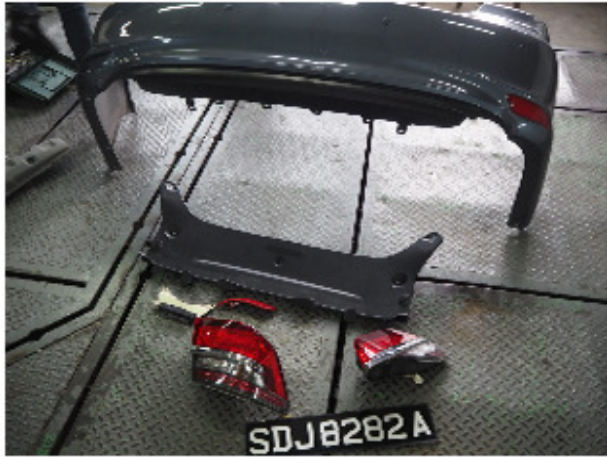
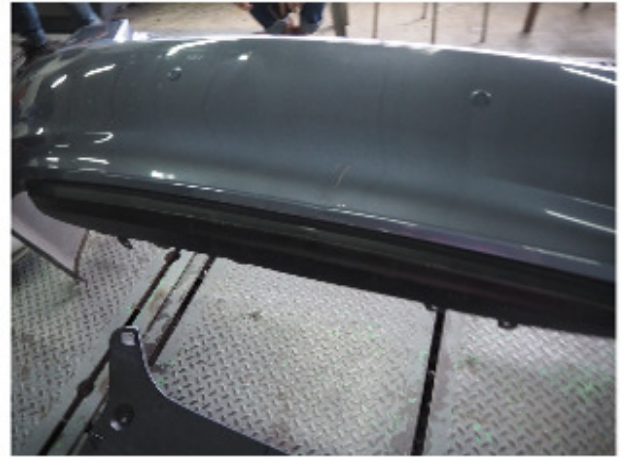
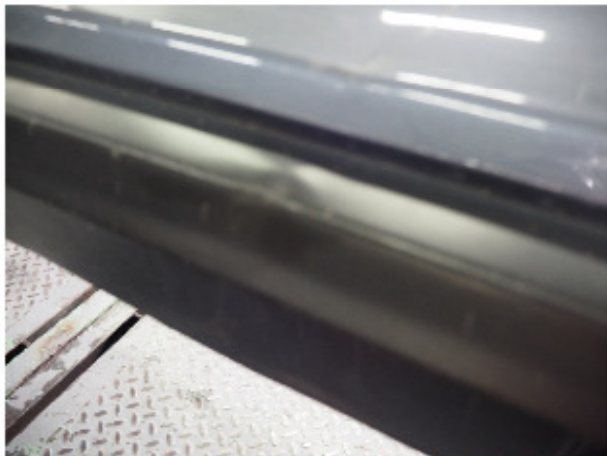
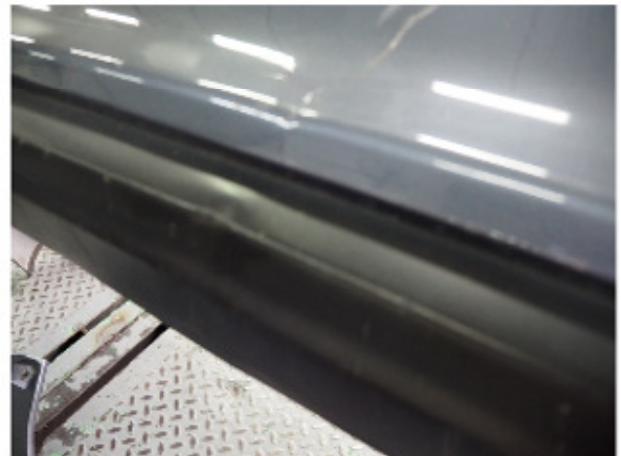
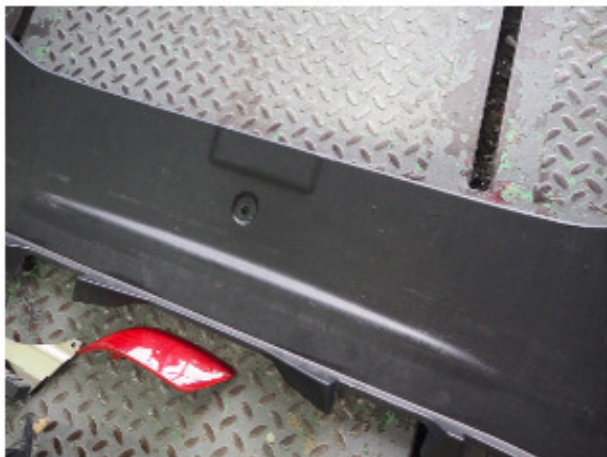
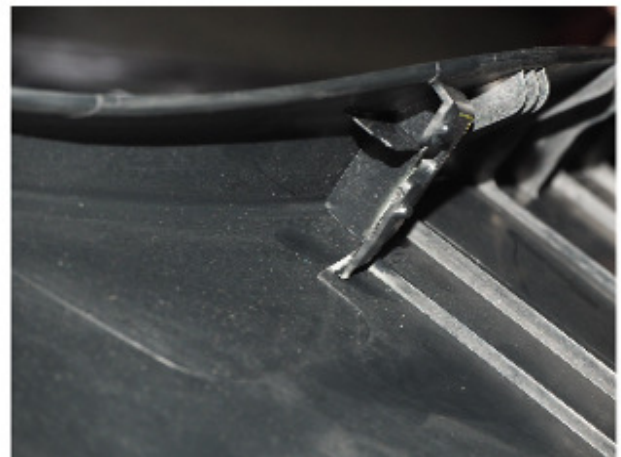
RE-INSPECTION

PHOTOGRAPHS FOR VEHICLE NO. SDJ 8282A
