Affiliated to Federation Internationale Des Experts En Automobile						
SOMPO INSURANCE SINGAPORE PL Ref : CS/S			Ref : CS/SMO20005340	/Esf3n2		
50 RAFFLES PLACE #05-01/06 SINGAPORE LAND TOWERSINGAPORE 048623		Date: 08-05-2020 Code: SMO

2.		Vehicle Partic	culars & Condition			
	Make & Model	SSANGYONG TIVOLI XLV	c.c	1597		
	Engine No.	HIDDEN	Year of Reg.	2017		
	Chassis No.	KPT36B1VSHP145838	Colour	GREY		
	Odometer	118591	Steering	IN ORDER		
	Brakes	IN ORDER	Modification	SPORTS RIM		
	General	GOOD

ADJUSTMENT ON REPAIR COST FOR VEHICLE NO. SLQ 4173B

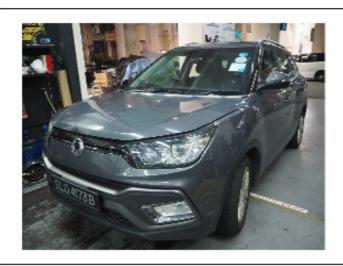
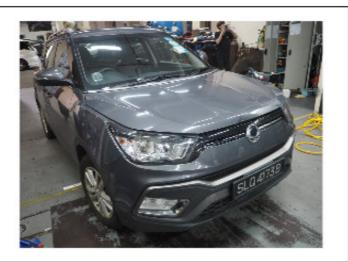
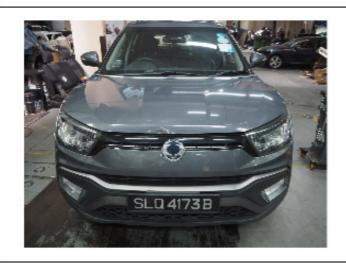
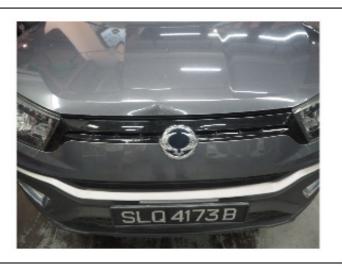
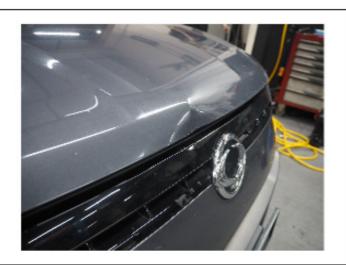
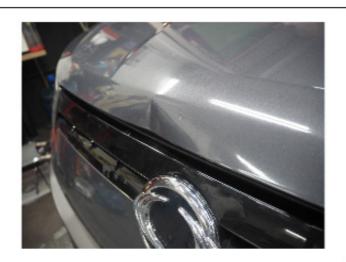
PHOTOGRAPHS FOR VEHICLE NO. SLQ 4173B

4.		•	on of Damages			
	THE VEHICLE SU	STAINED DAMAGES AT THE FRO	ONT PORTION.			
	DAMAGES SEE D					
5.		General	Information			
	Accident Date	13/04/2020	Inspection Date	30/04/2020		
	Survey held at	MY CAR CONSULTANT PTE LT	D			
	53 UBI AVENUE 1 #01-33 PAYA UBI INDUSTRIAL PARK SINGAPORE 408934					
5a.			emarks			
	A)THE INSPECTION WAS CONDUCTED ON A"WITHOUT PREJUDICE" BASIS. B)IN ACCORDANCE TO YOUR INSTRUCTIONS, WE HAVE NOT AUTHORISED REPAIRS.					
5b.	b. Estimate Days of Repair					
	ESTIMATED NORI	MAL PERIOD FOR REPAIR:	3 Working Days
